## Defect Listing

Pipe Segment Refere... <b>E10-1_E6-2</b>	City <b>Oliver Springs</b>	Street <b>Gail Ln</b>	Material <b>PolyVinyl Chloride</b>	Location C... <b>Easement/R...</b>	Sewer Use <b>Sanitary</b>
Upstream MH <b>E10-1</b>	Total Length <b>122.3</b>	Year Laid	Shape <b>Circular</b>	Location Details <b>Side of Road way</b>	
DS Manhole <b>E6-2</b>	Length surveyed <b>122.3</b>	Year Renewed	Height <b>8</b>	Width <b>8</b>	Pipe Joint... <b>13</b>

SPR <b>N/A</b>	MPR <b>11</b>	PO Number <b>4397-03</b>	Customer <b>GRW</b>		
SPRI <b>N/A</b>	MPRI <b>2.8</b>	Work Order <b>4397-02</b>	Purpose <b>Pre-Rehabilitation Survey</b>		
QSR <b>N/A</b>	QMR <b>4131</b>				
OPR <b>11</b>	Surveyed By <b>Barry Rogers</b>	Direction <b>Downstream</b>	Date <b>20150617</b>	Media label	
OPRI <b>2.8</b>	Certificate Number <b>U-1012-16405</b>	Pre-Cleaning <b>Heavy Cleaning</b>	Time <b>12:45</b>	Weather <b>Very Dry</b>	
Date Cleaned <b>20150617</b>			End Time <b>12:56</b>	Additional Info

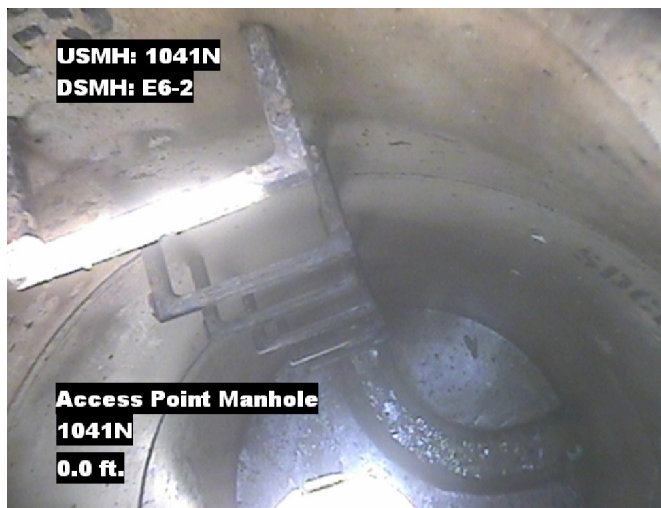
Distance: 0.0 ft. Grade: 0  
Condition: Access Point Manhole  
Remarks: E10-1

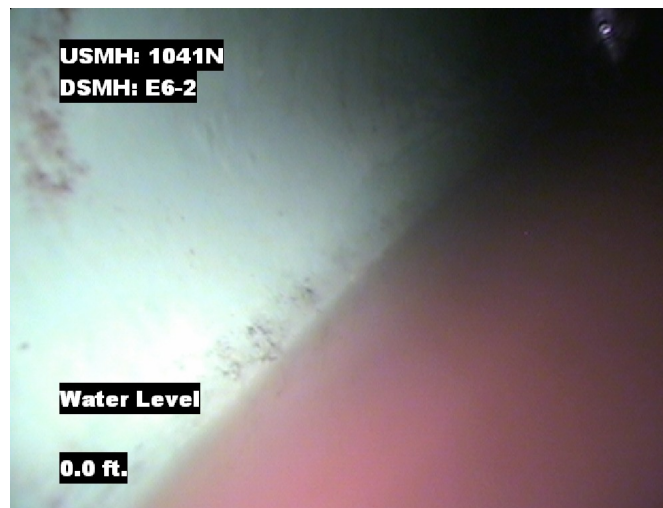
Distance: 0.0 ft. Grade: 0  
Condition: Water Level  
Remarks: N/A

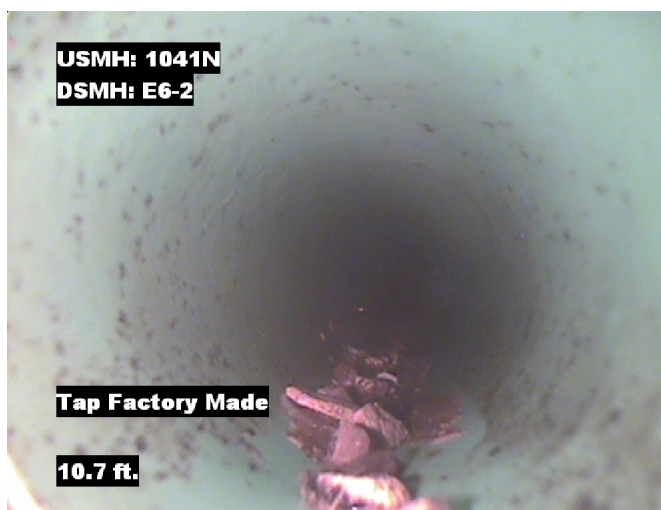
Distance: 10.7 ft. Grade: 0  
Condition: Tap Factory Made  
Remarks: N/A

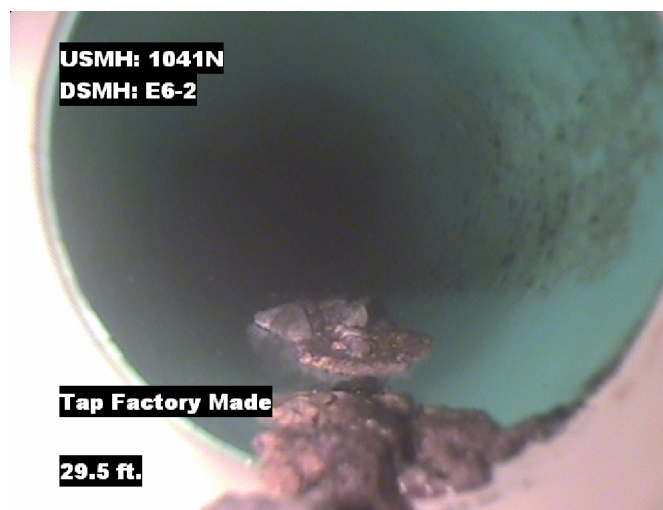
Distance: 29.5 ft. Grade: 0  
Condition: Tap Factory Made  
Remarks: N/A

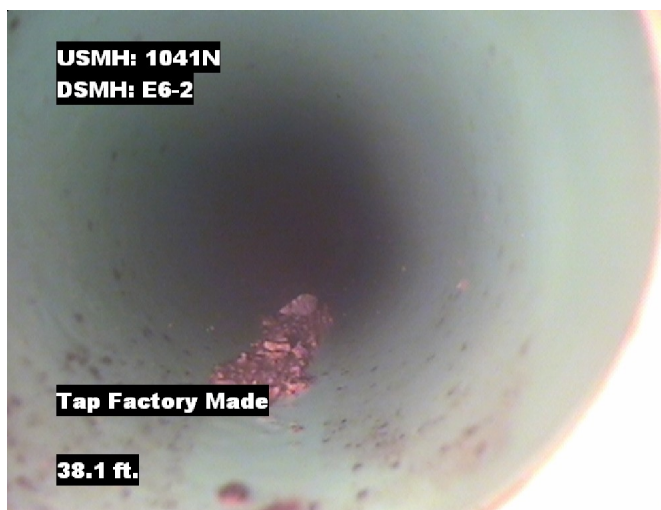
Distance: 38.1 ft. Grade: 0  
Condition: Tap Factory Made  
Remarks: N/A

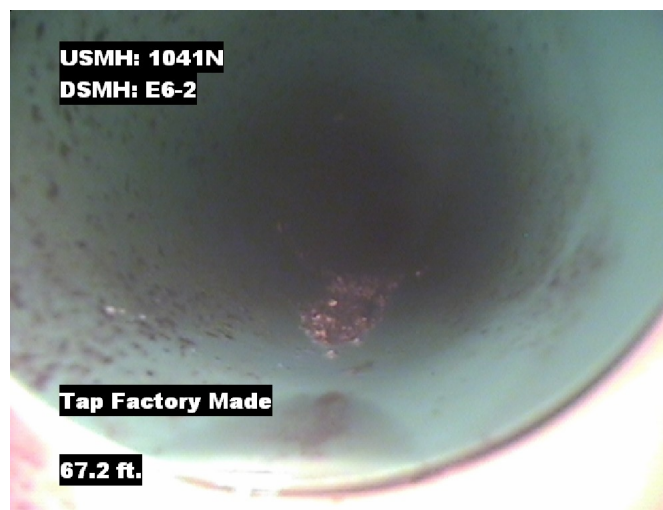
Distance: 67.2 ft. Grade: 0  
Condition: Tap Factory Made  
Remarks: N/A

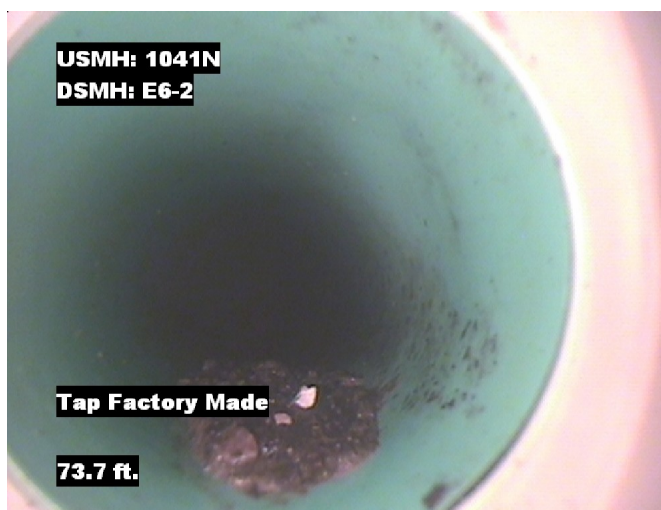
Distance: 73.7 ft. Grade: 0  
Condition: Tap Factory Made  
Remarks: N/A

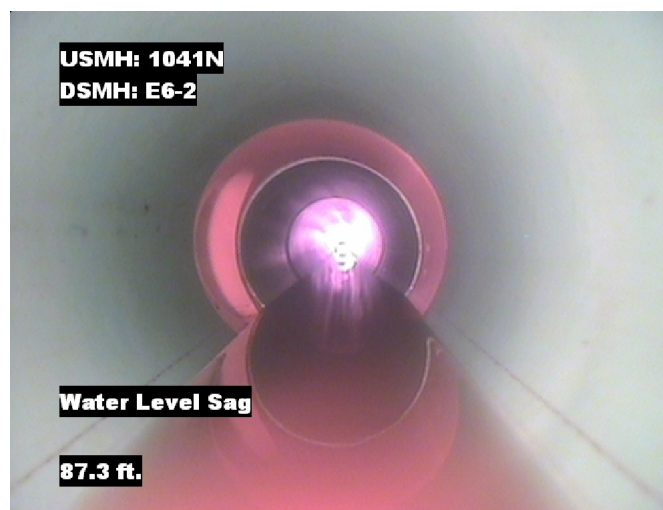
Distance: 87.3 ft. Grade: 2  
Condition: Water Level Sag  
Remarks: N/A

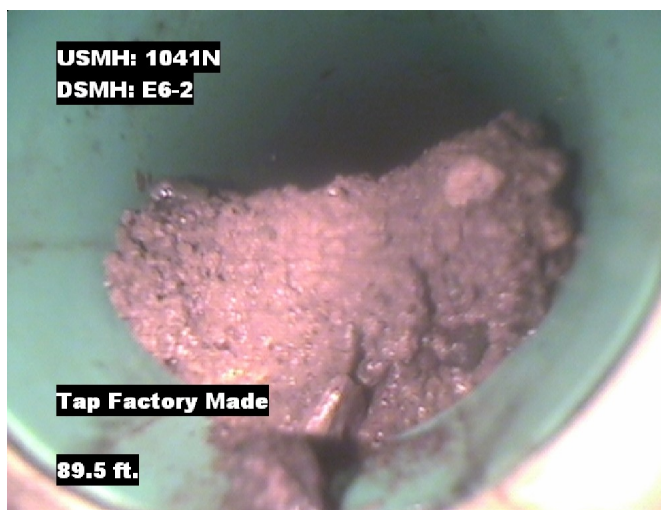
Distance: 89.5 ft. Grade: 0  
Condition: Tap Factory Made  
Remarks: N/A

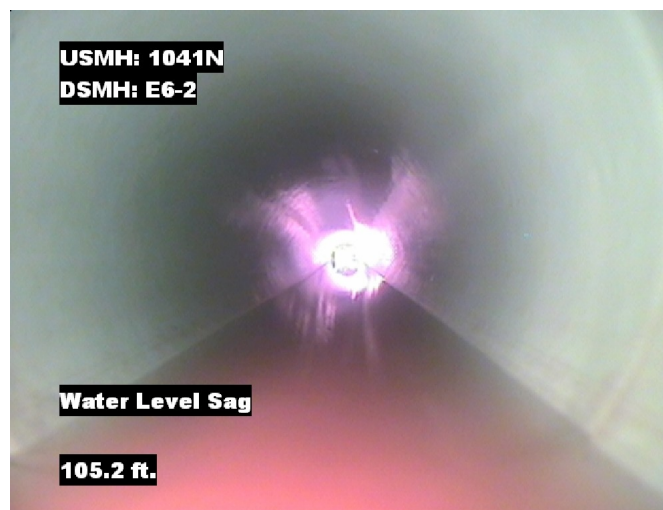
Distance: 105.2 ft. Grade: 2  
Condition: Water Level Sag  
Remarks: N/A

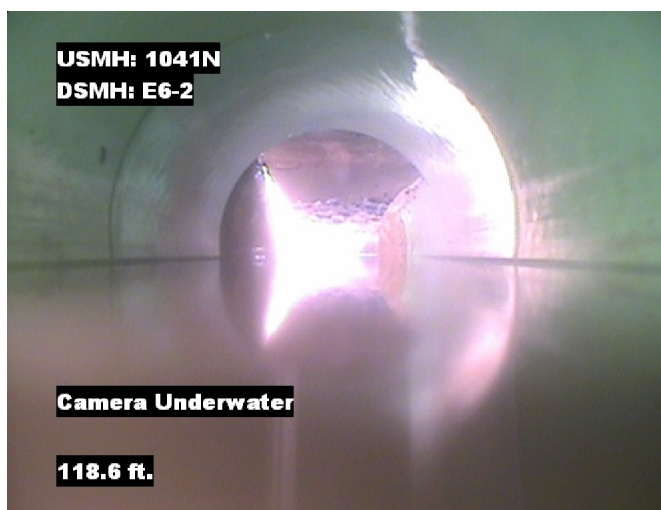
Distance: 118.6 ft. Grade: 4  
Condition: Camera Underwater  
Remarks: N/A

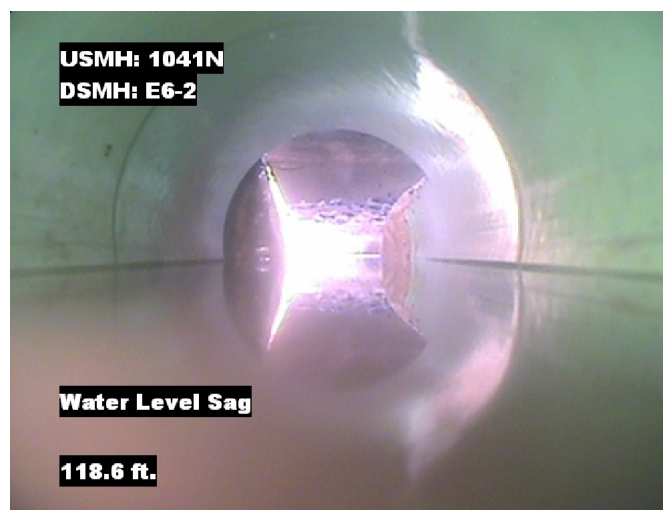
Distance: 118.6 ft. Grade: 3  
Condition: Water Level Sag  
Remarks: N/A

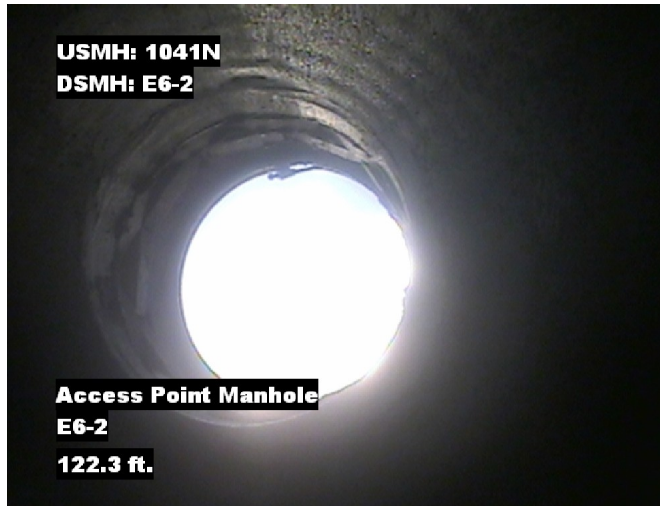
Distance: 122.3 ft.      Grade: 0  
Condition: Access Point Manhole  
Remarks: E6-2
