Defect Listing

Pipe Segment Refere... E10-2_E10-1	City Oliver Springs	Street Sturbridge Dr	Material PolyVinyl Chloride		Location C... Light High...	Sewer Use Sanitary
Upstream MH E10-2	Total Length 97.1	Year Laid	Shape Circular		Location Details New Subdivision	
DS Manhole E10-1	Length surveyed 97.1	Year Renewed	Height 8	Width 8	Pipe Joint... 13

SPR N/A	MPR N/A	PO Number 4397-03		Customer GRW	
SPRI N/A	MPRI N/A	Work Order 4397-02		Purpose Pre-Rehabilitation Survey	
QSR N/A	QMR N/A				
OPR N/A	Surveyed By Barry Rogers	Direction Downstream	Date 20150617		Media label
OPRI N/A	Certificate Number U-1012-16405	Pre-Cleaning Jetting	Time 10:50		Weather Very Dry
Date Cleaned 20150617			End Time 10:57		Additional Info

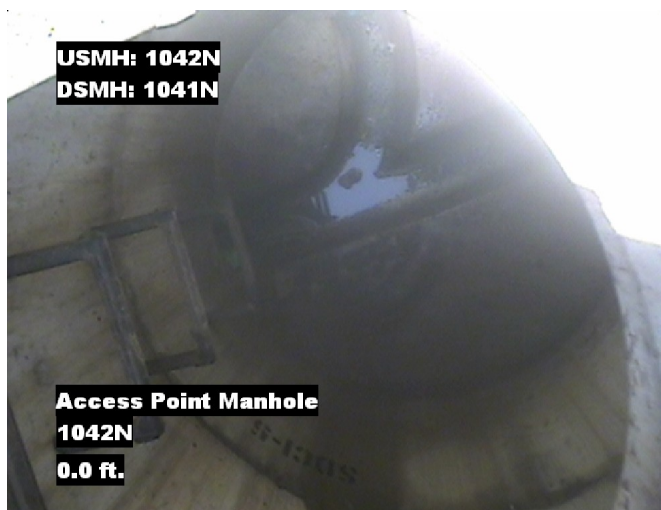
Distance: 0.0 ft. Grade: 0
Condition: Access Point Manhole
Remarks: E10-2

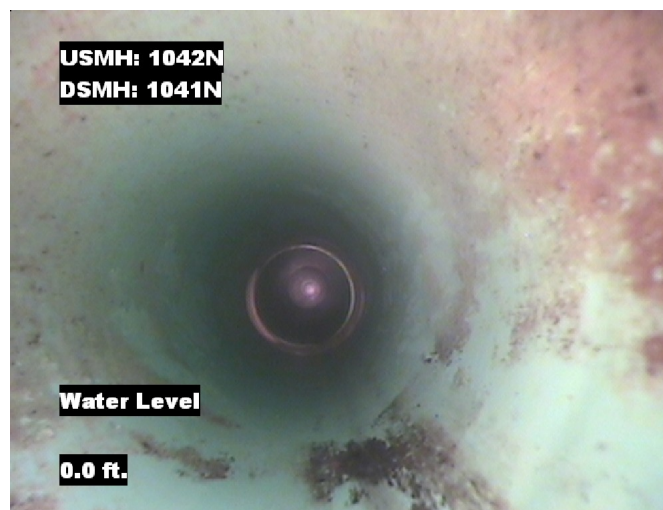
Distance: 0.0 ft. Grade: 0
Condition: Water Level
Remarks: N/A

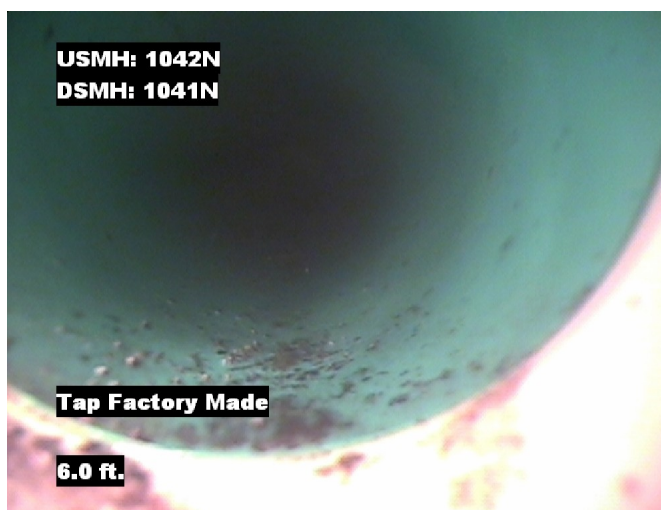
Distance: 6.0 ft. Grade: 0
Condition: Tap Factory Made
Remarks: N/A

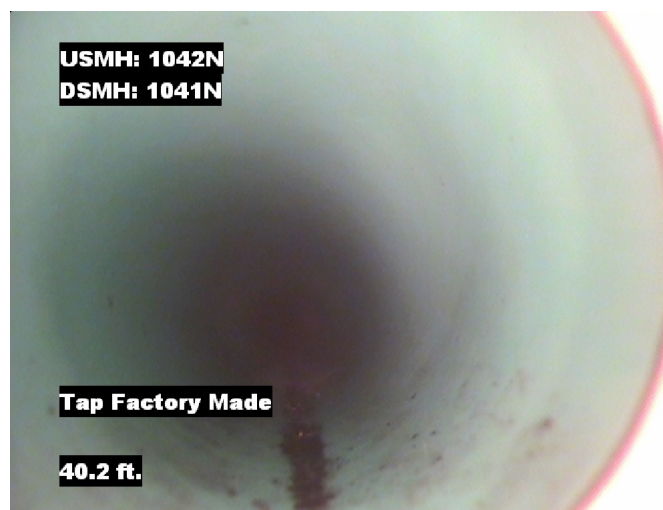
Distance: 40.2 ft. Grade: 0
Condition: Tap Factory Made
Remarks: N/A

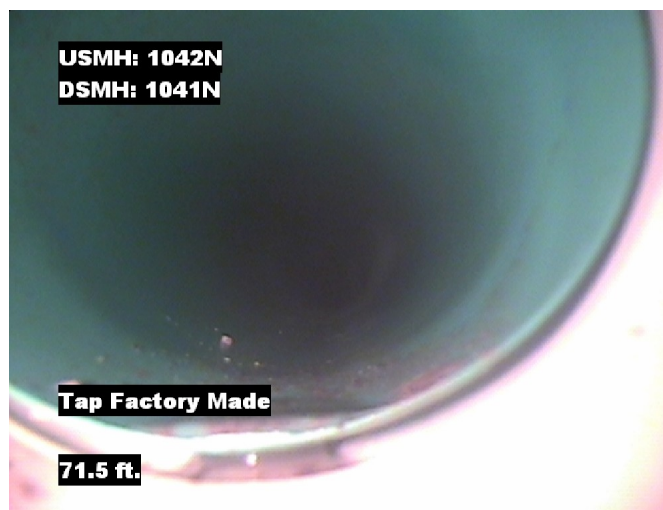
Distance: 71.5 ft. Grade: 0
Condition: Tap Factory Made
Remarks: N/A

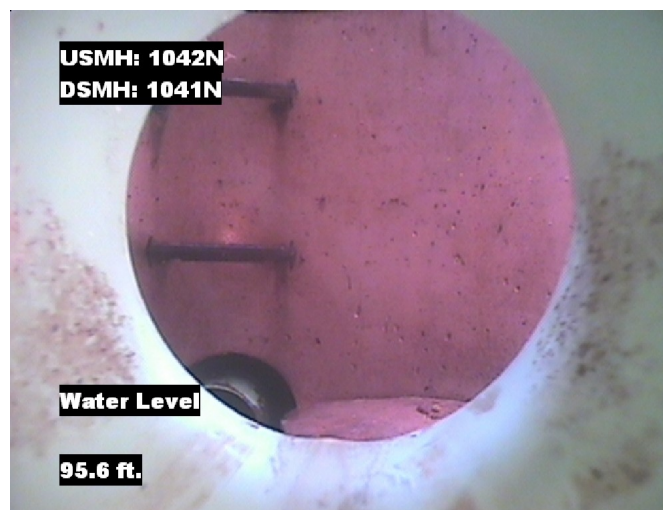
Distance: 95.6 ft. Grade: 0
Condition: Water Level
Remarks: N/A

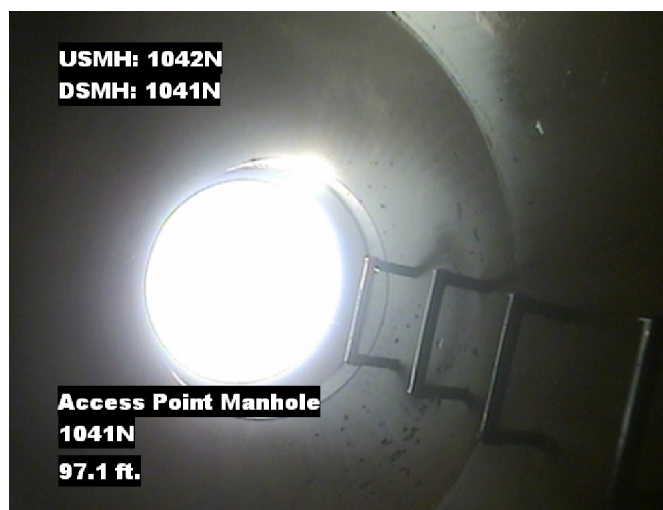
Distance: 97.1 ft. Grade: 0
Condition: Access Point Manhole
Remarks: E10-1
