## Defect Listing

| Pipe Segment Refere...<br><b>E10-4 E10-1</b> | City<br><b>Oliver Springs</b> | Street<br><b>Sturbridge Dr</b> | Material<br><b>PolyVinyl Chloride</b> | Location C...<br><b>Easement/R...</b> | Sewer Use<br><b>Sanitary</b> |

| SPRI<br><b>N/A</b> | MPRI<br><b>N/A</b> | Work Order<br><b>4397-02</b> | | Purpose<br><b>Pre-Rehabilitation Survey</b> | |

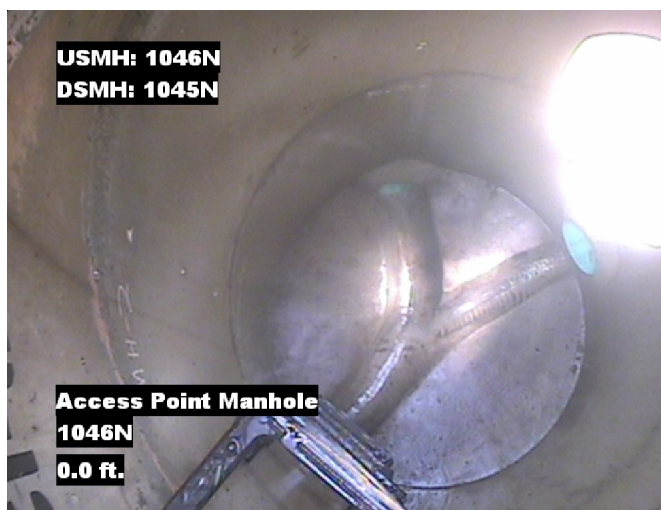
Distance: 0.0 ft. Grade: 0  
Condition: Access Point Manhole  
Remarks: E10-4

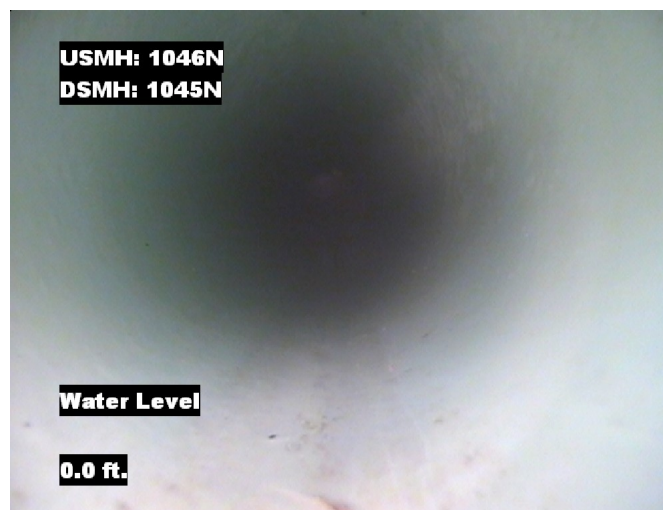
Distance: 0.0 ft. Grade: 0  
Condition: Water Level  
Remarks: N/A

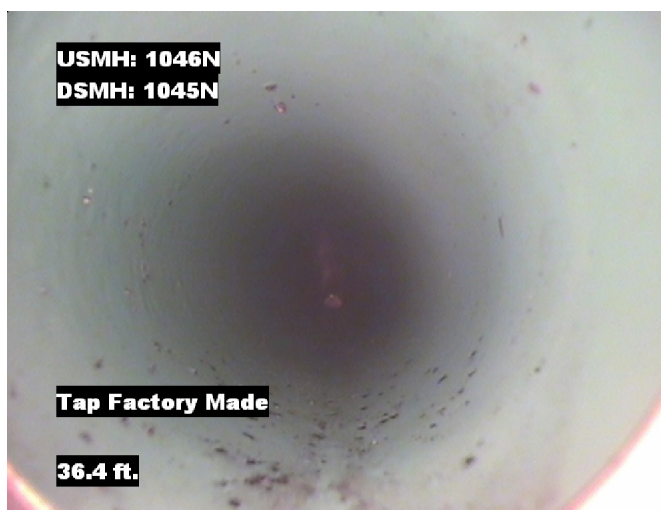
| Distance | Condition | Cont. Dfct. | Values | | | Joint | Clock Position | | Grade |
|---|---|---|---|---|---|---|---|---|---|
| 36.4 ft. | Tap Factory Made | | 6 | | 0 | <input checked="" type="checkbox"/> | 9 | | |

Distance: 36.4 ft. Grade: 0  
Condition: Tap Factory Made  
Remarks: N/A

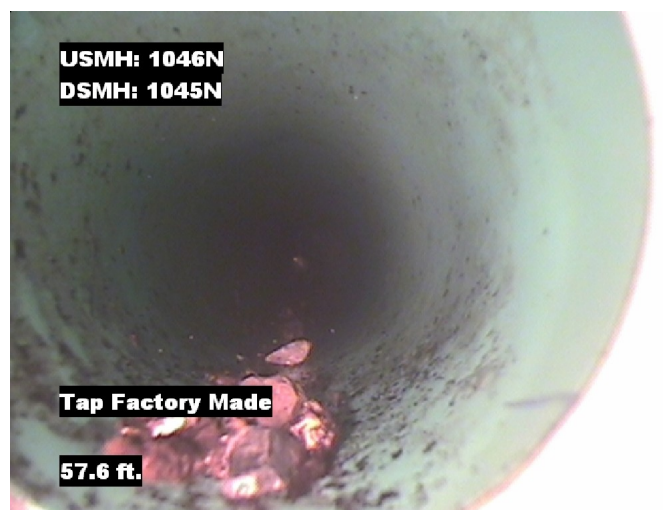
| Distance | Condition | Cont. Dfct. | Values | | | Joint | Clock Position | | Grade |
|---|---|---|---|---|---|---|---|---|---|
| 57.6 ft. | Tap Factory Made | | 6 | | 0 | <input type="checkbox"/> | 9 | | |

Distance: 57.6 ft. Grade: 0  
Condition: Tap Factory Made  
Remarks: N/A

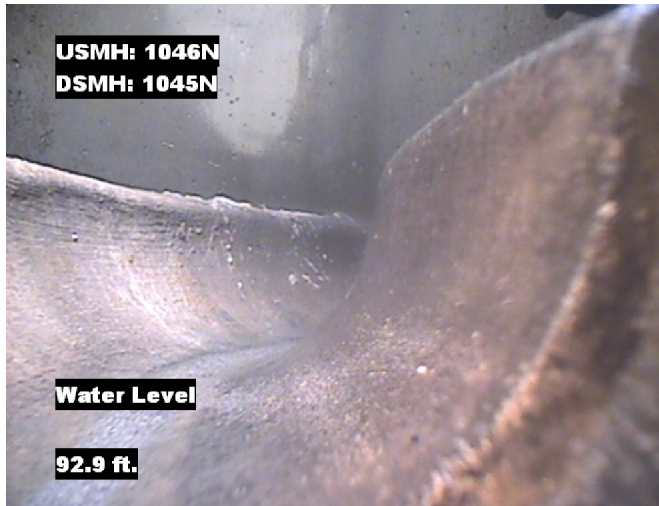
Distance: 92.9 ft. Grade: 0  
Condition: Water Level  
Remarks: N/A

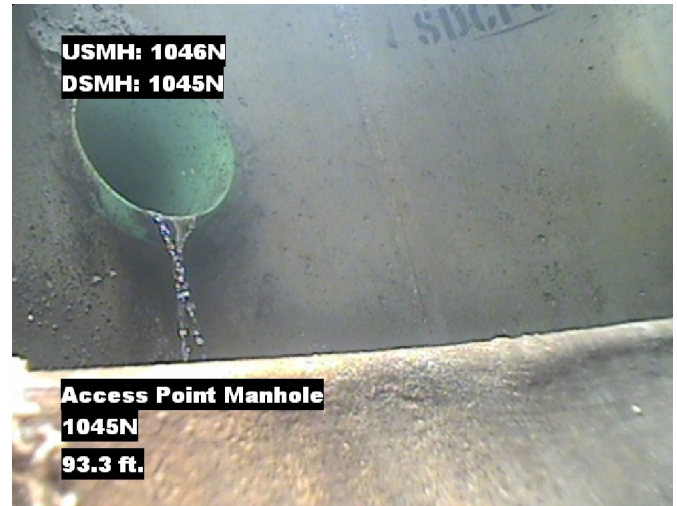
Distance: 93.3 ft. Grade: 0  
Condition: Access Point Manhole  
Remarks: E10-1
