## Defect Listing

| Pipe Segment Refere...<br><b>E10-5_E10-4</b> | City<br><b>Oliver Springs</b> | Street<br><b>Sturbridge dr</b> | Material<br><b>PolyVinyl Chloride</b> | Location C...<br><b>Easement/R...</b> | Sewer Use<br><b>Sanitary</b> |

| SPRI<br><b>N/A</b> | MPRI<br><b>N/A</b> | Work Order<br><b>4397-02</b> | | Purpose<br><b>Pre-Rehabilitation Survey</b> | |

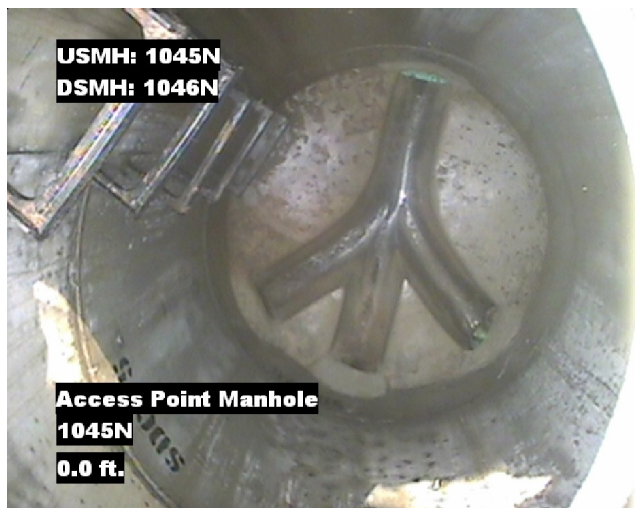
Distance: 0.0 ft. Grade: 0  
Condition: Access Point Manhole  
Remarks: E10-5

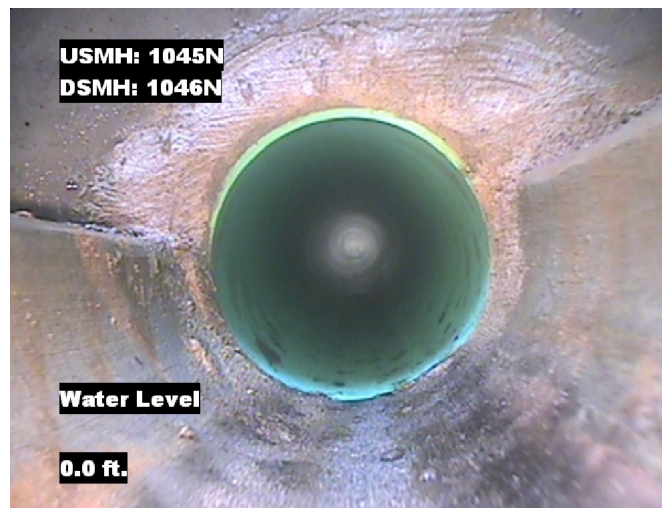
Distance: 0.0 ft. Grade: 0  
Condition: Water Level  
Remarks: N/A

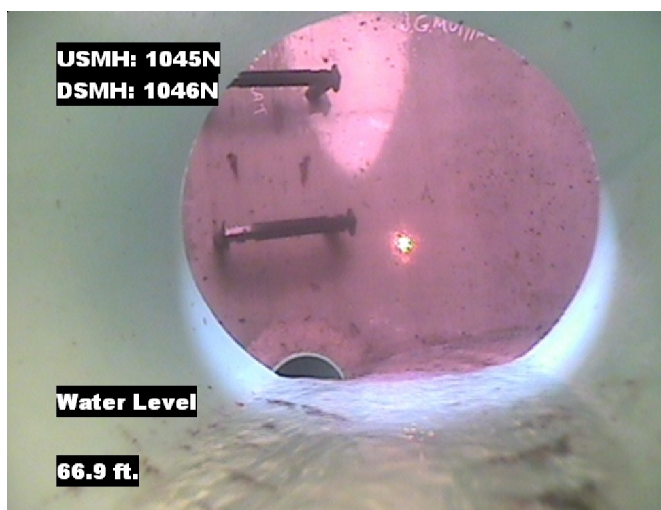
Distance: 66.9 ft. Grade: 0  
Condition: Water Level  
Remarks: N/A

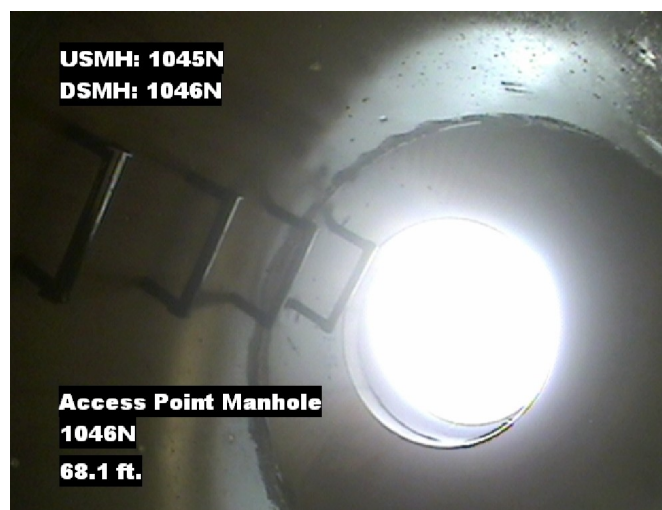
Distance: 68.1 ft. Grade: 0  
Condition: Access Point Manhole  
Remarks: E10-4
