## Defect Listing

| Pipe Segment Refere...<br><b>E10-6_E10-2</b> | City<br><b>Oliver Springs</b> | Street<br><b>Sturbridge Dr</b> | Material<br><b>PolyVinyl Chloride</b> | Location C...<br><b>Easement/R...</b> | Sewer Use<br><b>Sanitary</b> |

| SPRI<br><b>N/A</b> | MPRI<br><b>N/A</b> | Work Order<br><b>4397-02</b> | | Purpose<br><b>Pre-Rehabilitation Survey</b> | |

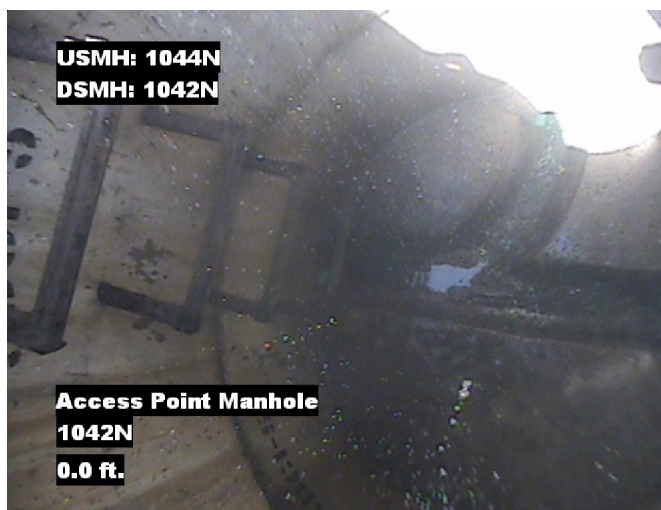
Distance: 0.0 ft. Grade: 0  
Condition: Access Point Manhole  
Remarks: E10-6

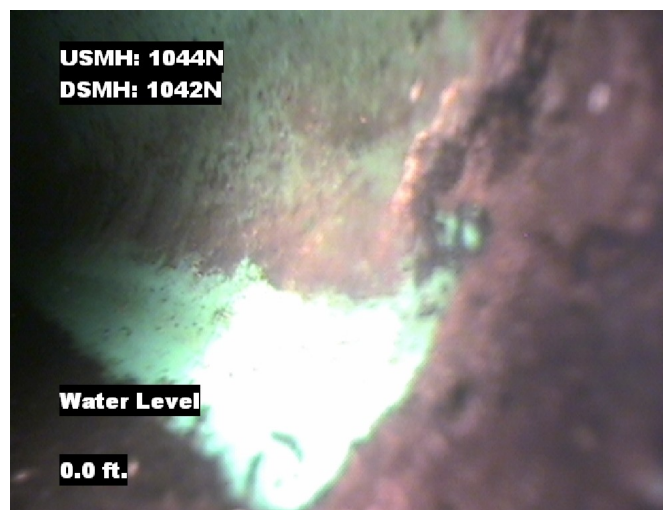
Distance: 0.0 ft. Grade: 0  
Condition: Water Level  
Remarks: N/A

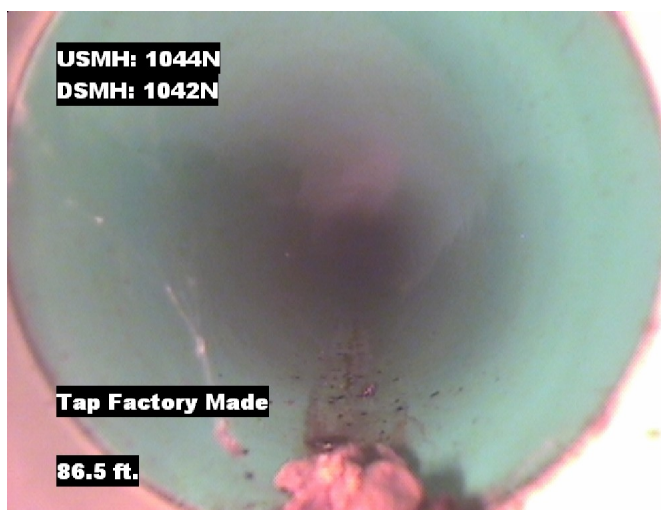
Distance: 86.5 ft. Grade: 0  
Condition: Tap Factory Made  
Remarks: N/A

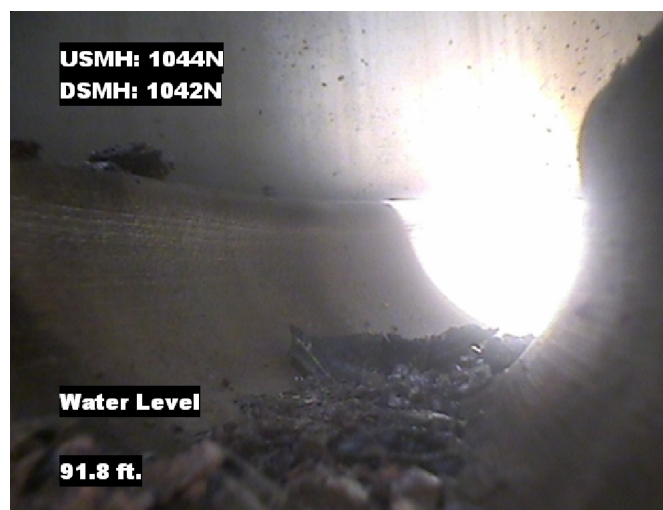
Distance: 91.8 ft. Grade: 0  
Condition: Water Level  
Remarks: N/A

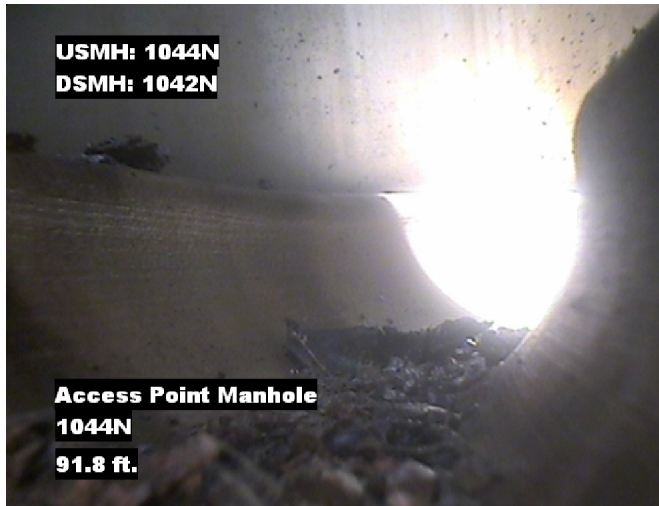
Distance: 91.8 ft.      Grade: 0  
Condition: Access Point Manhole  
Remarks: E10-2
