Defect Listing

Pipe Segment Refere... E12-1_E-9	City Oliver Springs	Street Null	Material Fiberglass Reinforc...	Location C... Easement/R...	Sewer Use Sanitary
Upstream MH E12-1	Total Length 133.9	Year Laid	Shape Circular	Location Details Cow Pasture	
DS Manhole E-9	Length surveyed 133.9	Year Renewed	Height 8	Width 8	Pipe Joint... N/A

Image Report 4/Page

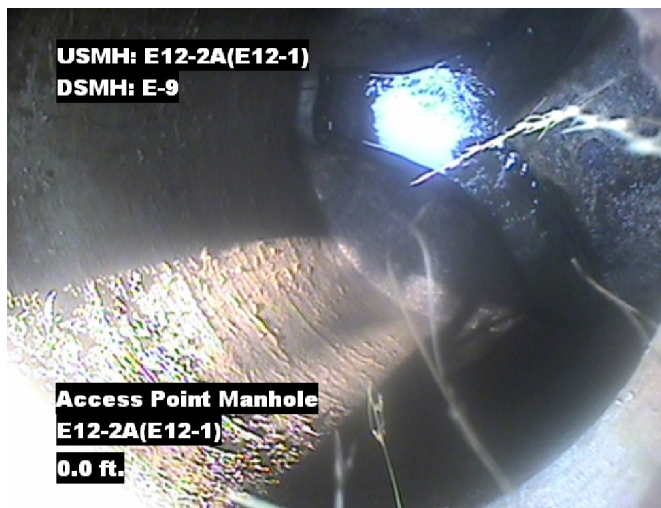
Distance: 0.0 ft. Grade: 0
Condition: Access Point Manhole
Remarks: E12-1

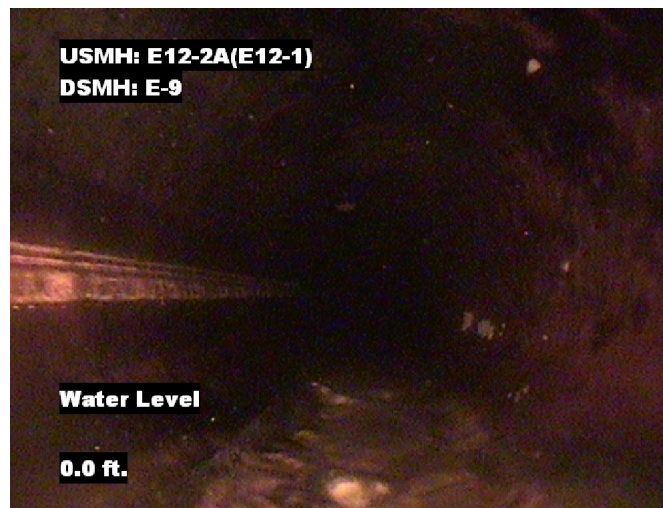
Distance: 0.0 ft. Grade: 0
Condition: Water Level
Remarks: N/A

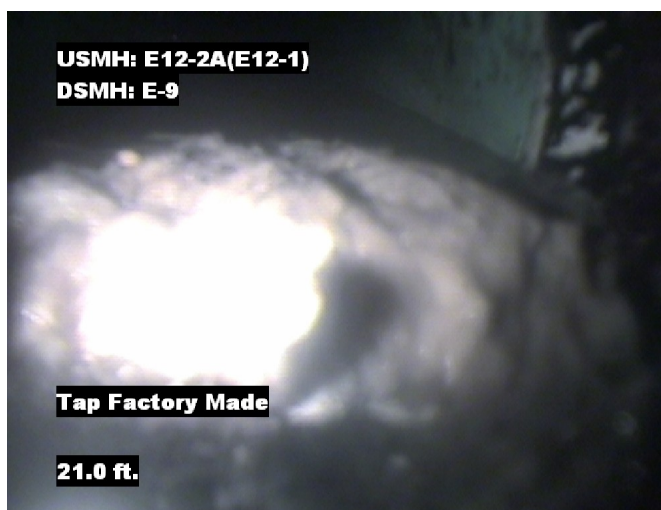
Distance: 21.0 ft. Grade: 0
Condition: Tap Factory Made
Remarks: N/A

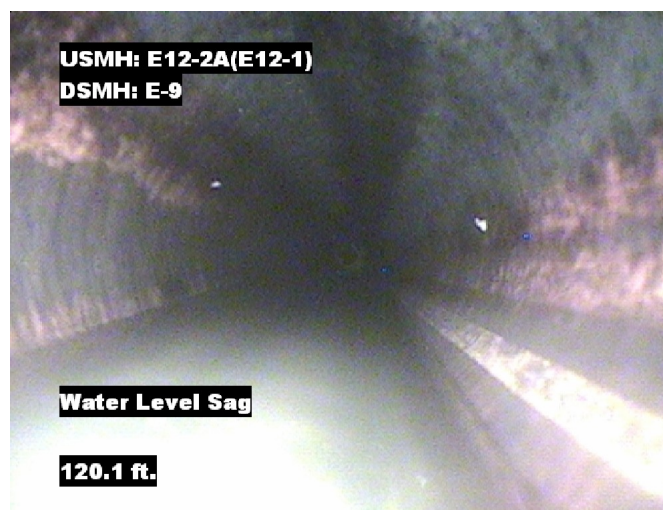
Distance: 120.1 ft. Grade: 2
Condition: Water Level Sag
Remarks: N/A

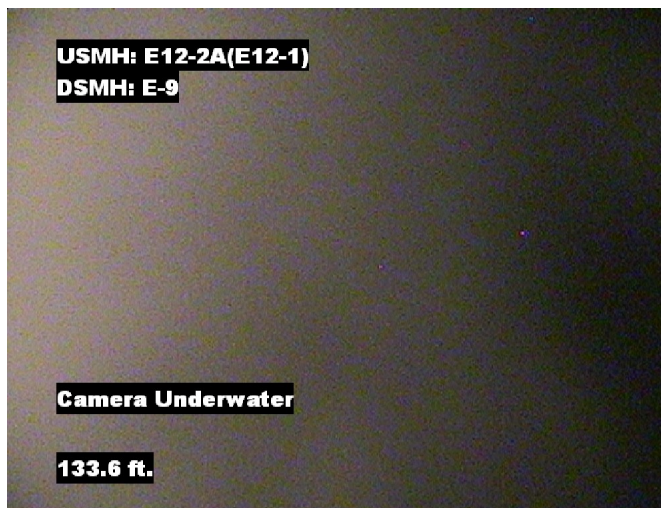
Distance: 133.6 ft. Grade: 4
Condition: Camera Underwater
Remarks: N/A

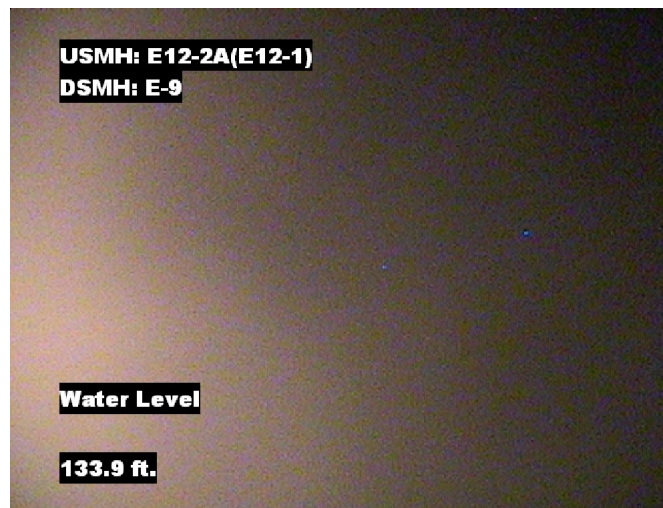
Distance: 133.9 ft. Grade: 0
Condition: Water Level
Remarks: N/A

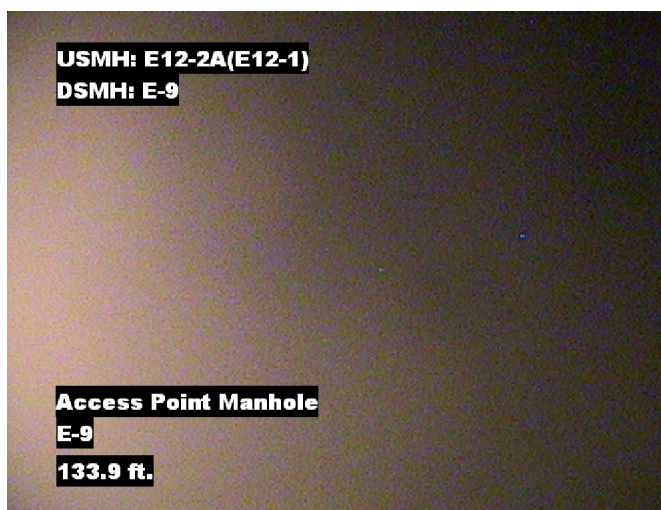
Distance: 133.9 ft. Grade: 0
Condition: Access Point Manhole
Remarks: E-9
