Defect Listing

Pipe Segment Refere... E12-2_E12-1	City Oliver Springs	Street Oak Circle	Material Concrete Pipe (non-...	Location C... Light High...	Sewer Use Sanitary
Upstream MH E12-2	Total Length 98.2	Year Laid	Shape Circular	Location Details Street	
DS Manhole E12-1	Length surveyed 98.2	Year Renewed	Height 8	Width 8	Pipe Joint... 4

Image Report 4/Page

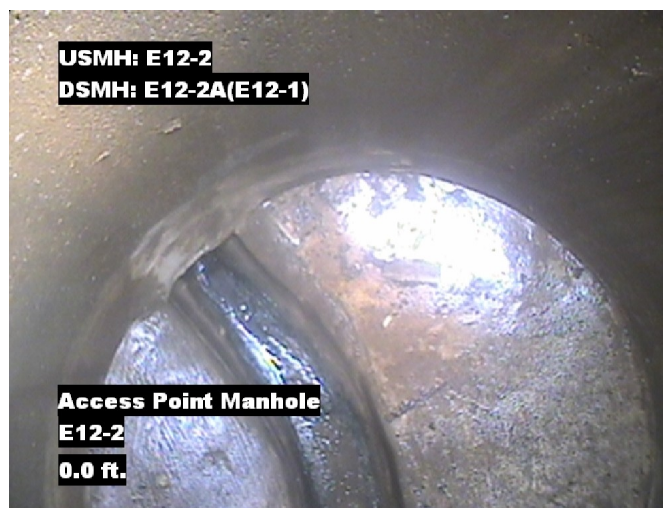
Distance: 0.0 ft. Grade: 0
Condition: Access Point Manhole
Remarks: E12-2

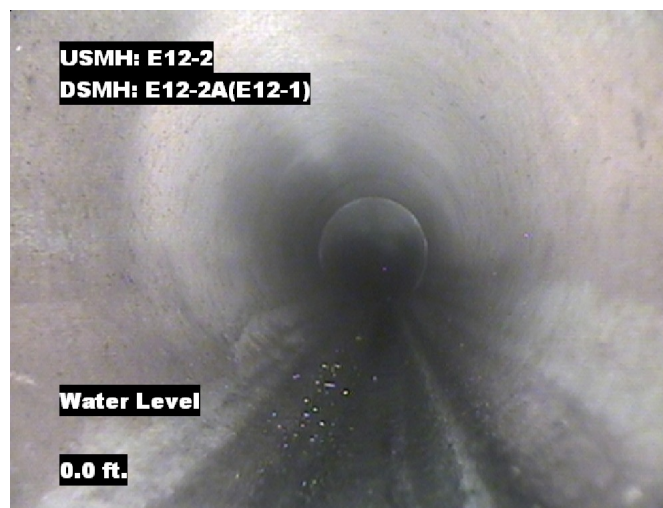
Distance: 0.0 ft. Grade: 0
Condition: Water Level
Remarks: N/A

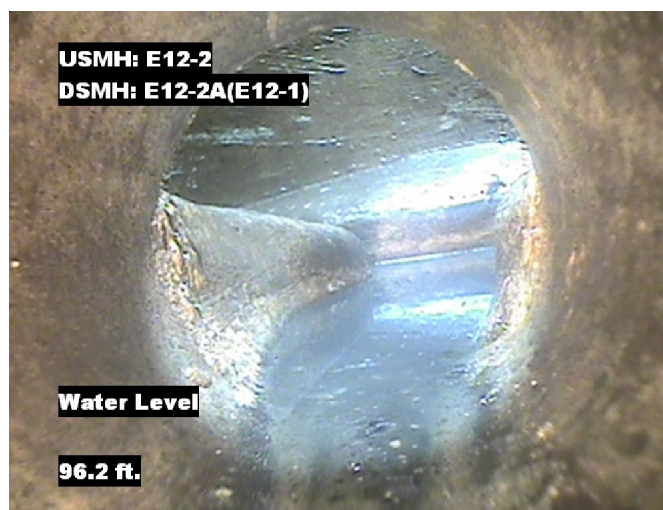
Distance: 96.2 ft. Grade: 0
Condition: Water Level
Remarks: N/A

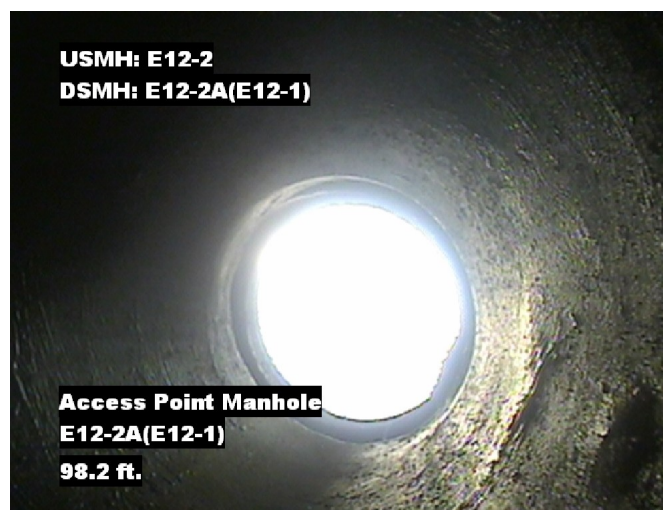
Distance: 98.2 ft. Grade: 0
Condition: Access Point Manhole
Remarks: E12-1
