Defect Listing

Pipe Segment Refere... E12-3_E12-2	City Oliver Springs	Street Oak Circle	Material Concrete Pipe (non-...	Location C... Light High...	Sewer Use Sanitary
Upstream MH E12-3	Total Length 354.5	Year Laid	Shape Circular	Location Details Street	
DS Manhole E12-2	Length surveyed 354.5	Year Renewed	Height 8	Width 8	Pipe Joint... 4

SPR N/A	MPR N/A	PO Number 4397-03	Customer GRW
SPRI N/A	MPRI N/A	Work Order 4397-02	Purpose Pre-Rehabilitation Survey
QSR N/A	QMR N/A		
OPR N/A	Surveyed By Barry Rogers	Direction Downstream	Date 20150610
OPRI N/A	Certificate Number U-1012-16405	Pre-Cleaning Jetting	Time 14:04
	Date Cleaned 20150610	End Time 14:29	Weather Dry
			Additional Info

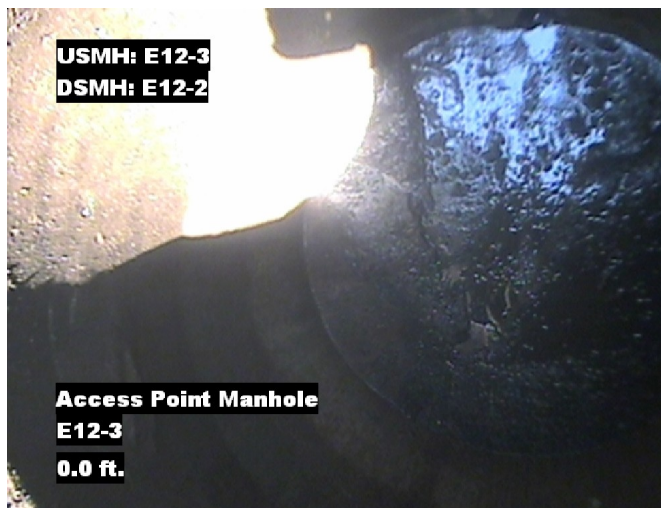
Distance: 0.0 ft. Grade: 0
Condition: Access Point Manhole
Remarks: E12-3

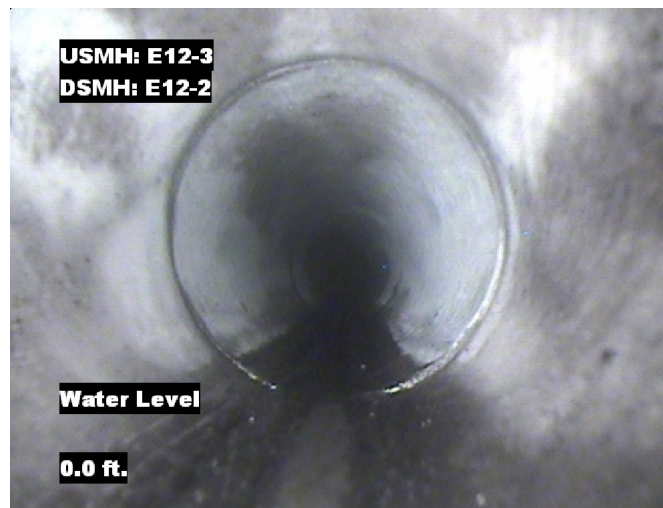
Distance: 0.0 ft. Grade: 0
Condition: Water Level
Remarks: N/A

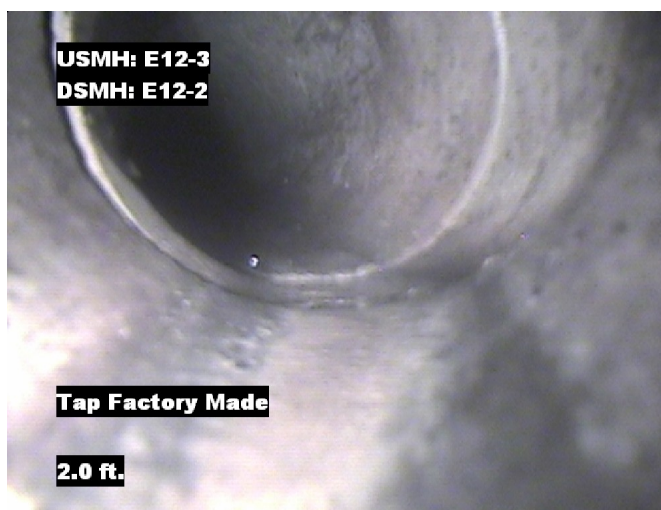
Distance: 2.0 ft. Grade: 0
Condition: Tap Factory Made
Remarks: N/A

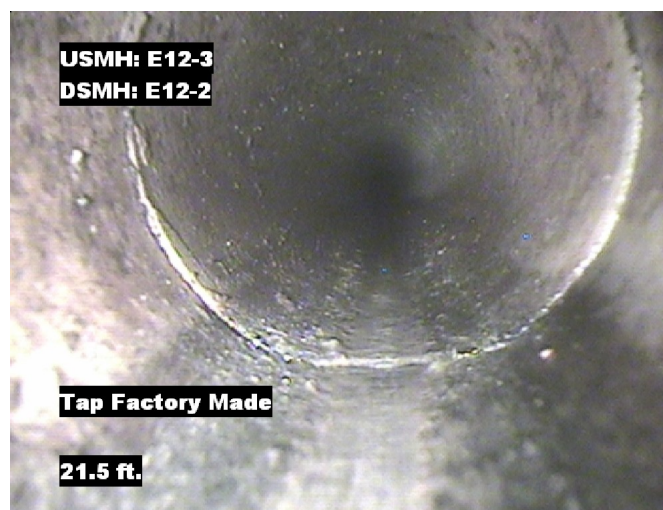
Distance: 21.5 ft. Grade: 0
Condition: Tap Factory Made
Remarks: N/A

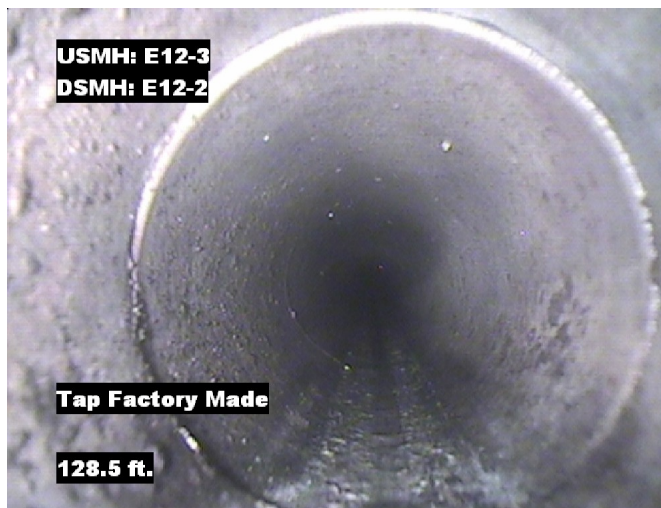
Distance: 128.5 ft. Grade: 0
Condition: Tap Factory Made
Remarks: N/A

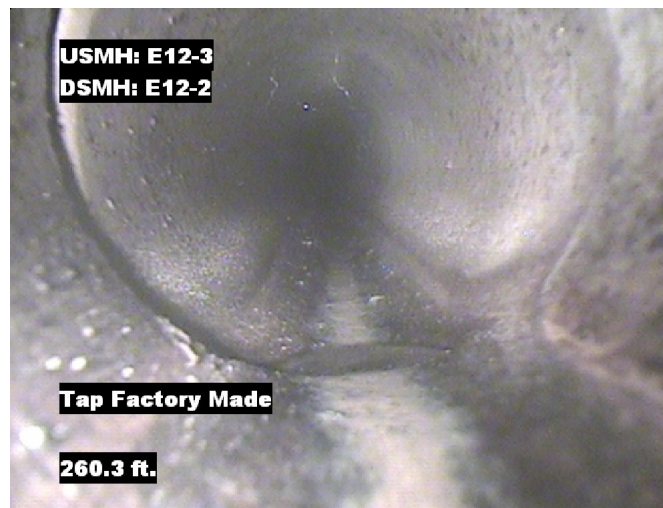
Distance: 260.3 ft. Grade: 0
Condition: Tap Factory Made
Remarks: N/A

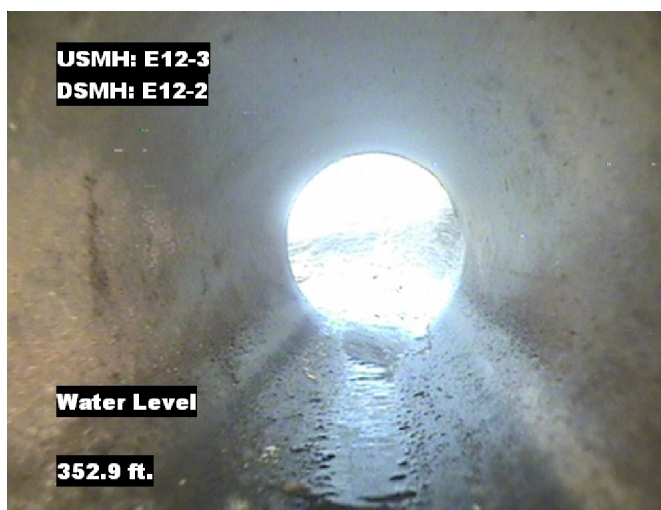
Distance: 352.9 ft. Grade: 0
Condition: Water Level
Remarks: N/A

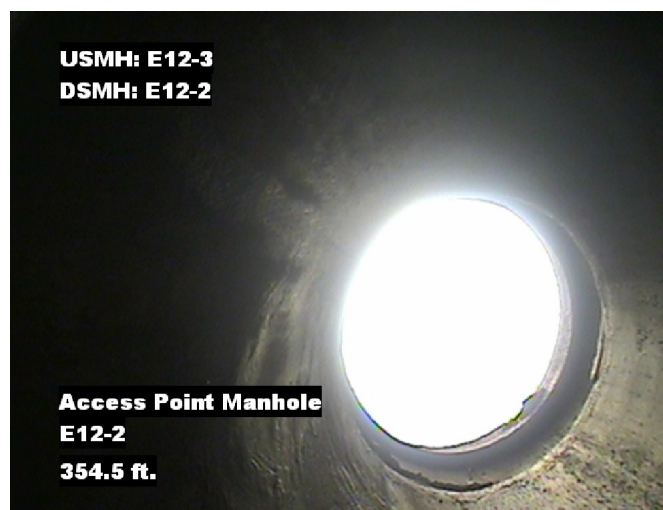
Distance: 354.5 ft. Grade: 0
Condition: Access Point Manhole
Remarks: E12-2
