Defect Listing

Pipe Segment Refere... E12-4_E13-6	City Oliver Springs	Street Oak Circle	Material Concrete Pipe (non-...	Location C... Light High...	Sewer Use Sanitary
Upstream MH E12-4	Total Length 220.6	Year Laid	Shape Circular	Location Details Street	
DS Manhole E13-6	Length surveyed 220.6	Year Renewed	Height 8	Width 8	Pipe Joint... 4

SPR N/A	MPR N/A	PO Number 4397-03		Customer GRW	
SPRI N/A	MPRI N/A	Work Order 4397-02		Purpose Pre-Rehabilitation Survey	
QSR N/A	QMR N/A				
OPR N/A	Surveyed By Barry Rogers	Direction Downstream	Date 20150610	Media label	
OPRI N/A	Certificate Number U-1012-16405	Pre-Cleaning Jetting	Time 14:53	Weather Dry	
Date Cleaned 20150610			End Time 15:04	Additional Info

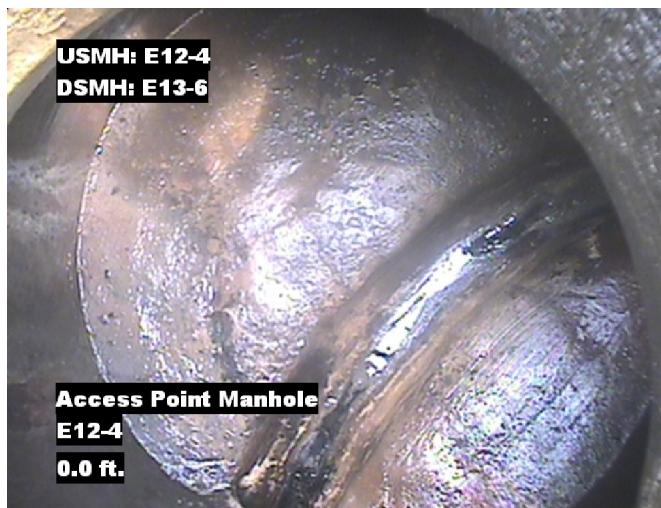
Distance: 0.0 ft. Grade: 0
Condition: Access Point Manhole
Remarks: E12-4

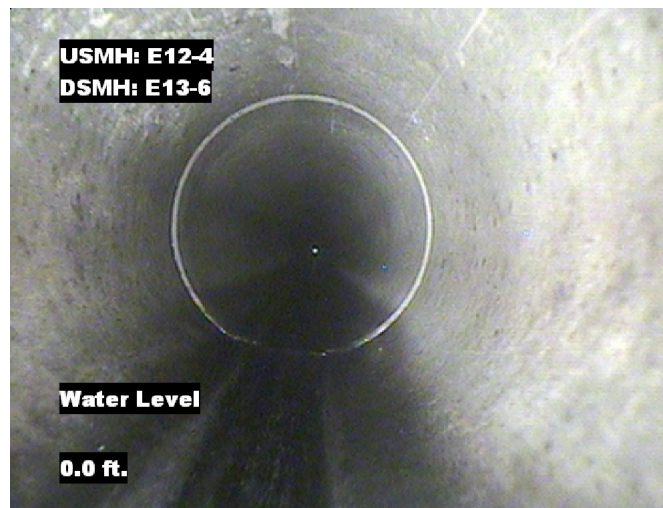
Distance: 0.0 ft. Grade: 0
Condition: Water Level
Remarks: N/A

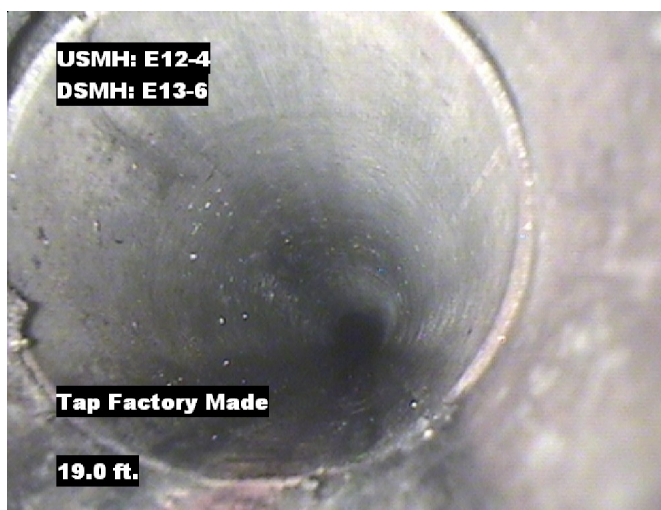
Distance: 19.0 ft. Grade: 0
Condition: Tap Factory Made
Remarks: N/A

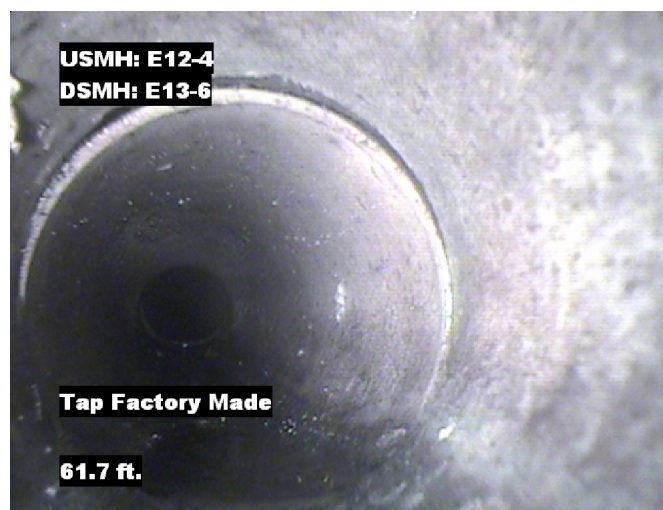
Distance: 61.7 ft. Grade: 0
Condition: Tap Factory Made
Remarks: N/A

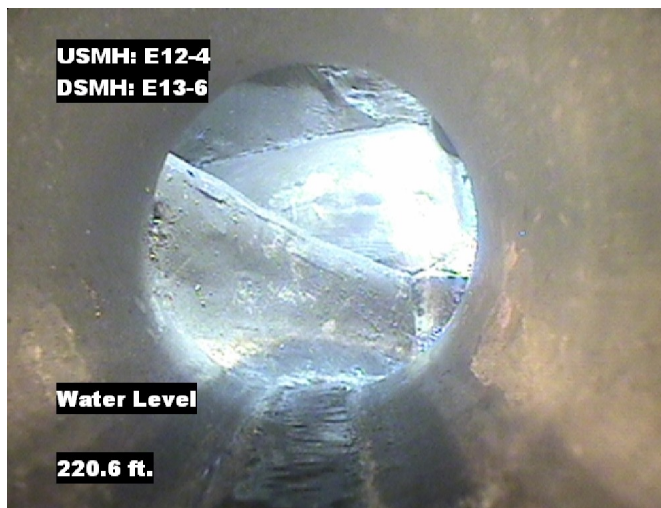
Distance: 220.6 ft. Grade: 0
Condition: Water Level
Remarks: N/A

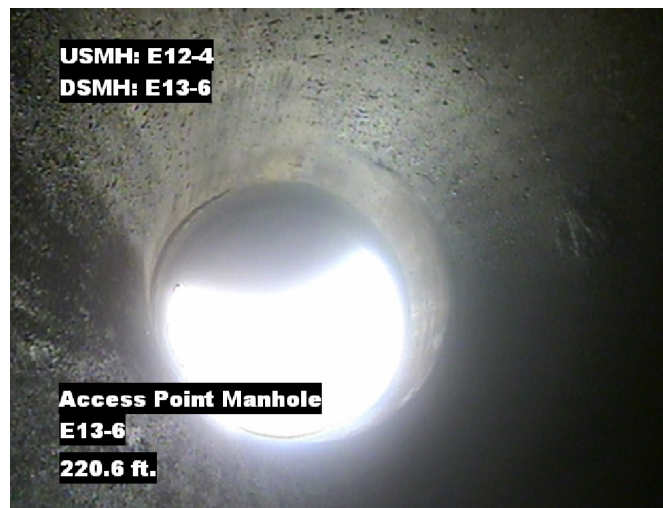
Distance: 220.6 ft. Grade: 0
Condition: Access Point Manhole
Remarks: E13-6
