## Defect Listing

| Pipe Segment Refere...<br><b>E13-1 E12-1</b> | City<br><b>Oliver Springs</b> | Street<br><b>Oak Circle</b> | Material<br><b>Concrete Pipe (non-...</b> | Location C...<br><b>Light High...</b> | Sewer Use<br><b>Sanitary</b> |

| SPRI<br><b>2</b> | MPRI<br><b>2</b> | Work Order<br><b>4397-02</b> | Purpose<br><b>Pre-Rehabilitation Survey</b> |

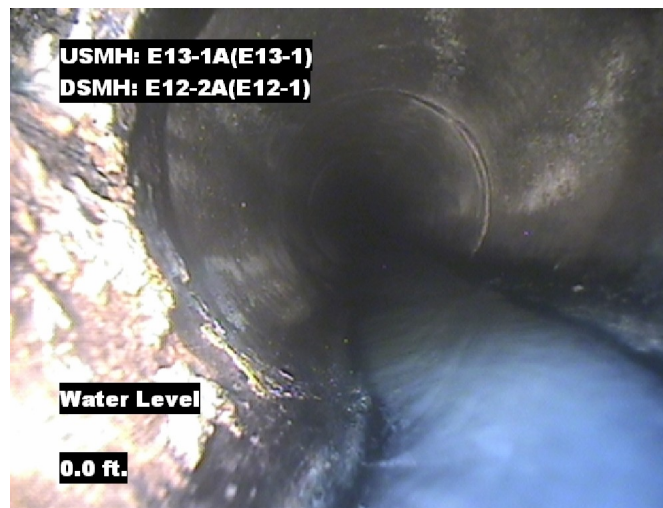
Distance: 0.0 ft. Grade: 0  
Condition: Water Level  
Remarks: N/A

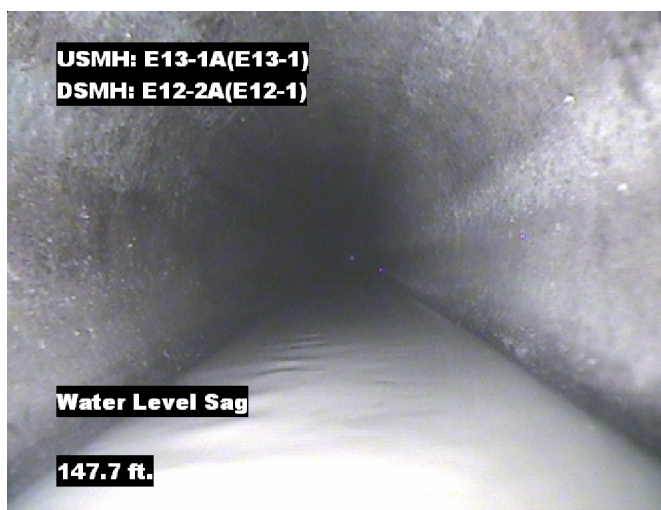
| Distance | Condition | Cont. Dfct. | Values | | | Joint | Clock Position | | Grade |
|---|---|---|---|---|---|---|---|---|---|
| 147.7 ft. | Water Level Sag | | | | 15 | <input type="checkbox"/> | | | 2 |

Distance: 147.7 ft. Grade: 2  
Condition: Water Level Sag  
Remarks: N/A

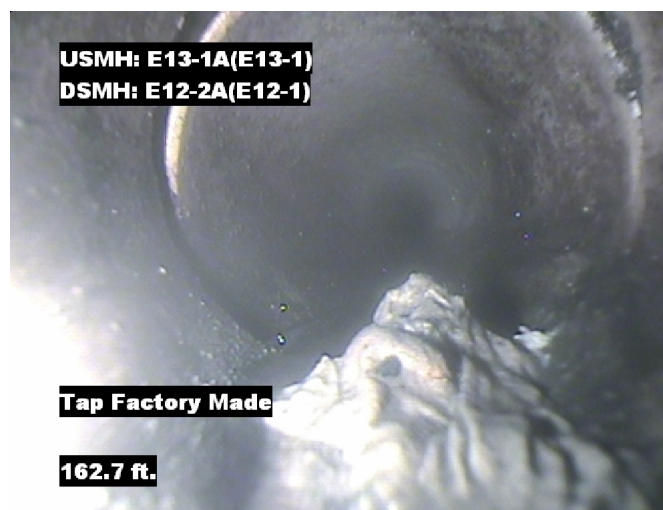
Distance: 162.7 ft. Grade: 0  
Condition: Tap Factory Made  
Remarks: N/A

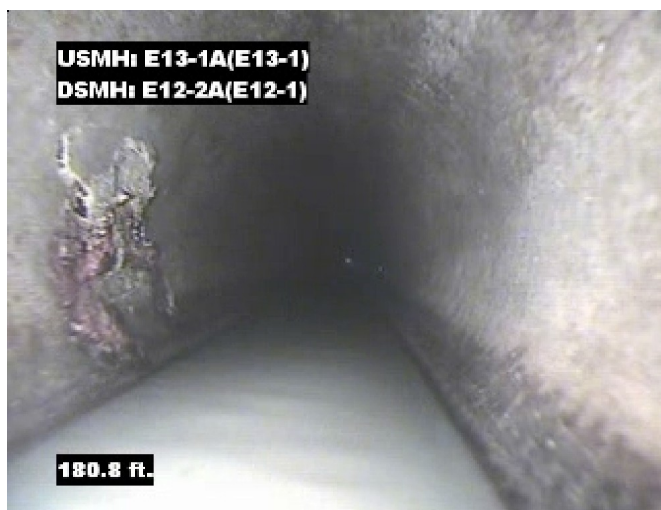
| Distance | Condition | Cont. Dfct. | Values | | | Joint | Clock Position | | Grade |
|---|---|---|---|---|---|---|---|---|---|
| 180.8 ft. | Surface Spalling Other | | | | | <input type="checkbox"/> | 7 | 10 | 2 |

Distance: 180.8 ft. Grade: 2  
Condition: Surface Spalling Other  
Remarks: N/A

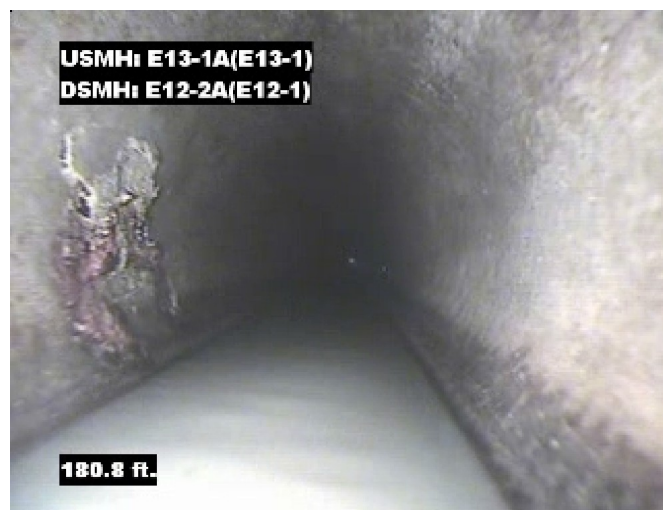
| Distance | Condition | Cont. Dfct. | Values | | | Joint | Clock Position | | Grade |
|---|---|---|---|---|---|---|---|---|---|
| 180.8 ft. | Infiltration Stain | | | | | <input type="checkbox"/> | 7 | 9 | |

Distance: 180.8 ft. Grade: 0  
Condition: Infiltration Stain  
Remarks: N/A

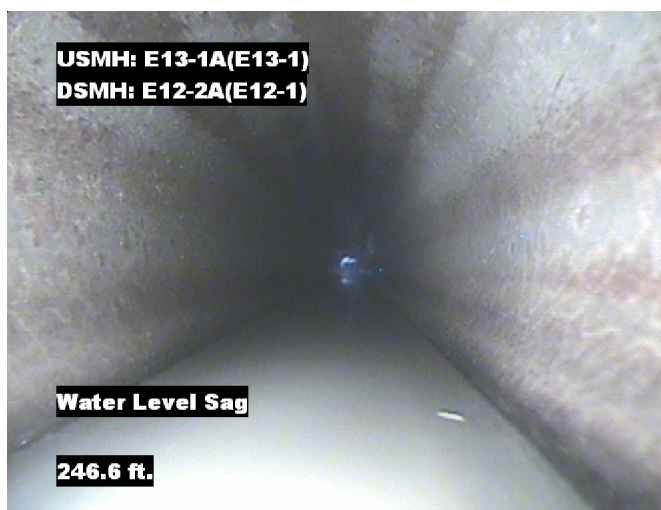
| Distance | Condition | Cont. Dfct. | Values | | | Joint | Clock Position | | Grade |
|---|---|---|---|---|---|---|---|---|---|
| 246.6 ft. | Water Level Sag | | | | 15 | <input type="checkbox"/> | | | 2 |

Distance: 246.6 ft. Grade: 2  
Condition: Water Level Sag  
Remarks: N/A

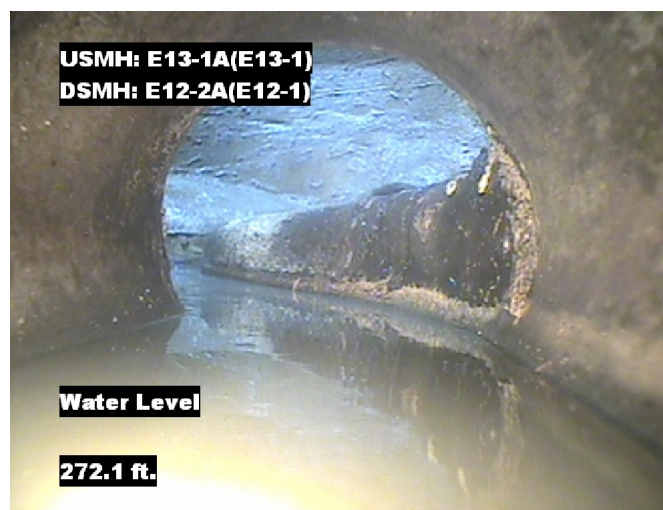
Distance: 272.1 ft. Grade: 0  
Condition: Water Level  
Remarks: N/A
