## Defect Listing

| Pipe Segment Refere...<br><b>E13-2 E13-1</b> | City<br><b>Oliver Springs</b> | Street<br><b>Oak Circle</b> | Material<br><b>Concrete Pipe (non-...</b> | Location C...<br><b>Light High...</b> | Sewer Use<br><b>Sanitary</b> |

| SPRI<br><b>2</b> | MPRI<br><b>N/A</b> | Work Order<br><b>4397-02</b> | | Purpose<br><b>Pre-Rehabilitation Survey</b> | |

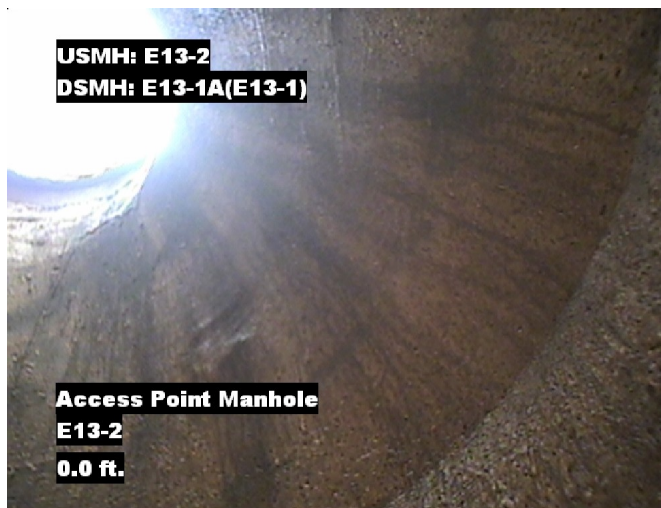
Distance: 0.0 ft. Grade: 0  
Condition: Access Point Manhole  
Remarks: E13-2

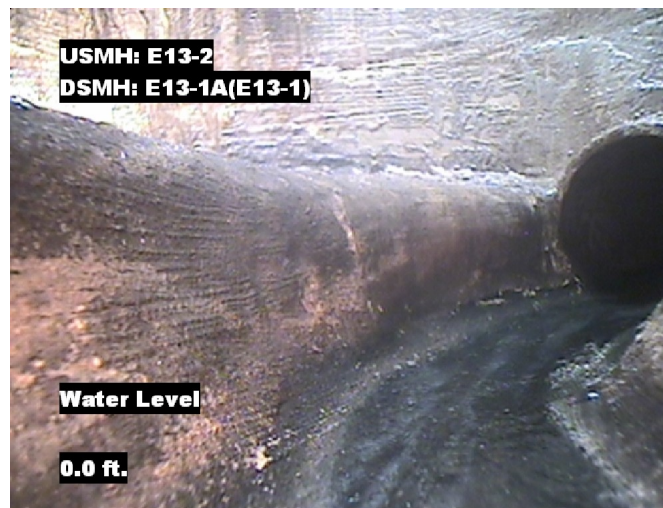
Distance: 0.0 ft. Grade: 0  
Condition: Water Level  
Remarks: N/A

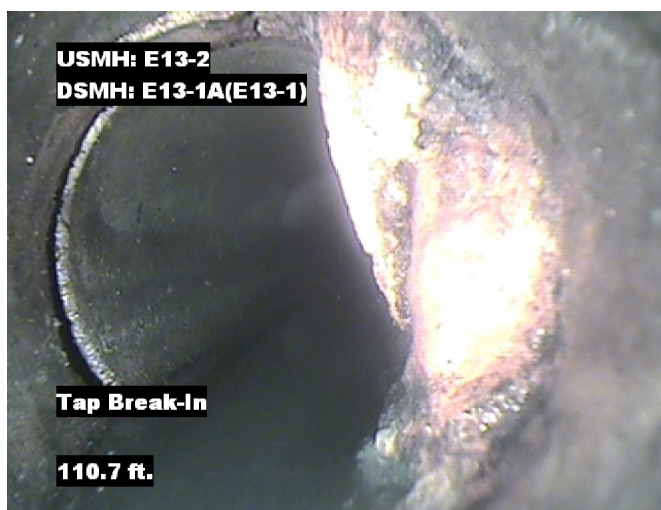
| Distance | Condition | Cont. Dfct. | Values | | | Joint | Clock Position | | Grade |
|---|---|---|---|---|---|---|---|---|---|
| 110.7 ft. | Tap Break-In | | 6 | | 0 | <input type="checkbox"/> | 3 | | |

Distance: 110.7 ft. Grade: 0  
Condition: Tap Break-In  
Remarks: N/A

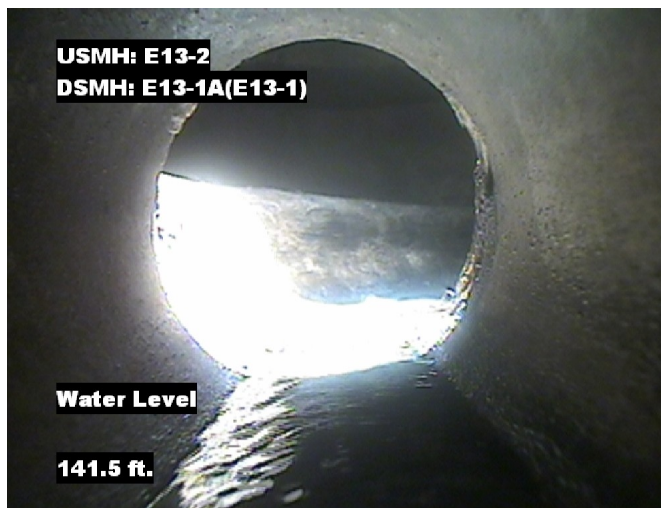
Distance: 141.5 ft. Grade: 0  
Condition: Water Level  
Remarks: N/A

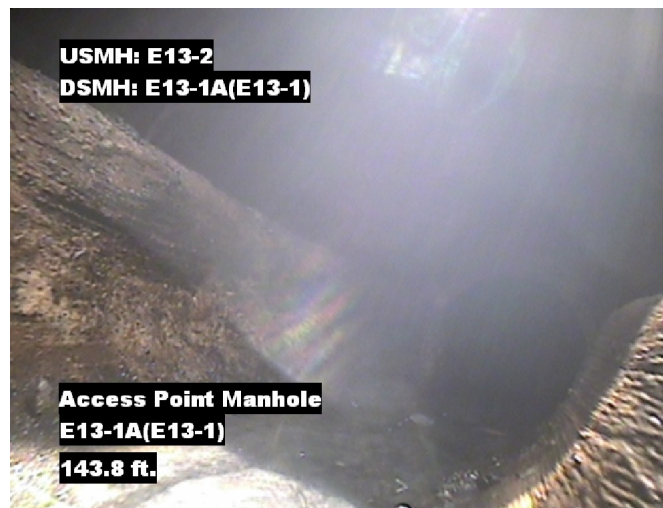
Distance: 143.8 ft. Grade: 0  
Condition: Access Point Manhole  
Remarks: E13-1
