Defect Listing

Pipe Segment Refere... E13-3_E13-2	City Oliver Springs	Street Oak Circle	Material Concrete Pipe (non-...	Location C... Light High...	Sewer Use Sanitary
Upstream MH E13-3	Total Length 229.8	Year Laid	Shape Circular	Location Details Street	
DS Manhole E13-2	Length surveyed 229.8	Year Renewed	Height 8	Width 8	Pipe Joint... 4

SPR 2	MPR 4	PO Number 4397-03		Customer GRW	
SPRI 2	MPRI 2	Work Order 4397-02		Purpose Pre-Rehabilitation Survey	
QSR 2100	QMR 2200				
OPR 6	Surveyed By Barry Rogers	Direction Downstream	Date 20150609	Media label	
OPRI 2	Certificate Number U-1012-16405	Pre-Cleaning Jetting	Time 12:59	Weather Dry	
Date Cleaned 20150609			End Time 13:18	Additional Info

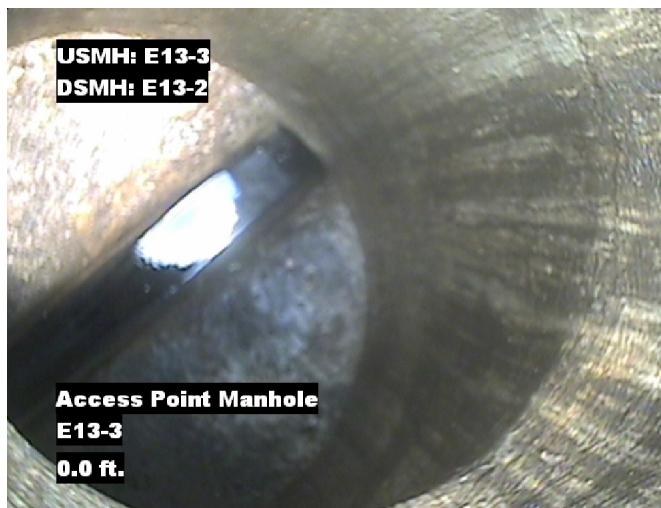
Distance: 0.0 ft. Grade: 0
Condition: Access Point Manhole
Remarks: E13-3

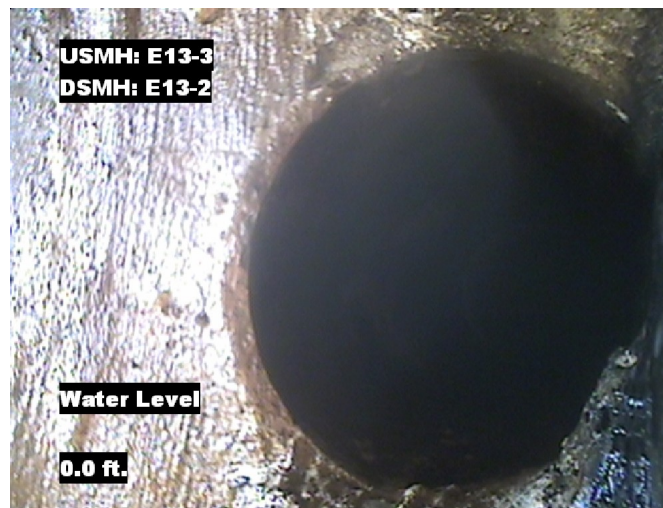
Distance: 0.0 ft. Grade: 0
Condition: Water Level
Remarks: N/A

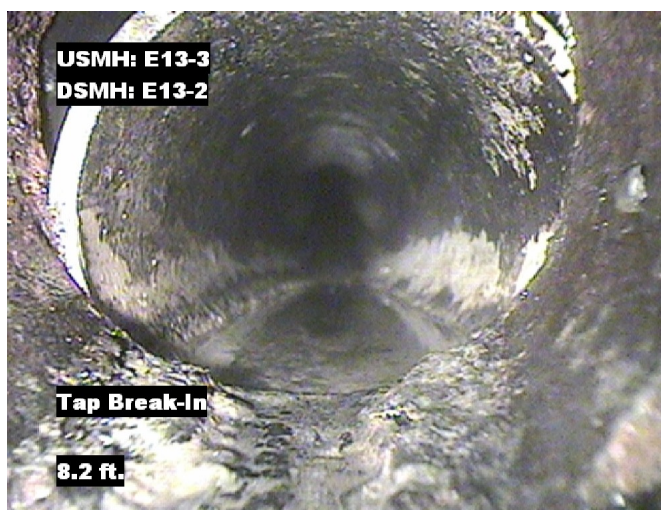
Distance: 8.2 ft. Grade: 0
Condition: Tap Break-In
Remarks: N/A

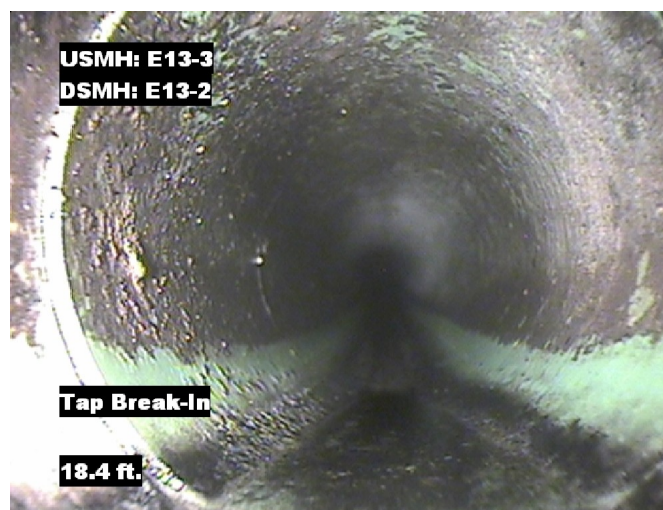
Distance: 18.4 ft. Grade: 0
Condition: Tap Break-In
Remarks: N/A

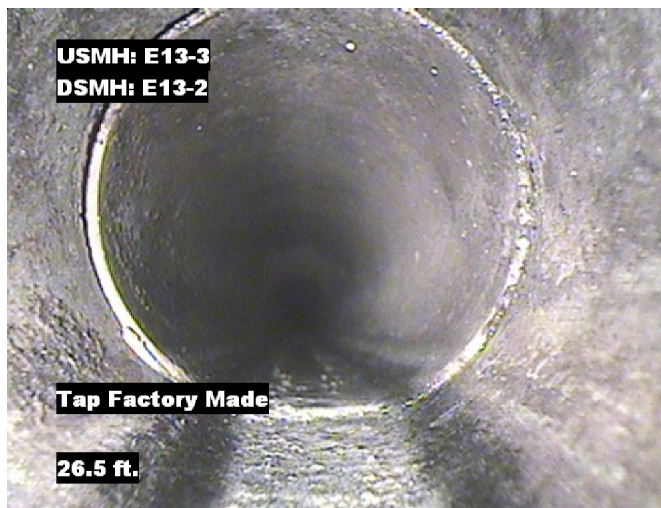
Distance: 26.5 ft. Grade: 0
Condition: Tap Factory Made
Remarks: N/A

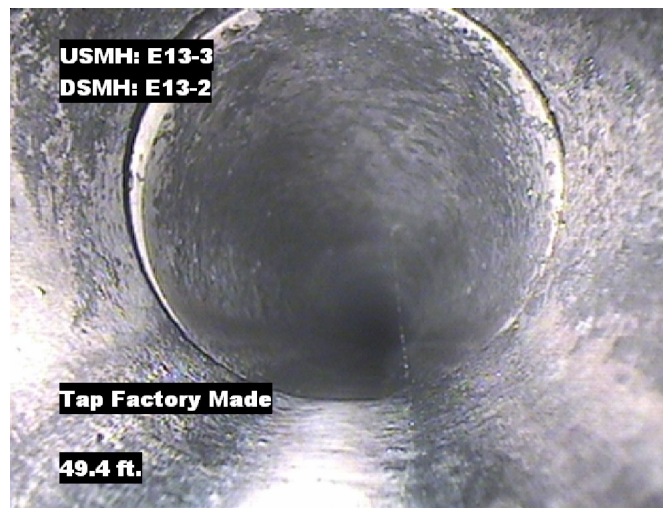
Distance: 49.4 ft. Grade: 0
Condition: Tap Factory Made
Remarks: N/A

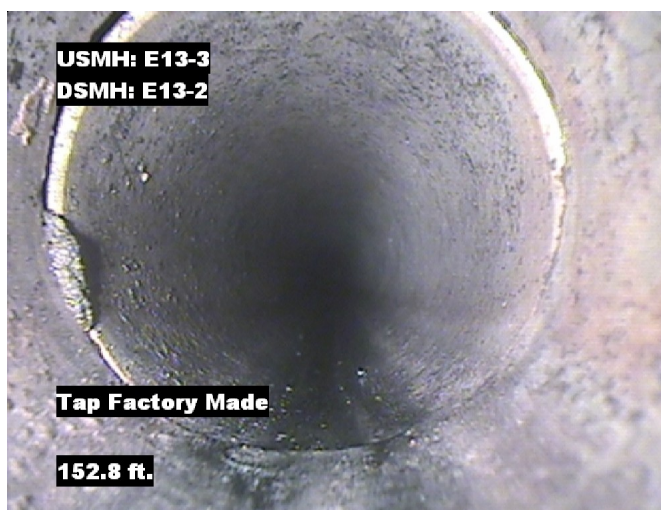
Distance: 152.8 ft. Grade: 0
Condition: Tap Factory Made
Remarks: N/A

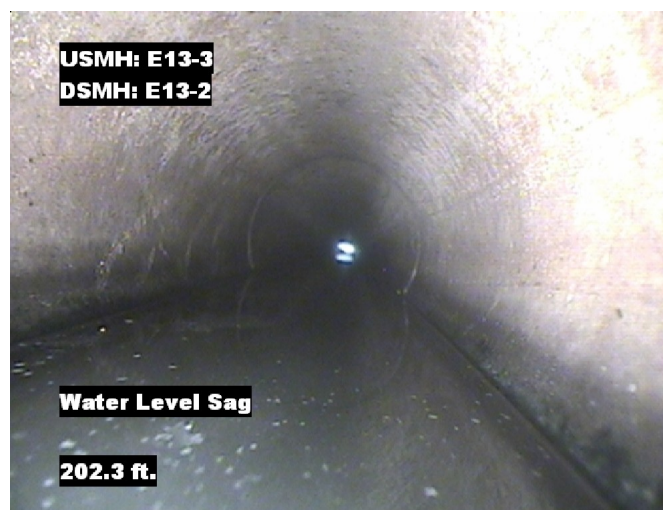
Distance: 202.3 ft. Grade: 2
Condition: Water Level Sag
Remarks: N/A

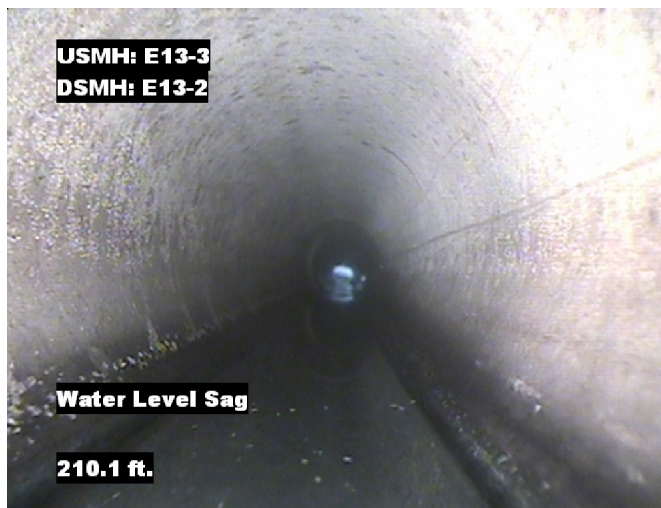
Distance: 210.1 ft. Grade: 2
Condition: Water Level Sag
Remarks: N/A

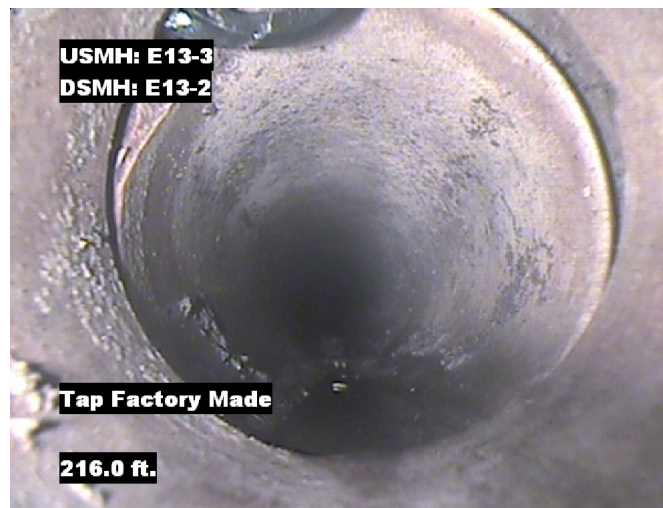
Distance: 216.0 ft. Grade: 0
Condition: Tap Factory Made
Remarks: N/A

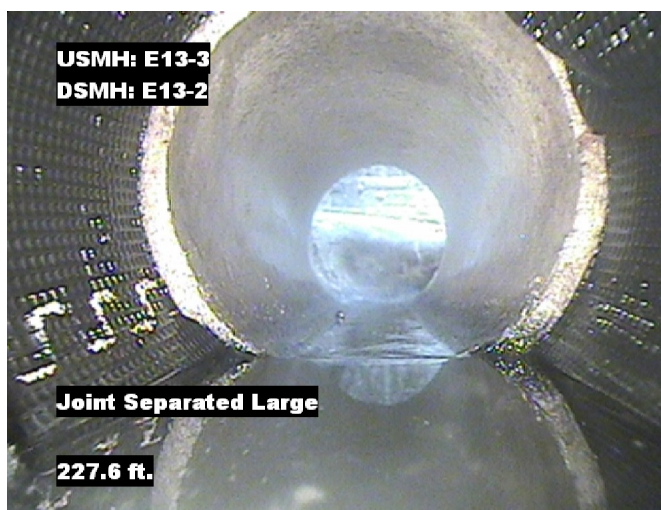
Distance: 227.6 ft. Grade: 2
Condition: Joint Separated Large
Remarks: N/A

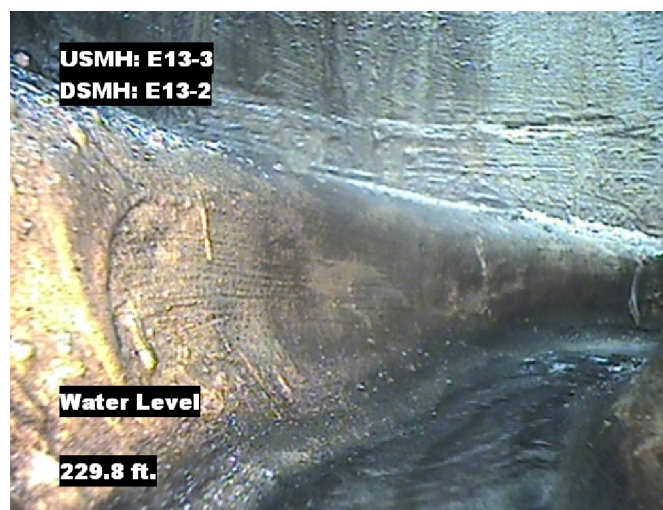
Distance: 229.8 ft. Grade: 0
Condition: Water Level
Remarks: N/A

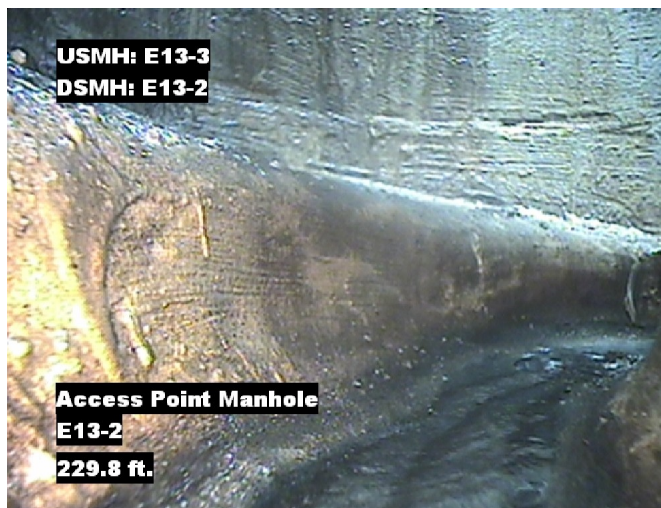
Distance: 229.8 ft. Grade: 0
Condition: Access Point Manhole
Remarks: E13-2
