## Defect Listing

| Pipe Segment Refere...<br><b>E13-4_E13-3</b> | City<br><b>Oliver Springs</b> | Street<br><b>Oak Circle</b> | Material<br><b>Concrete Pipe (non-...</b> | Location C...<br><b>Light High...</b> | Sewer Use<br><b>Sanitary</b> |

| SPRI<br><b>N/A</b> | MPRI<br><b>N/A</b> | Work Order<br><b>4397-02</b> | Purpose<br><b>Pre-Rehabilitation Survey</b> |

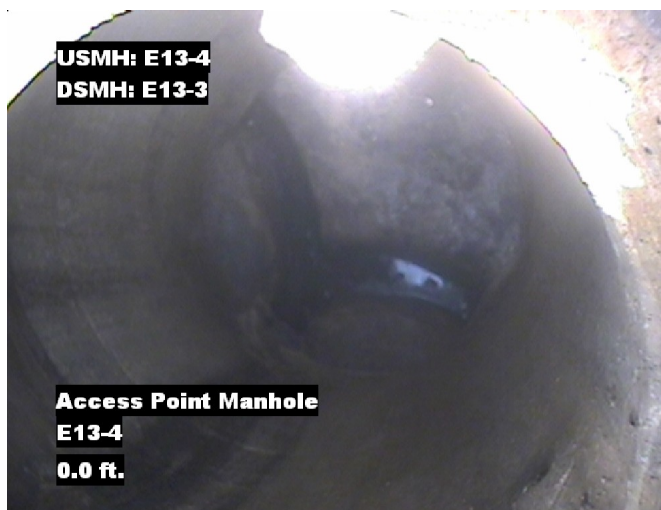
Distance: 0.0 ft. Grade: 0  
Condition: Access Point Manhole  
Remarks: E13-4

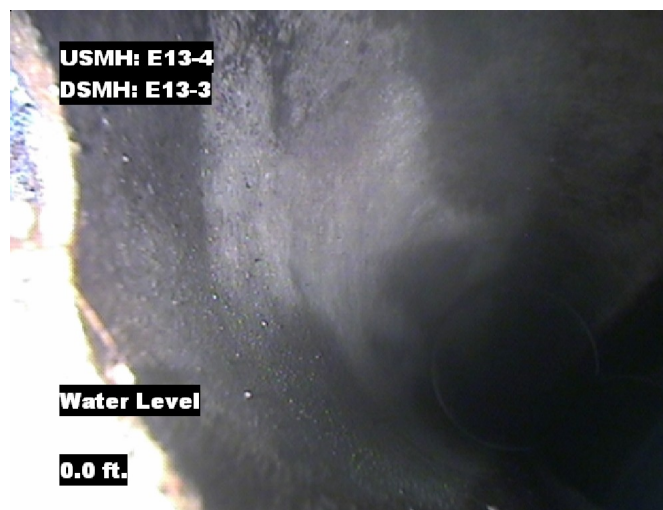
Distance: 0.0 ft. Grade: 0  
Condition: Water Level  
Remarks: N/A

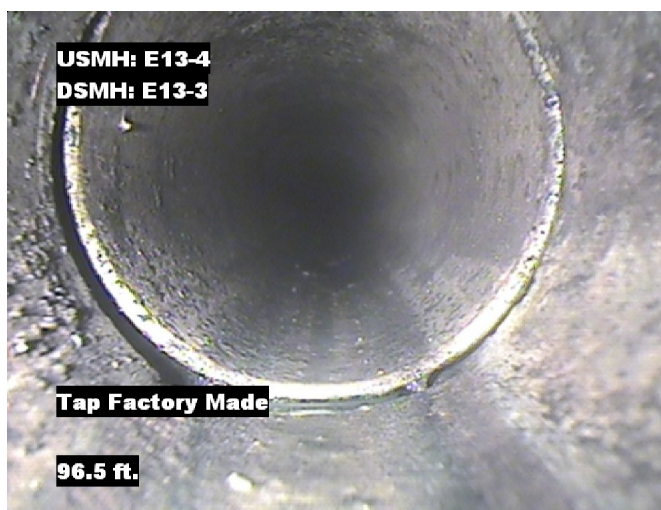
Distance: 96.5 ft. Grade: 0  
Condition: Tap Factory Made  
Remarks: N/A

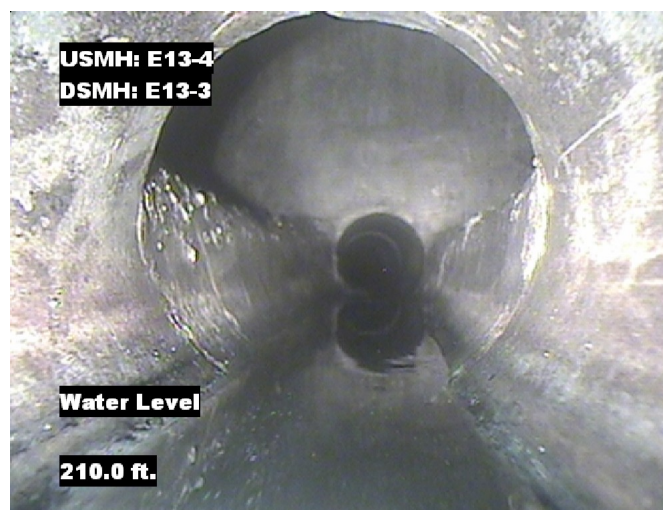
Distance: 210.0 ft. Grade: 0  
Condition: Water Level  
Remarks: N/A

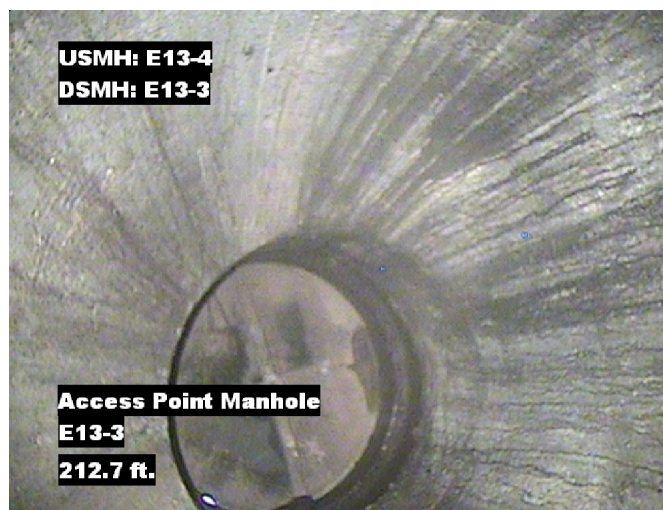
Distance: 212.7 ft. Grade: 0  
Condition: Access Point Manhole  
Remarks: E13-3
