Defect Listing

Pipe Segment Refere... E13-5_E13-4	City Oliver Springs	Street Valley Drive	Material Concrete Pipe (non-...	Location C... Light High...	Sewer Use Sanitary
Upstream MH E13-5	Total Length 196	Year Laid	Shape Circular	Location Details Street	
DS Manhole E13-4	Length surveyed 196	Year Renewed	Height 8	Width 8	Pipe Joint... 4

SPR 1	MPR 2	PO Number 4397-03	Customer GRW
SPRI 1	MPRI 2	Work Order 4397-02	Purpose Pre-Rehabilitation Survey
QSR 1100	QMR 2100		
OPR 3	Surveyed By Barry Rogers	Direction Upstream	Date 20150609
OPRI 1.5	Certificate Number U-1012-16405	Pre-Cleaning Jetting	Time 10:29
	Date Cleaned 20150609	End Time 10:47	Weather Saturated
			Media label
			Additional Info

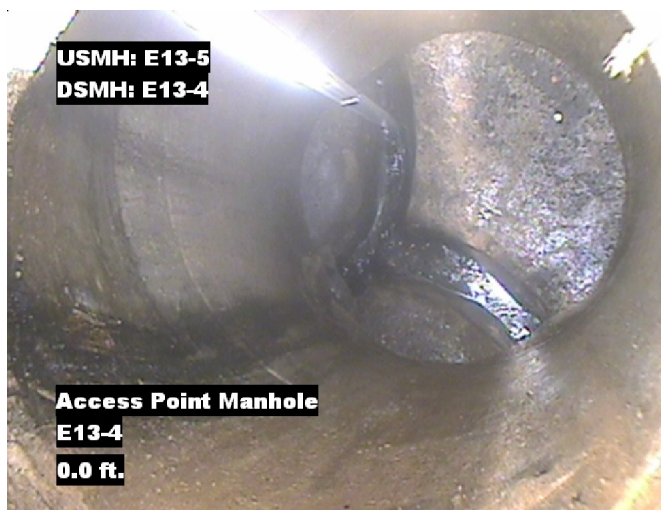
Distance: 0.0 ft. Grade: 0
Condition: Access Point Manhole
Remarks: E13-4

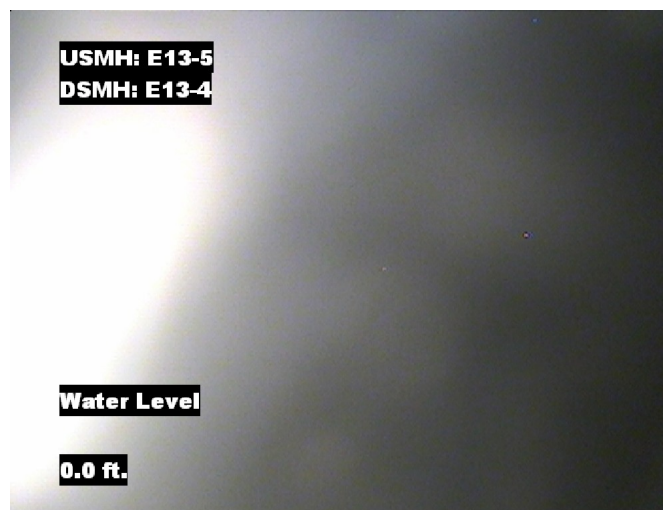
Distance: 0.0 ft. Grade: 0
Condition: Water Level
Remarks: N/A

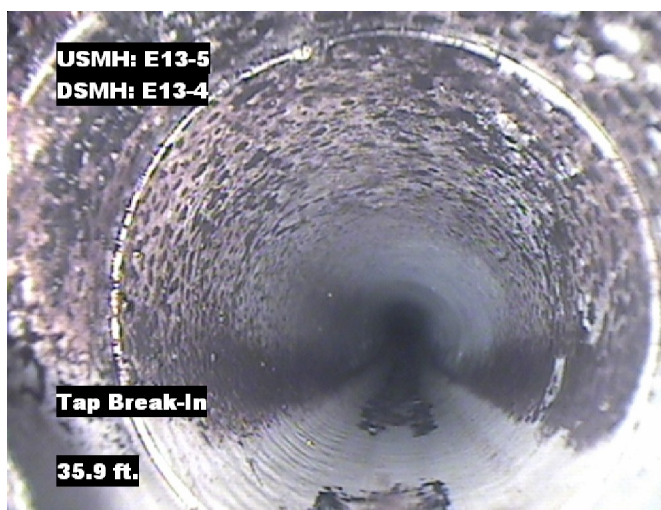
Distance: 35.9 ft. Grade: 0
Condition: Tap Break-In
Remarks: N/A

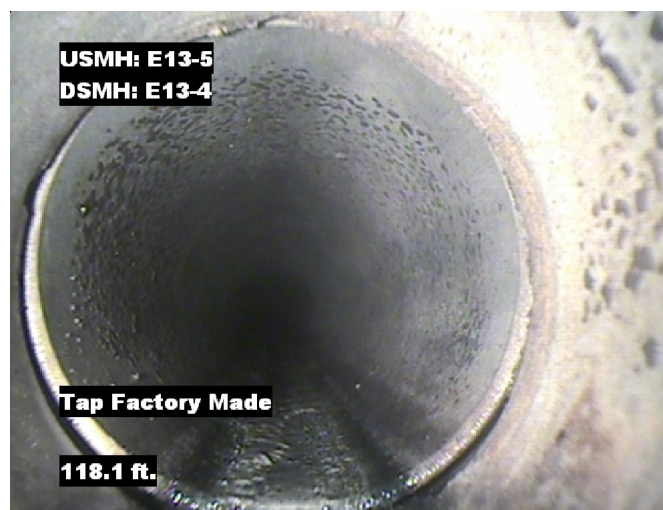
Distance: 118.1 ft. Grade: 0
Condition: Tap Factory Made
Remarks: N/A

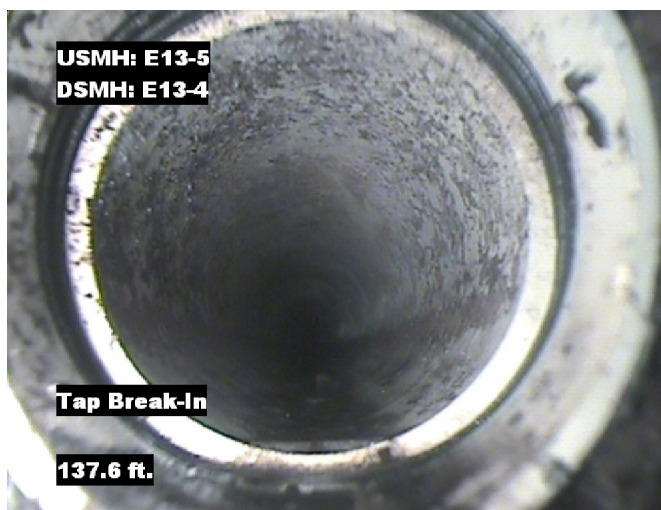
Distance: 137.6 ft. Grade: 0
Condition: Tap Break-In
Remarks: N/A

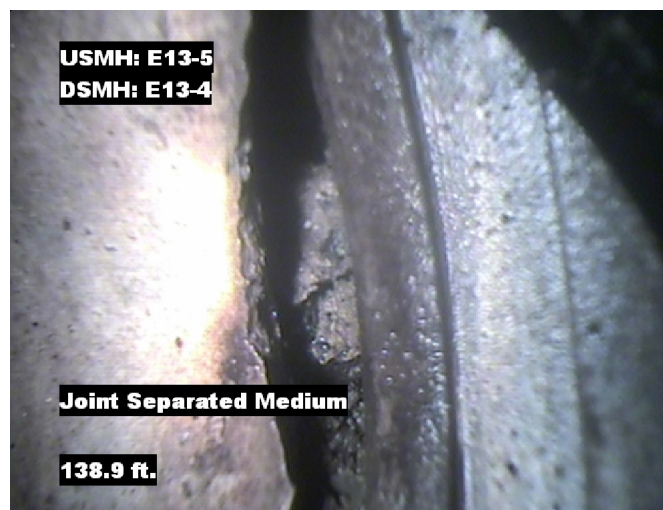
Distance: 138.9 ft. Grade: 1
Condition: Joint Separated Medium
Remarks: N/A

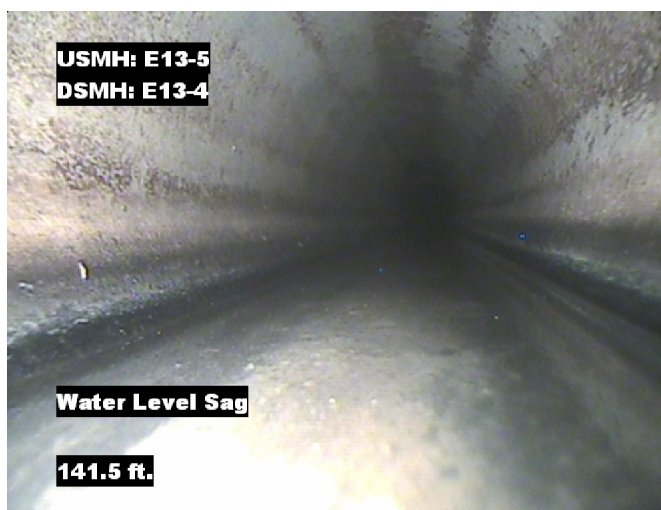
Distance: 141.5 ft. Grade: 2
Condition: Water Level Sag
Remarks: N/A

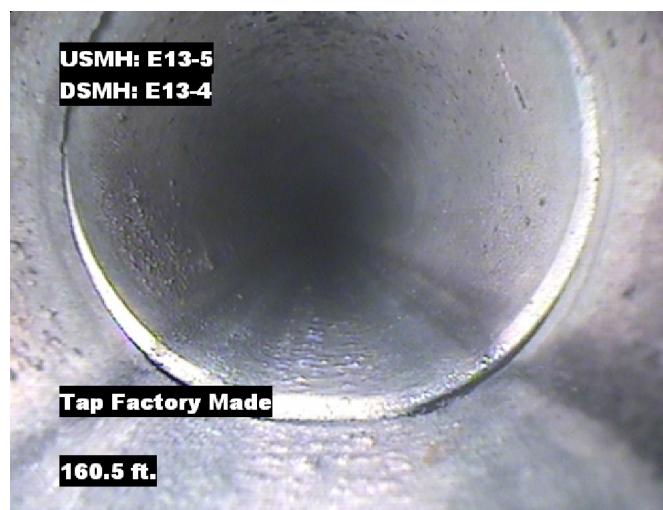
Distance: 160.5 ft. Grade: 0
Condition: Tap Factory Made
Remarks: N/A

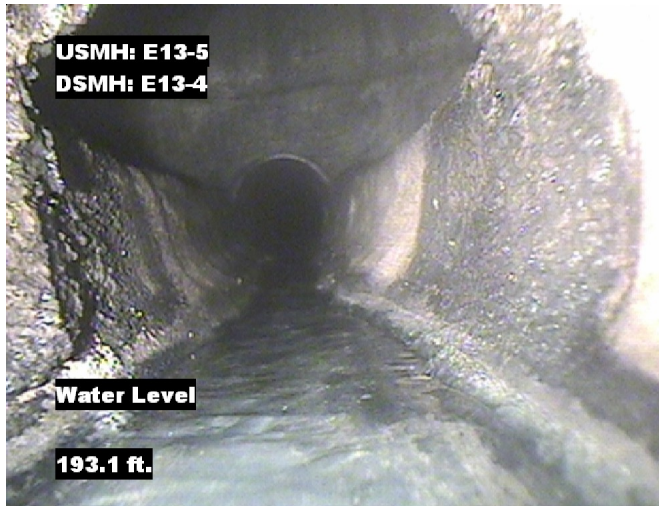
Distance: 193.1 ft. Grade: 0
Condition: Water Level
Remarks: N/A

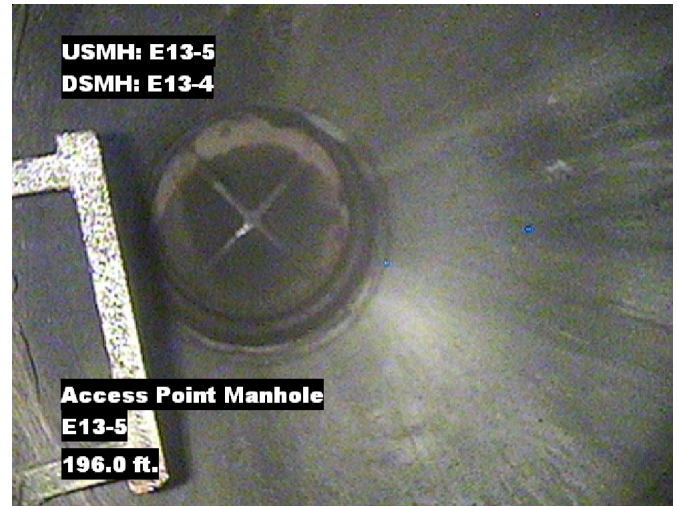
Distance: 196.0 ft. Grade: 0
Condition: Access Point Manhole
Remarks: E13-5
