## **Defect Listing**

Pipe Segment Refere		City		Street	Material		Location C	Sewer Use	
E13-6_	_E13-5	Oliver	Springs	Valley Dr	/alley Dr Concrete Pipe (non		Light High	Sanitary	
Upstream MH		Total Length		Year Laid	Sh	Shape		Details	
E1:	3-6	32	6.5		Circular		Str	eet	
DS Ma	anhole	Length s	surveyed	Year Renewed	Height	ht Width Pipe Joint			
E1:	3-5	326.5			8	8	4		
SPR	N/A	MPR	N/A	PO Number 4397-03 Work Order		Customer			
0001		MDDI				GRW			
SPRI	N/A	MPRI	N/A			Purpose			
QSR	N/A	QMR	N/A	4397-02		Pre-Rehabilitation Survey		urvey	
OF	PR	Surve	yed By	Direction	Di	Date Media la		alabel	
N/	N/A		Rogers	Downstream	20150609				
OF	PRI	Certificate Number		Pre-Cleaning	Time		Weather		
N/	N/A		2-16405	Jetting	09:35		Saturated		
	Date Cleaned			Er		End Time A		nal Info	
	20150609				09:51

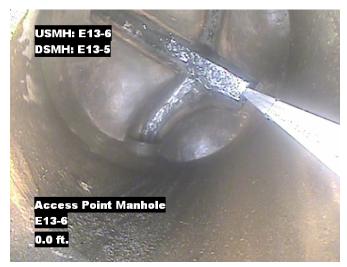
Distance: 0.0 ft. Grade: 0

Condition: Access Point Manhole

Remarks: E13-6

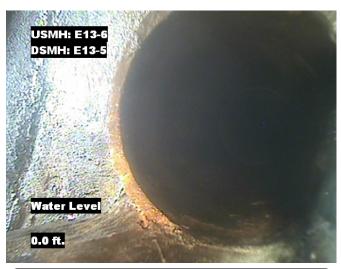
Distance: 0.0 ft. Grade: 0

Condition: Water Level

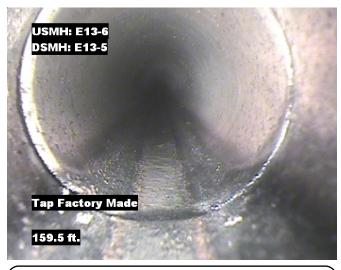
Distance: 159.5 ft. Grade: 0

Condition: Tap Factory Made

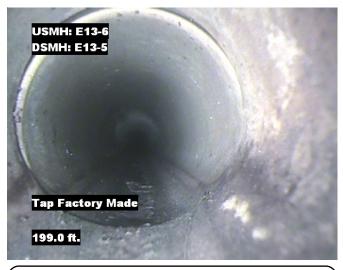
Distance: 199.0 ft. Grade: 0

Condition: Tap Factory Made

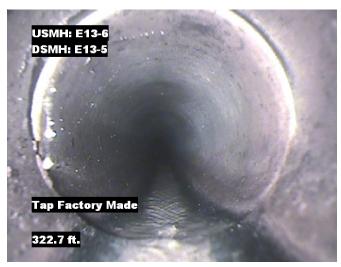
Distance: 322.7 ft. Grade: 0

Condition: Tap Factory Made

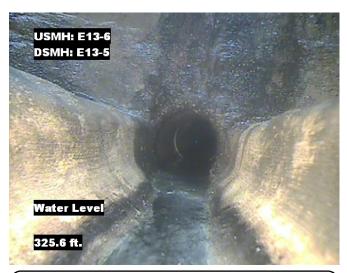
Distance: 325.6 ft. Grade: 0

Condition: Water Level
