Defect Listing

Pipe Segment Refere... E13-6A_E13-6	City Oliver Springs	Street Valley Drive	Material Concrete Pipe (non-...	Location C... Light High...	Sewer Use Sanitary
Upstream MH E13-6A	Total Length 267.3	Year Laid	Shape Circular	Location Details Street	
DS Manhole E13-6	Length surveyed 267.3	Year Renewed	Height 8	Width 8	Pipe Joint... 4

SPR N/A	MPR N/A	PO Number 4397-03	Customer GRW
SPRI N/A	MPRI N/A	Work Order 4397-02	Purpose Pre-Rehabilitation Survey
QSR N/A	QMR N/A		
OPR N/A	Surveyed By Barry Rogers	Direction Downstream	Date 20150609
OPRI N/A	Certificate Number U-1012-16405	Pre-Cleaning Jetting	Time 08:32
	Date Cleaned 20150609	End Time 09:00	Weather Saturated
			Media label
			Additional Info

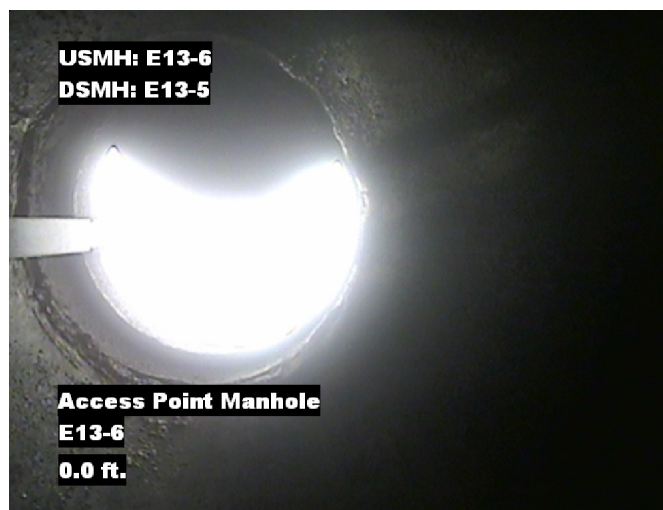
Distance: 0.0 ft. Grade: 0
Condition: Access Point Manhole
Remarks: E13-6A

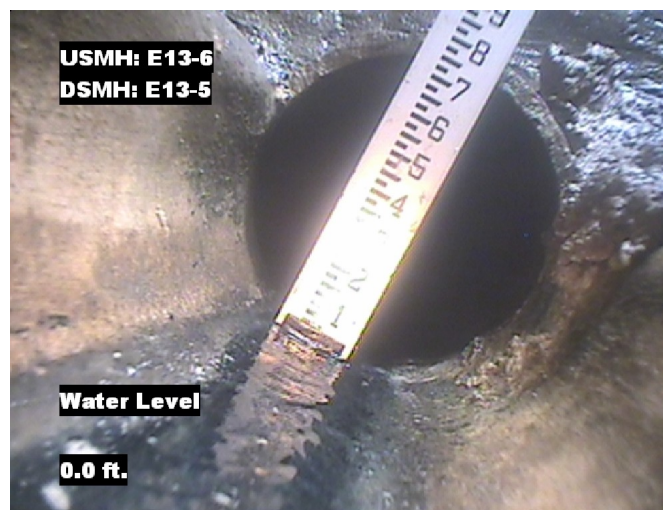
Distance: 0.0 ft. Grade: 0
Condition: Water Level
Remarks: N/A

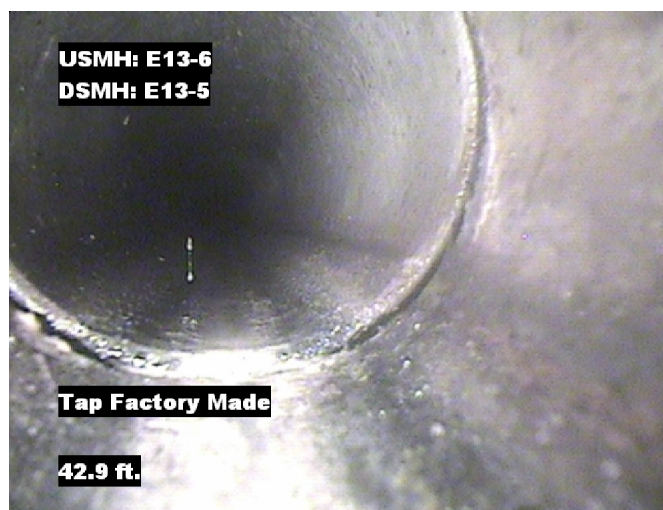
Distance: 42.9 ft. Grade: 0
Condition: Tap Factory Made
Remarks: N/A

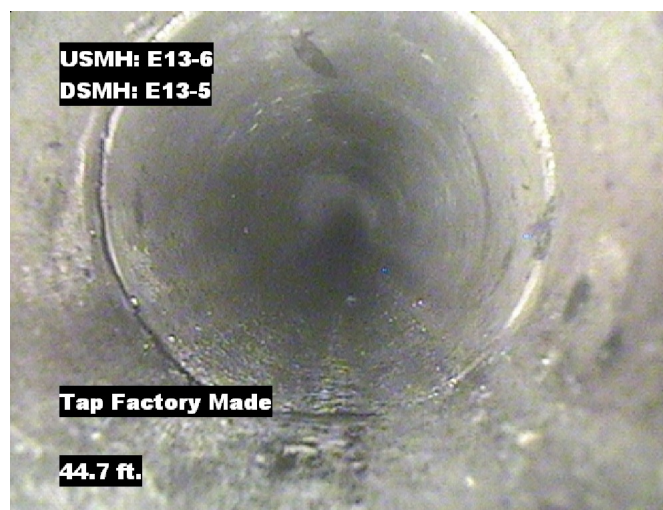
Distance: 44.7 ft. Grade: 0
Condition: Tap Factory Made
Remarks: N/A

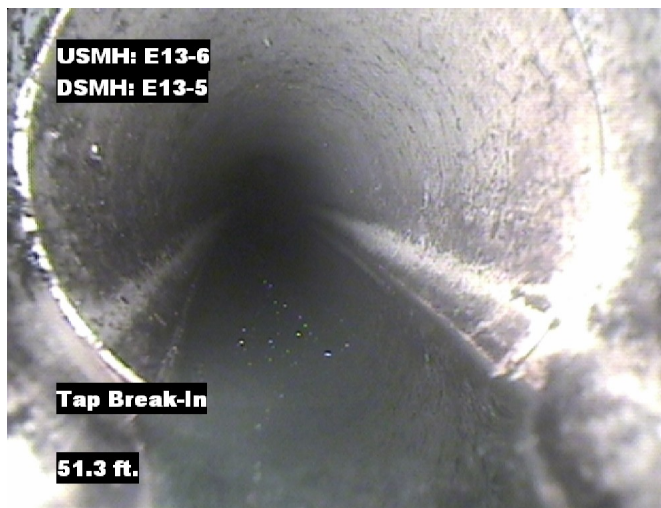
Distance: 51.3 ft. Grade: 0
Condition: Tap Break-In
Remarks: N/A

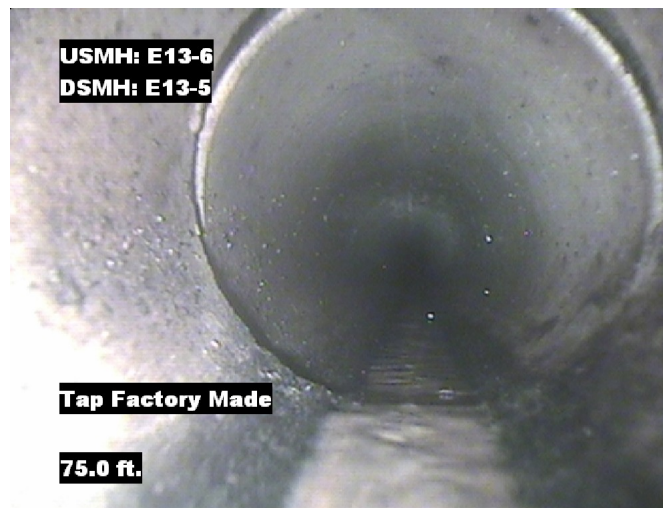
Distance: 75.0 ft. Grade: 0
Condition: Tap Factory Made
Remarks: N/A

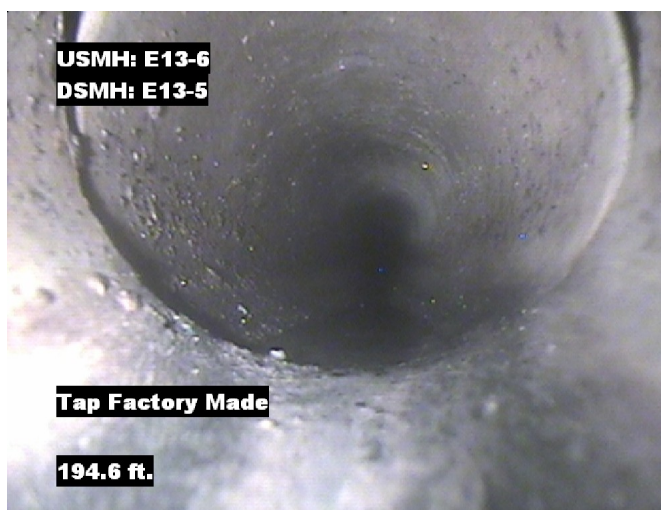
Distance: 194.6 ft. Grade: 0
Condition: Tap Factory Made
Remarks: N/A

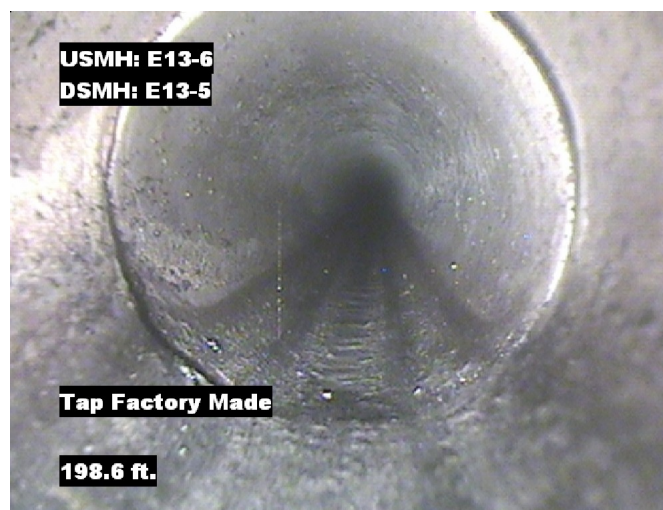
Distance: 198.6 ft. Grade: 0
Condition: Tap Factory Made
Remarks: N/A

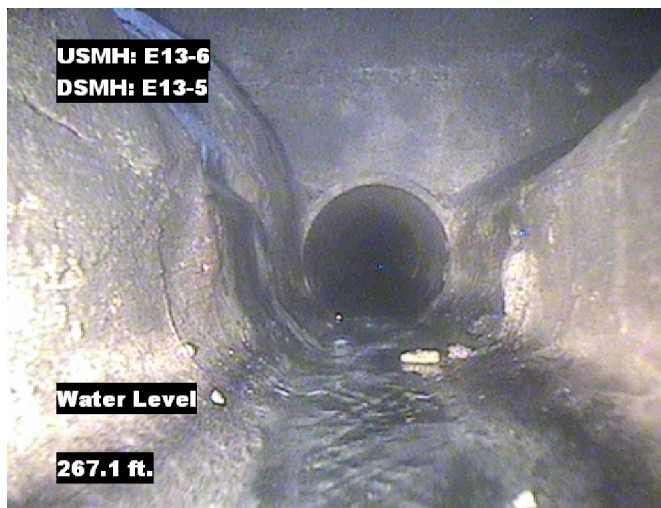
Distance: 267.1 ft. Grade: 0
Condition: Water Level
Remarks: N/A

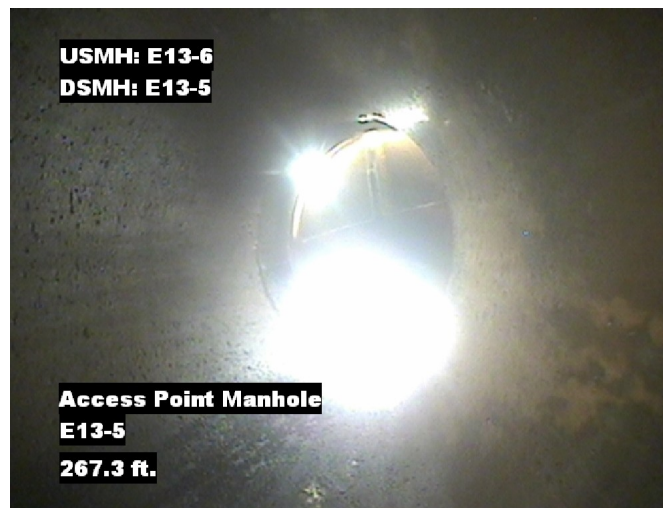
Distance: 267.3 ft. Grade: 0
Condition: Access Point Manhole
Remarks: E13-6
