Defect Listing

Pipe Segment Refere... E13-7_E13-6A	City Oliver Springs	Street Valley Drive	Material Concrete Pipe (non-...	Location C... Light High...	Sewer Use Sanitary
Upstream MH E13-7	Total Length 254.6	Year Laid	Shape Circular	Location Details Street	
DS Manhole E13-6A	Length surveyed 254.6	Year Renewed	Height 8	Width 8	Pipe Joint... 4

SPR N/A	MPR N/A	PO Number 4397-03	Customer GRW
SPRI N/A	MPRI N/A	Work Order 4397-02	Purpose Pre-Rehabilitation Survey
QSR N/A	QMR N/A		
OPR N/A	Surveyed By Barry Rogers	Direction Downstream	Date 20150609
OPRI N/A	Certificate Number U-1012-16405	Pre-Cleaning Jetting	Time 07:53
	Date Cleaned 20150609	End Time 08:09	Weather Saturated
			Media label
			Additional Info

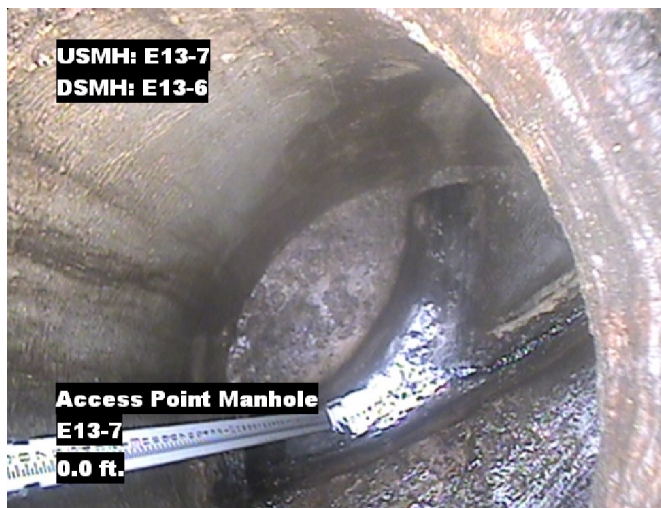
Distance: 0.0 ft. Grade: 0
Condition: Access Point Manhole
Remarks: E13-7

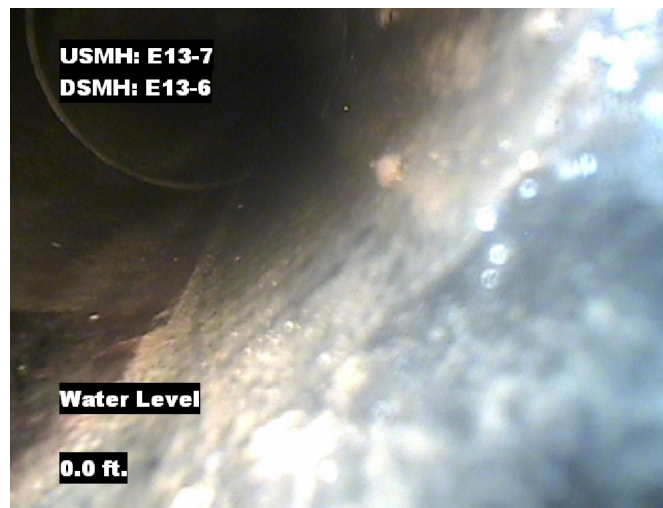
Distance: 0.0 ft. Grade: 0
Condition: Water Level
Remarks: N/A

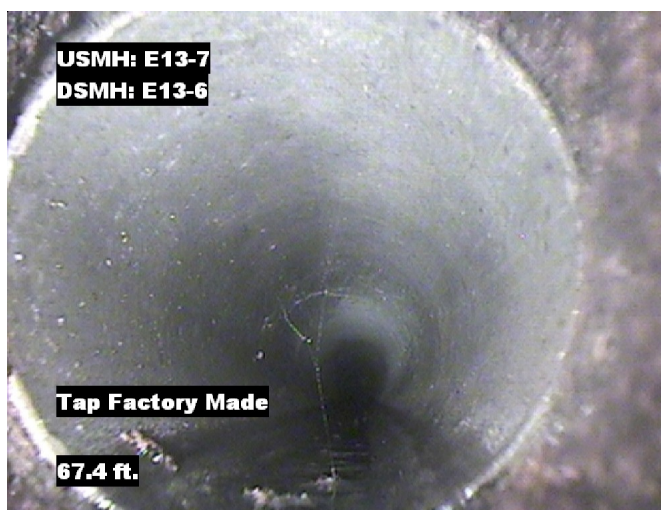
Distance: 67.4 ft. Grade: 0
Condition: Tap Factory Made
Remarks: N/A

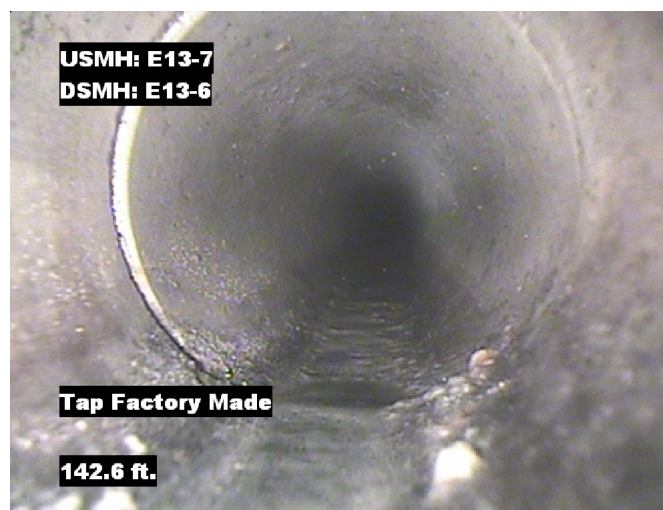
Distance: 142.6 ft. Grade: 0
Condition: Tap Factory Made
Remarks: N/A

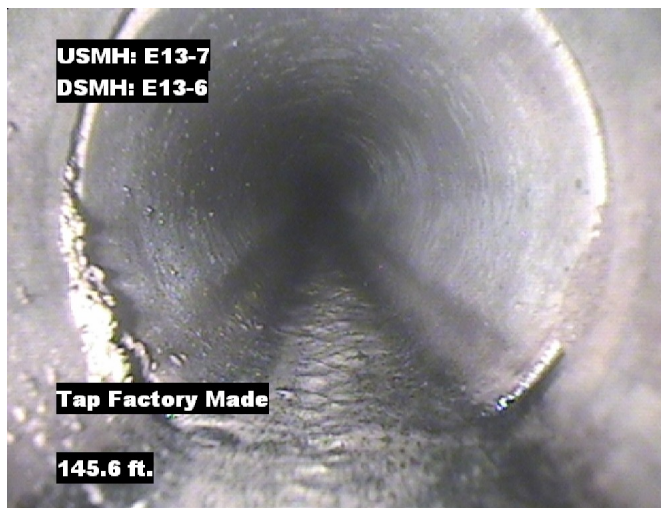
Distance: 145.6 ft. Grade: 0
Condition: Tap Factory Made
Remarks: N/A

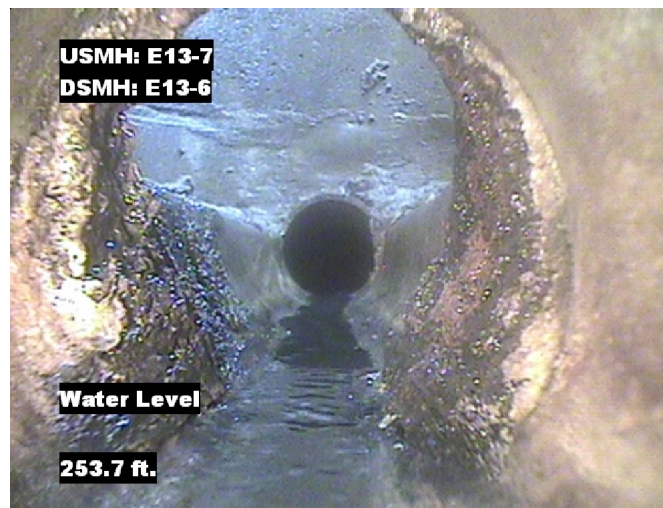
Distance: 253.7 ft. Grade: 0
Condition: Water Level
Remarks: N/A

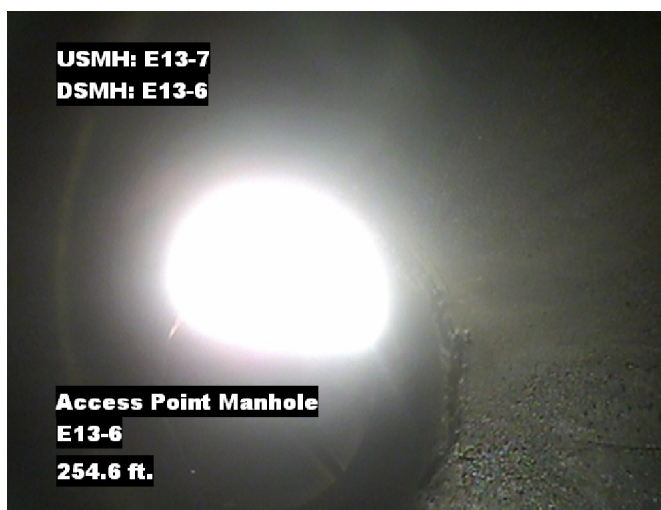
Distance: 254.6 ft. Grade: 0
Condition: Access Point Manhole
Remarks: E13-6A
