Defect Listing

Pipe Segment Refere... E13-8_E13-7	City Oliver Springs	Street Ray Drive	Material Concrete Pipe (non-...	Location C... Light High...	Sewer Use Sanitary
Upstream MH E13-8	Total Length 200.6	Year Laid	Shape Circular	Location Details Street	
DS Manhole E13-7	Length surveyed 200.6	Year Renewed	Height 8	Width 8	Pipe Joint... 4

Image Report 4/Page

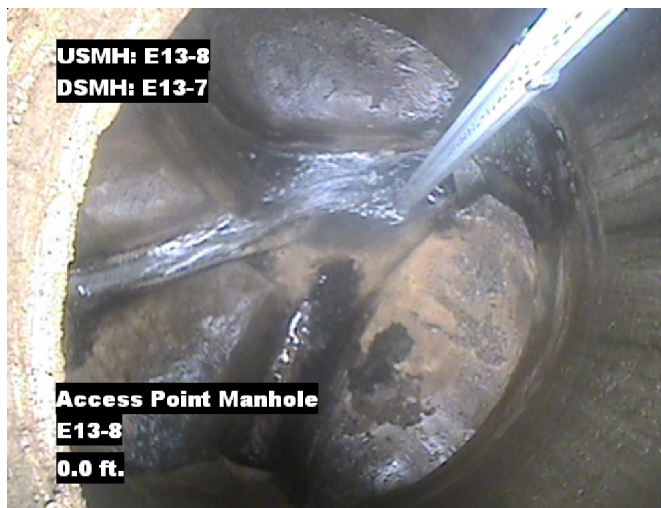
Distance: 0.0 ft. Grade: 0
Condition: Access Point Manhole
Remarks: E13-8

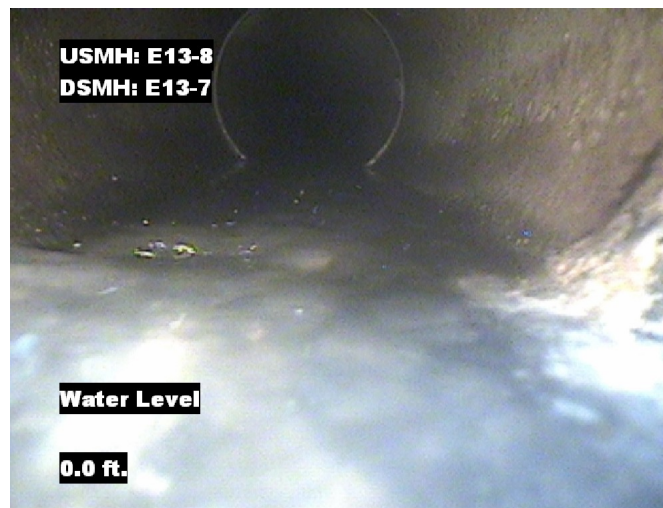
Distance: 0.0 ft. Grade: 0
Condition: Water Level
Remarks: N/A

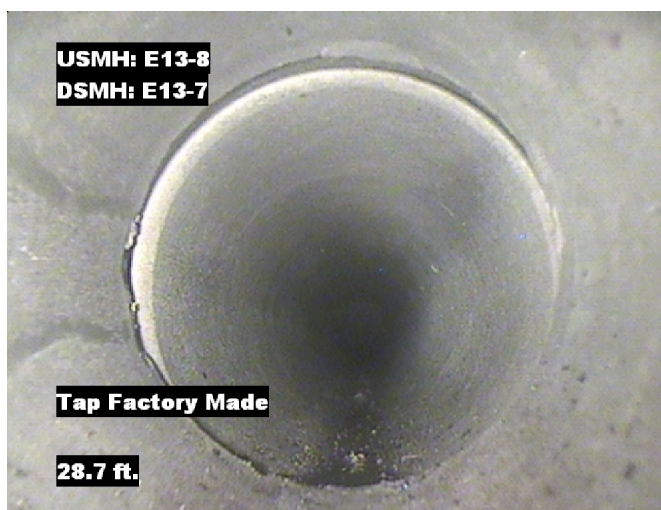
Distance: 28.7 ft. Grade: 0
Condition: Tap Factory Made
Remarks: N/A

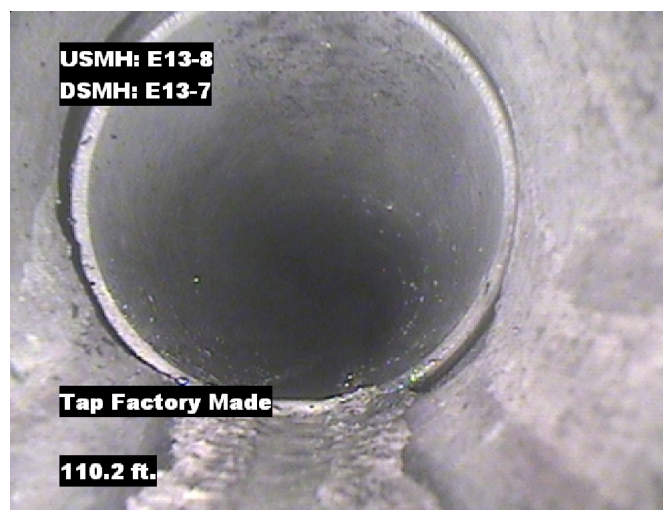
Distance: 110.2 ft. Grade: 0
Condition: Tap Factory Made
Remarks: N/A

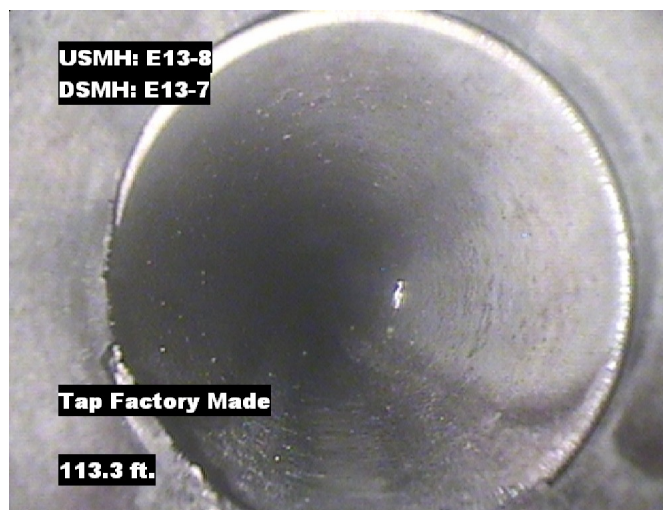
Distance: 113.3 ft. Grade: 0
Condition: Tap Factory Made
Remarks: N/A

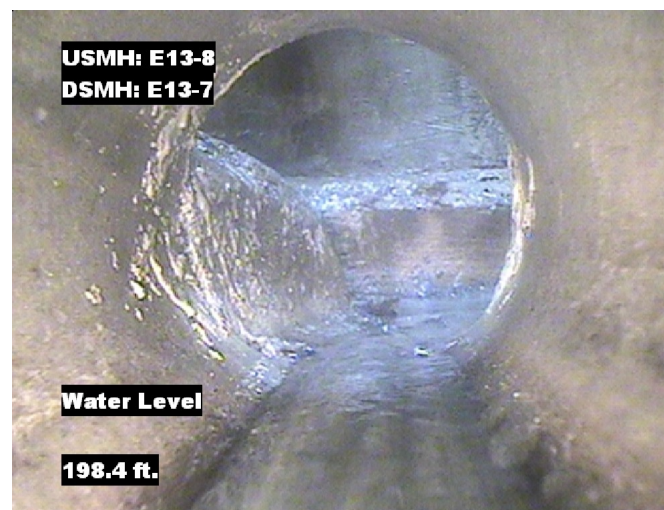
Distance: 198.4 ft. Grade: 0
Condition: Water Level
Remarks: N/A

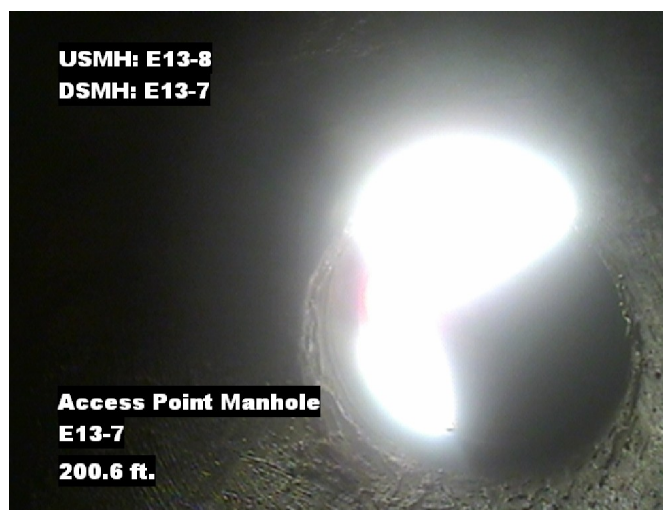
Distance: 200.6 ft. Grade: 0
Condition: Access Point Manhole
Remarks: E13-7
