## Defect Listing

| Pipe Segment Refere...<br><b>E13-9_E13-8</b> | City<br><b>Oliver Springs</b> | Street<br><b>Devaney Ln</b> | Material<br><b>Concrete Pipe (non-...</b> | Location C...<br><b>Light High...</b> | Sewer Use<br><b>Sanitary</b> |

## Image Report 4/Page

## PACP Conditions

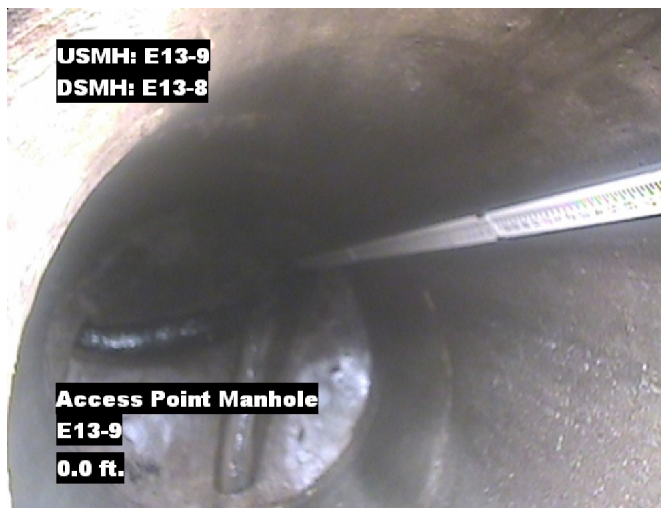
Distance: 0.0 ft. Grade: 0  
Condition: Access Point Manhole  
Remarks: E13-9

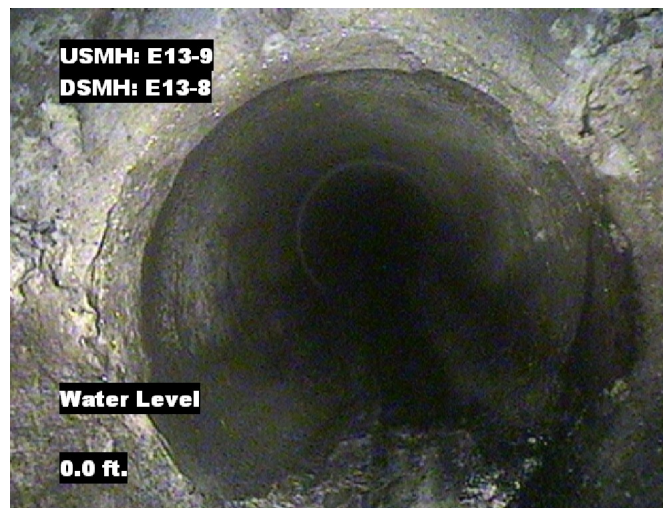
Distance: 0.0 ft. Grade: 0  
Condition: Water Level  
Remarks: N/A

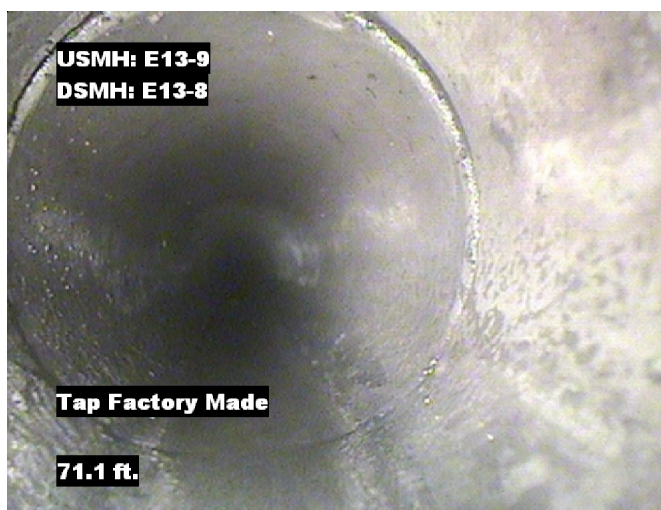
| Distance | Condition | Cont. Dfct. | Values | | | Joint | Clock Position | | Grade |
|---|---|---|---|---|---|---|---|---|---|
| 71.1 ft. | Tap Factory Made | | 6 | | 0 | <input type="checkbox"/> | 9 | | |

Distance: 71.1 ft. Grade: 0  
Condition: Tap Factory Made  
Remarks: N/A

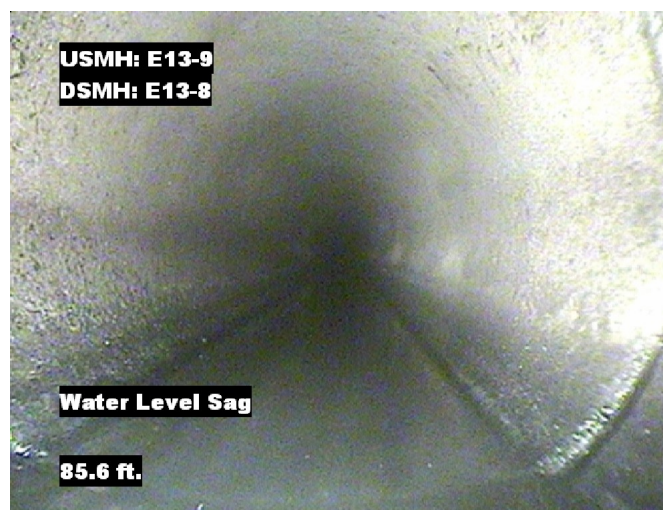
| Distance | Condition | Cont. Dfct. | Values | | | Joint | Clock Position | | Grade |
|---|---|---|---|---|---|---|---|---|---|
| 85.6 ft. | Water Level Sag | S01 | | | 15 | <input type="checkbox"/> | | | 2 |

Distance: 85.6 ft. Grade: 2  
Condition: Water Level Sag  
Remarks: N/A

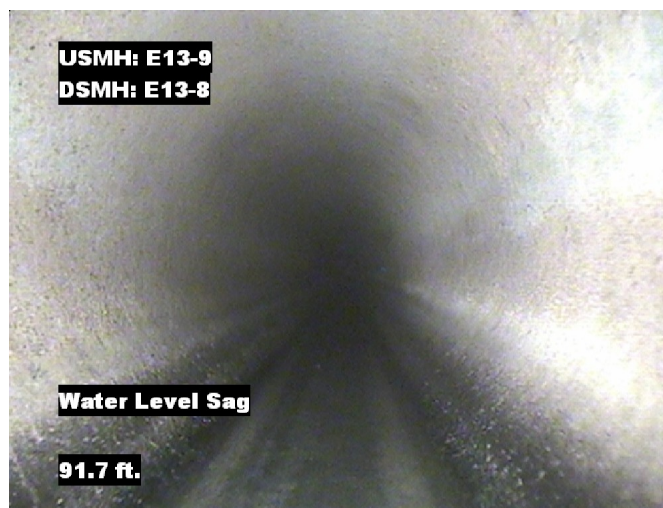
| Distance | Condition | Cont. Dfct. | Values | | | Joint | Clock Position | | Grade |
|---|---|---|---|---|---|---|---|---|---|
| 91.7 ft. | Water Level Sag | F01 | | | 15 | <input type="checkbox"/> | | | 2 |

Distance: 91.7 ft. Grade: 2  
Condition: Water Level Sag  
Remarks: N/A

| Normal Defects | | | Structural Ratings | | | O & M Ratings | | | Combined Ratings | | |
|---|---|---|---|---|---|---|---|---|---|---|---|
| MWLS | F01 | 6.1 | | | | | | | | | |

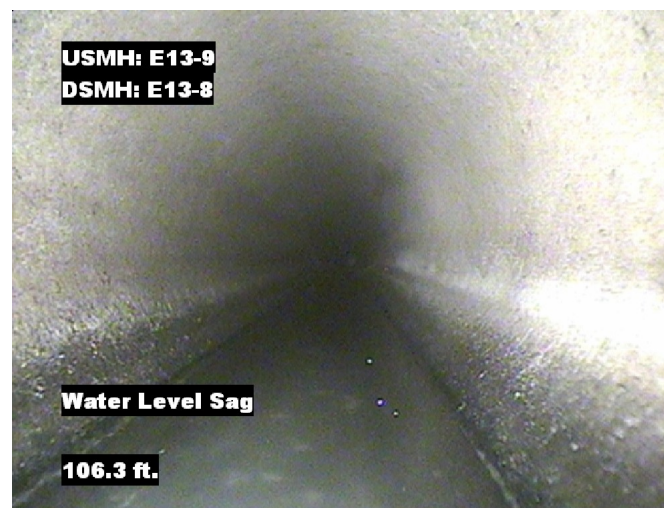
| Distance | Condition | Cont. Dfct. | Values | | | Joint | Clock Position | | Grade |
|---|---|---|---|---|---|---|---|---|---|
| 106.3 ft. | Water Level Sag | | | | 15 | <input type="checkbox"/> | | | 2 |

Distance: 106.3 ft. Grade: 2  
Condition: Water Level Sag  
Remarks: N/A

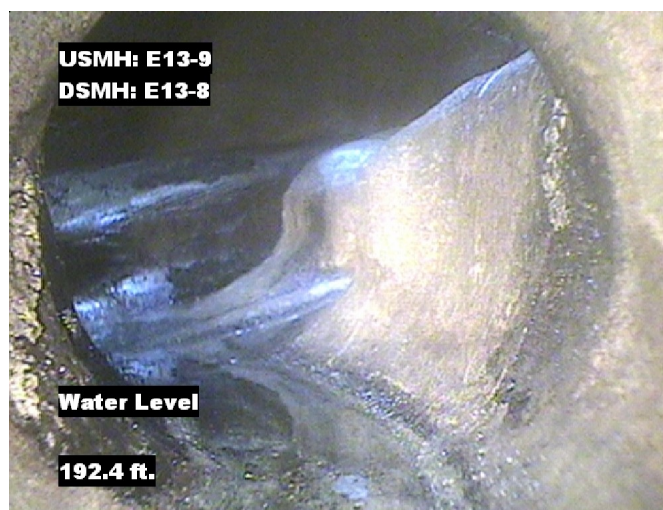
Distance: 192.4 ft. Grade: 0  
Condition: Water Level  
Remarks: N/A

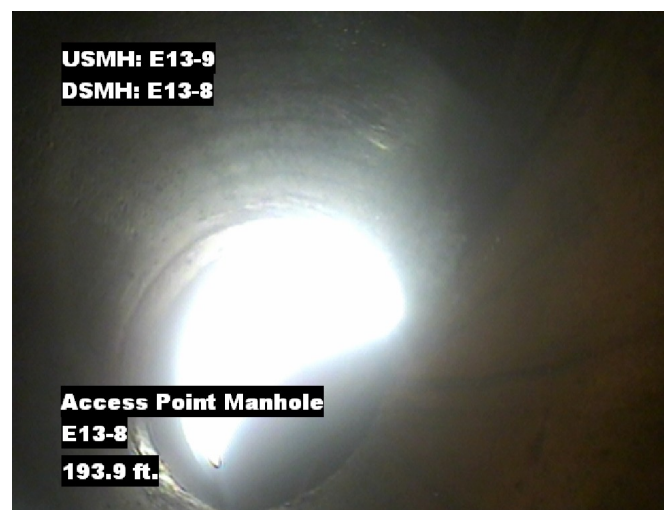
Distance: 193.9 ft. Grade: 0  
Condition: Access Point Manhole  
Remarks: E13-8
