## Defect Listing

Pipe Segment Refere... <b>E15-1_E-14</b>	City <b>Oliver Springs</b>	Street <b>Cedar Ln</b>	Material <b>PolyVinyl Chloride</b>	Location C... <b>Easement/R...</b>	Sewer Use <b>Sanitary</b>
Upstream MH <b>E15-1</b>	Total Length <b>132</b>	Year Laid	Shape <b>Circular</b>	Location Details <b>Back of Houses</b>	
DS Manhole <b>E-14</b>	Length surveyed <b>132</b>	Year Renewed	Height <b>8</b>	Width <b>8</b>	Pipe Joint... <b>13</b>

SPR <b>N/A</b>	MPR <b>8</b>	PO Number <b>4397-03</b>	Customer <b>GRW</b>
SPRI <b>N/A</b>	MPRI <b>2</b>	Work Order <b>4397-02</b>	Purpose <b>Pre-Rehabilitation Survey</b>
QSR <b>N/A</b>	QMR <b>2400</b>		
OPR <b>8</b>	Surveyed By <b>Barry Rogers</b>	Direction <b>Upstream</b>	Date <b>20150605</b>
OPRI <b>2</b>	Certificate Number <b>U-1012-16405</b>	Pre-Cleaning <b>Jetting</b>	Time <b>11:07</b>
	Date Cleaned <b>20150605</b>	End Time <b>11:28</b>	Weather <b>Dry</b>
			Media label
			Additional Info

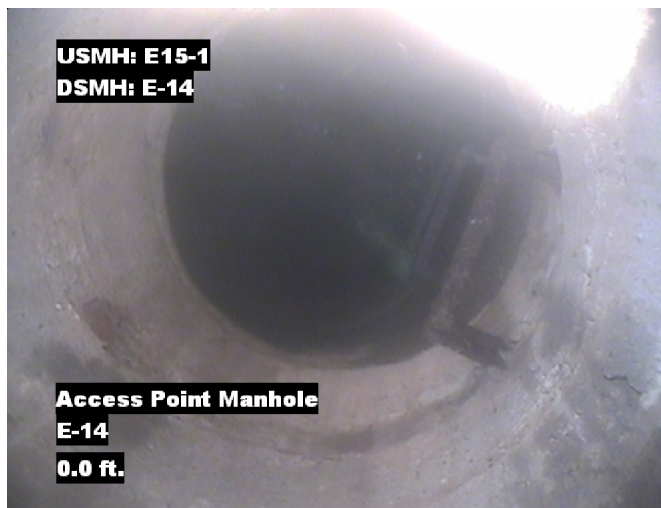
Distance: 0.0 ft. Grade: 0  
Condition: Access Point Manhole  
Remarks: E15-1

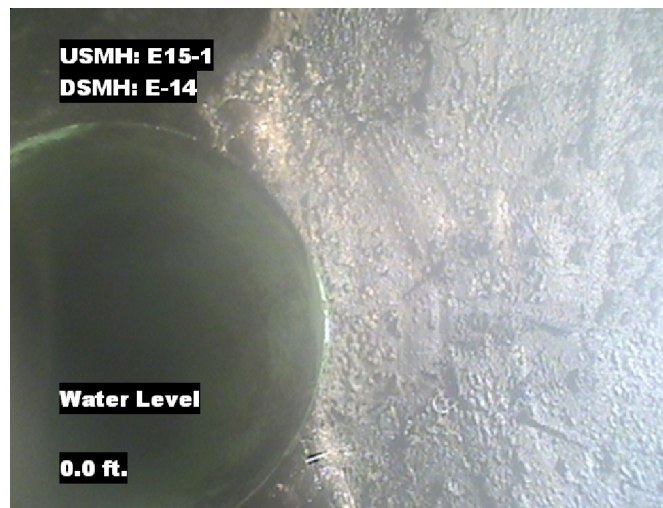
Distance: 0.0 ft. Grade: 0  
Condition: Water Level  
Remarks: N/A

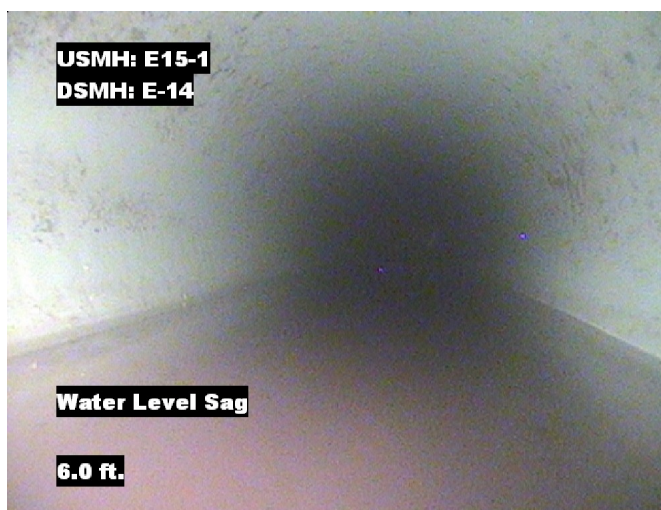
Distance: 6.0 ft. Grade: 2  
Condition: Water Level Sag  
Remarks: N/A

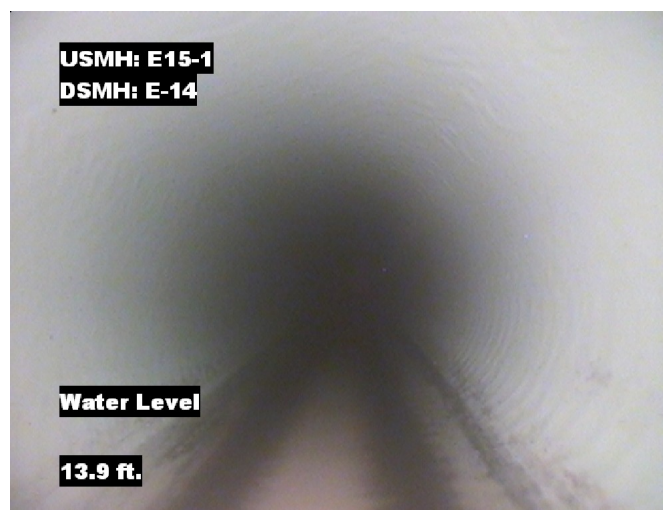
Distance: 13.9 ft. Grade: 0  
Condition: Water Level  
Remarks: N/A

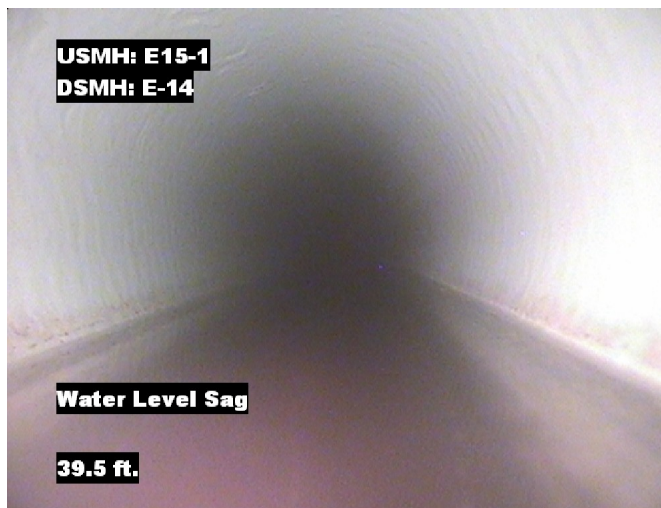
Distance: 39.5 ft. Grade: 2  
Condition: Water Level Sag  
Remarks: N/A

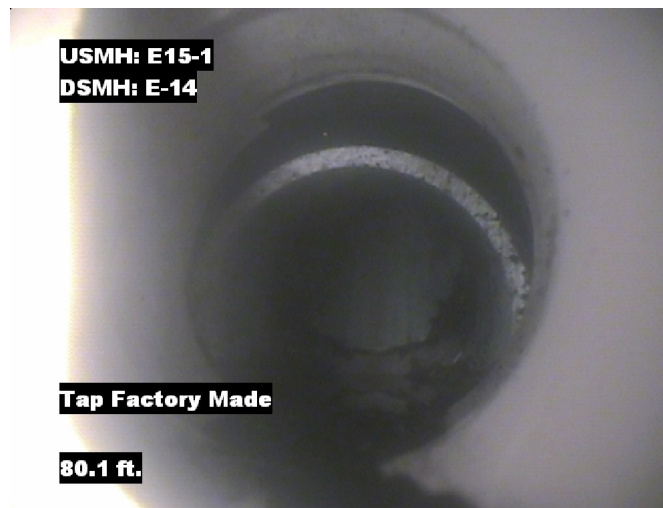
Distance: 80.1 ft. Grade: 0  
Condition: Tap Factory Made  
Remarks: N/A

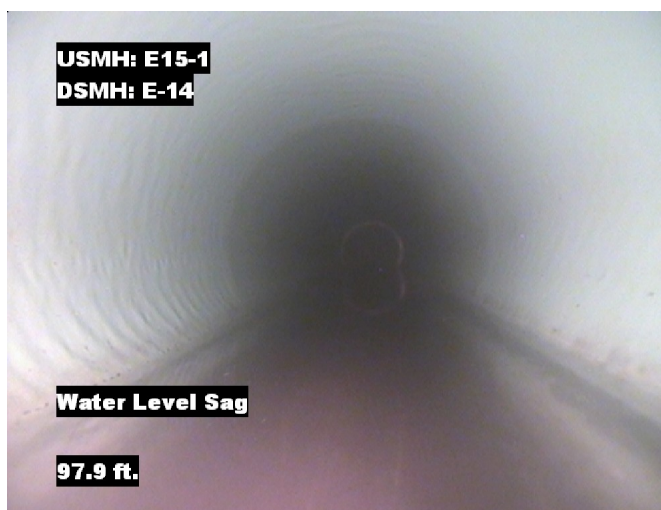
Distance: 97.9 ft. Grade: 2  
Condition: Water Level Sag  
Remarks: N/A

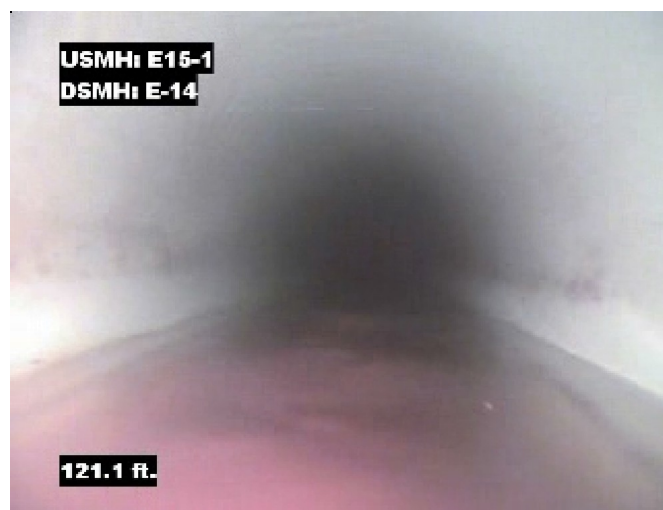
Distance: 121.0 ft. Grade: 2  
Condition: Water Level Sag  
Remarks: N/A

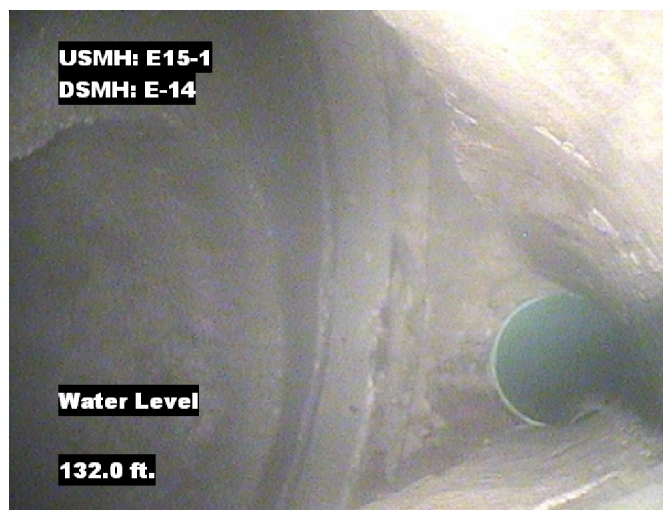
Distance: 132.0 ft.      Grade: 0  
Condition: Water Level  
Remarks: N/A

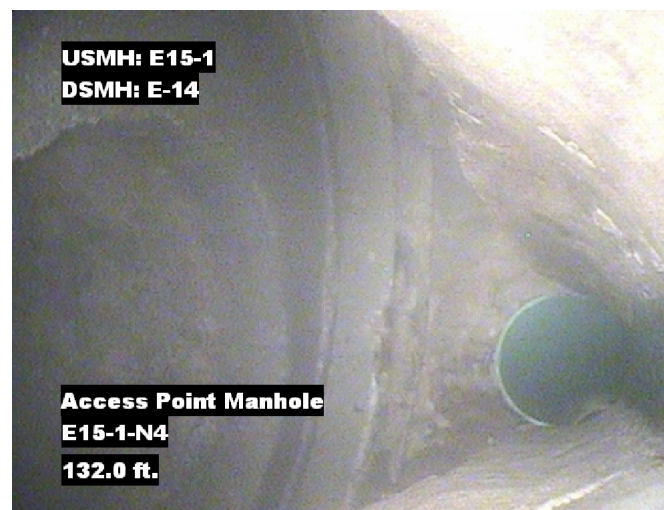
Distance: 132.0 ft.      Grade: 0  
Condition: Access Point Manhole  
Remarks: E-14
