Defect Listing

Pipe Segment Refere		City		Street	Mat	Material		Sewer Use	
E15-2_E15-2A		Oliver Springs		Sleepy Hollow	PolyViny	PolyVinyl Chloride		Sanitary	
Upstrea	am MH	Total	Length	Year Laid	Sha	ape	Location Details		
E15	5-2	34	7.4		Circ	ular	Houses		
DS Ma	anhole	Length	surveyed	Year Renewed	Height	Width	Pipe Joint		
E15	-2A	347.4			8	8	13		
SPR	N/A	MPR	44	PO Number 4397-03			Customer		
2001	-					GRW			
SPRI	N/A	MPRI	2	Work Order		Purpose			
QSR	N/A	QMR	2C00	4397-02		Pre	Pre-Rehabilitation Survey		
OF	PR	Surveyed By		Direction	Da	Date Media la		alabel	
4	4	Barry_Rogers		Downstream	20150605				
OF	PRI	Certificate Number		Pre-Cleaning	Time		Weather		
2	2	U-1012-16405		Jetting	09	09:22			
	Date Cleaned						Additional Info		
l	20150605						Manholes are Not La

Pipe Segment Refere	City	Street	Material		Location C	Sewer Use
E15-2_E15-2A	Oliver Springs	Sleepy Hollow	PolyVinyl Chloride		Easement/R	Sanitary
Upstream MH	Total Length	Year Laid	Shape		Location Details	
E15-2	347.4		Circular		Behind	Houses
DS Manhole	Length surveyed	Year Renewed	Height	Width	Pipe Joint	
E15-2A	347.4		8	8	13

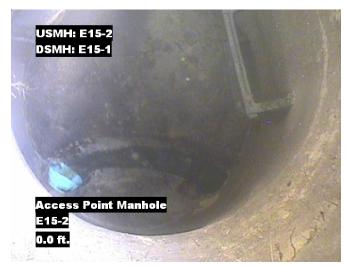
Distance: 0.0 ft. Grade: 0

Condition: Access Point Manhole

Remarks: E15-2

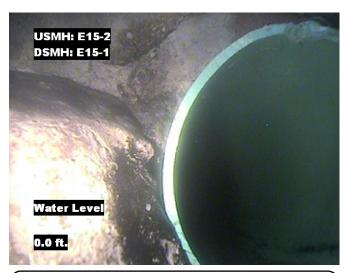
Distance: 0.0 ft. Grade: (

Condition: Water Level

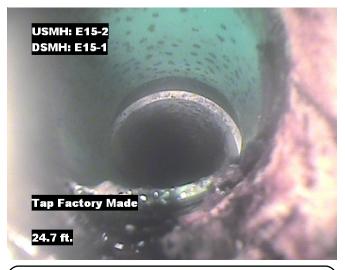
Distance: 24.7 ft. Grade: 0

Condition: Tap Factory Made

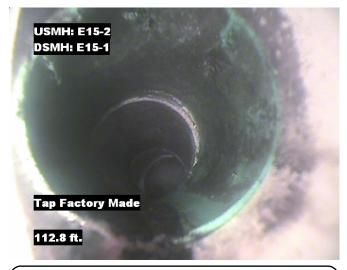
Distance: 112.8 ft. Grade: 0

Condition: Tap Factory Made

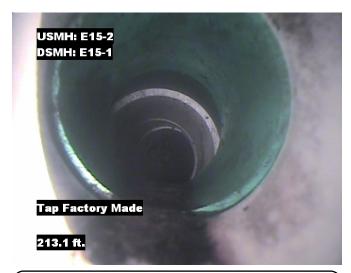
Distance: 213.1 ft. Grade: 0

Condition: Tap Factory Made

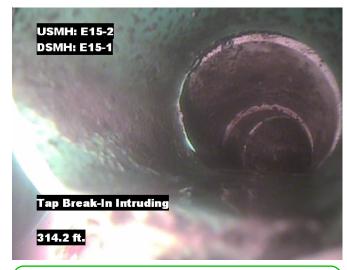
Distance: 314.2 ft. Grade: 2

Condition: Tap Break-In Intruding

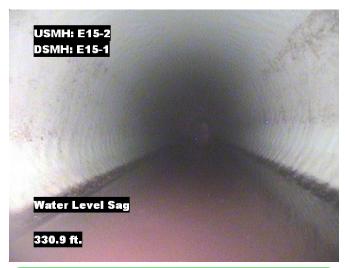
Distance: 330.9 ft. Grade: 2

Condition: Water Level Sag

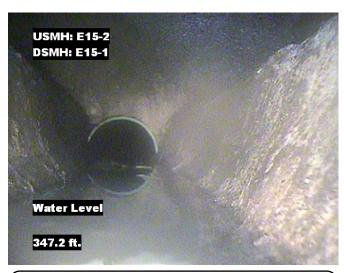
Distance: 347.2 ft. Grade: (

Condition: Water Level

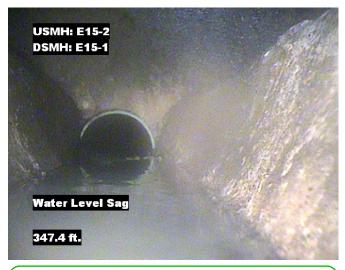
Distance: 347.4 ft. Grade: 2

Condition: Water Level Sag

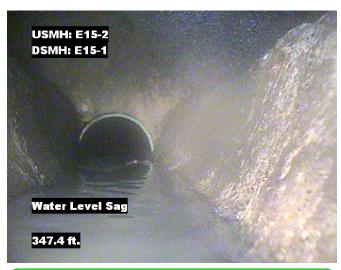
Distance: 347.4 ft. Grade: 2

Condition: Water Level Sag
