## Defect Listing

| Pipe Segment Refere...<br><b>E15-2A E15-1</b> | City<br><b>Oliver Springs</b> | Street<br><b>Cedar Ln</b> | Material<br><b>PolyVinyl Chloride</b> | Location C...<br><b>Easement/R...</b> | Sewer Use<br><b>Sanitary</b> |

| SPRI<br><b>N/A</b> | MPRI<br><b>2</b> | Work Order<br><b>4397-02</b> | | Purpose<br><b>Pre-Rehabilitation Survey</b> | |

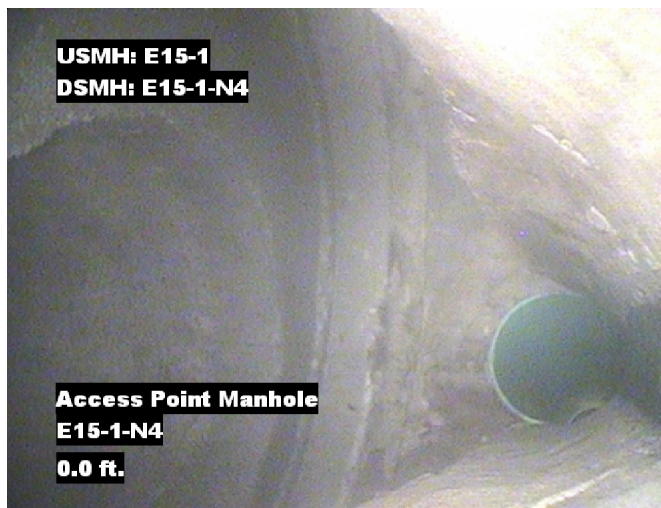
Distance: 0.0 ft. Grade: 0  
Condition: Access Point Manhole  
Remarks: E15-2A

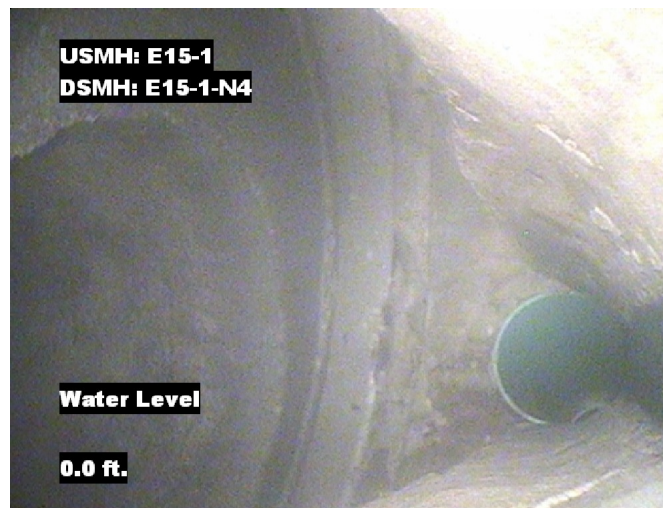
Distance: 0.0 ft. Grade: 0  
Condition: Water Level  
Remarks: N/A

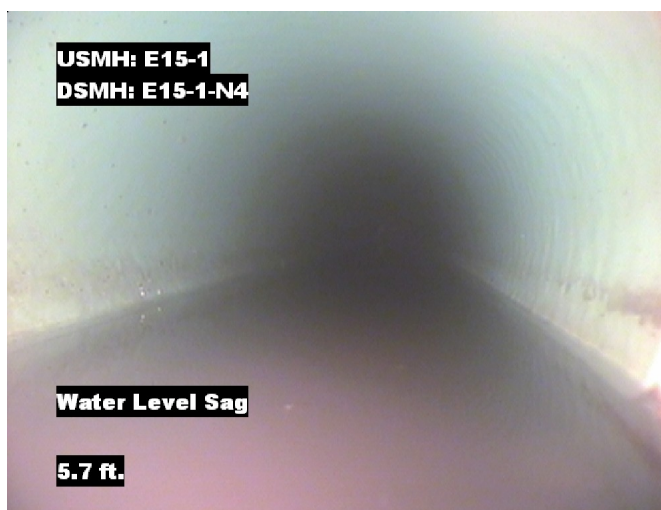
| Distance | Condition | Cont. Dfct. | Values | | | Joint | Clock Position | | Grade |
|---|---|---|---|---|---|---|---|---|---|
| 5.7 ft. | Water Level Sag | | | | 20 | <input type="checkbox"/> | | | 2 |

Distance: 5.7 ft. Grade: 2  
Condition: Water Level Sag  
Remarks: N/A

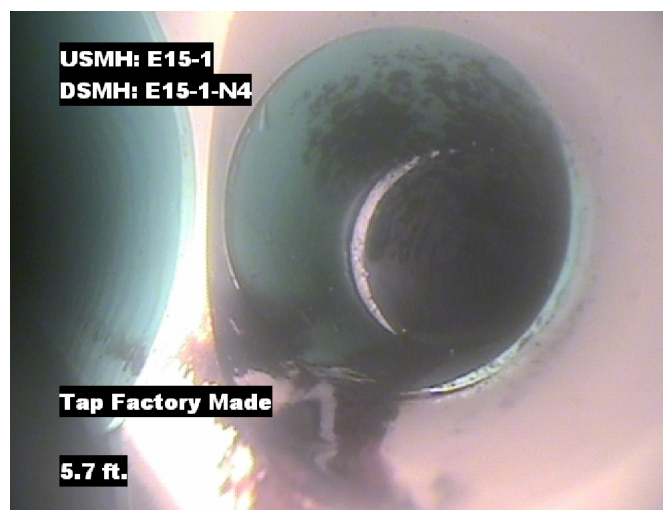
Distance: 5.7 ft. Grade: 0  
Condition: Tap Factory Made  
Remarks: N/A

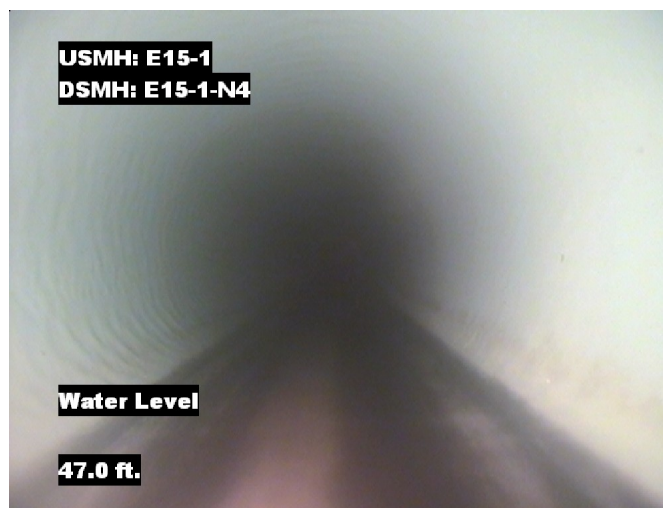
Distance: 47.0 ft. Grade: 0  
Condition: Water Level  
Remarks: N/A

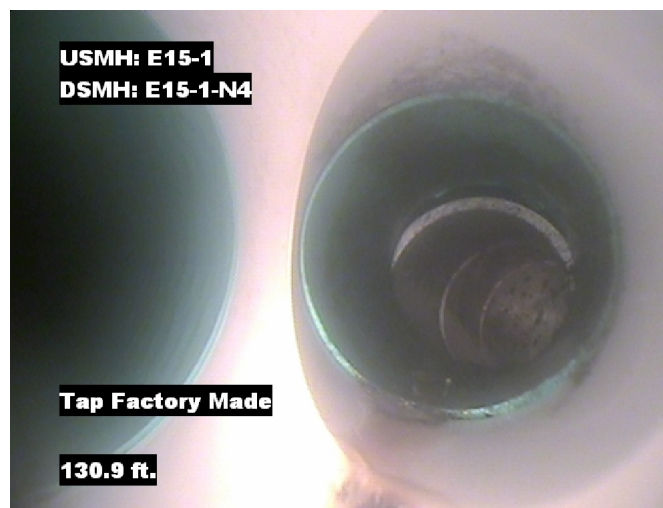
Distance: 130.9 ft. Grade: 0  
Condition: Tap Factory Made  
Remarks: N/A

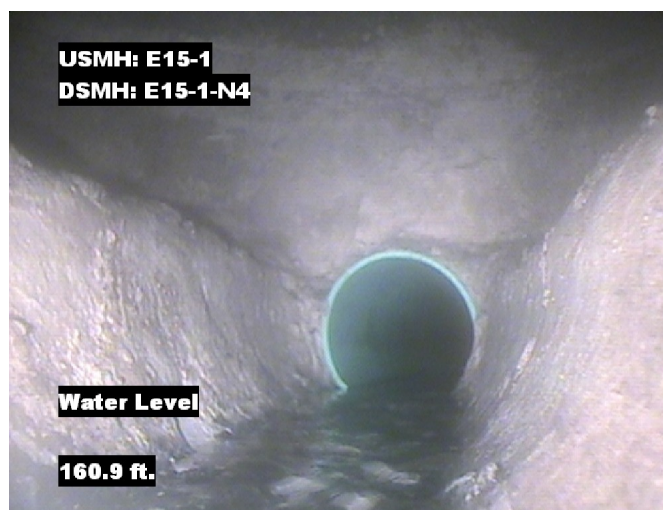
Distance: 160.9 ft. Grade: 0  
Condition: Water Level  
Remarks: N/A

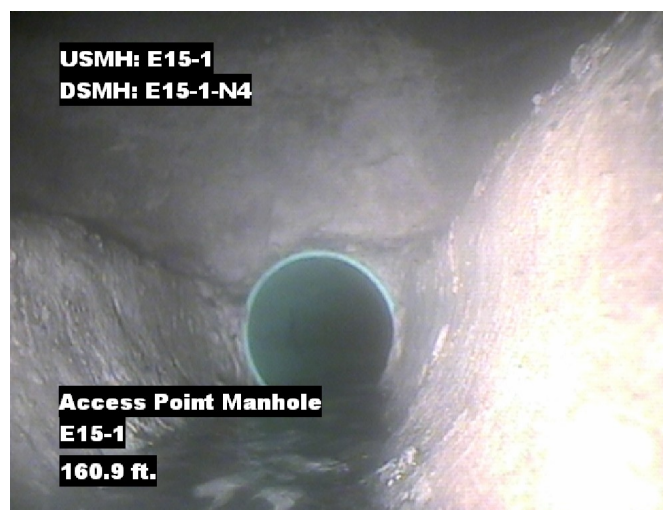
Distance: 160.9 ft. Grade: 0  
Condition: Access Point Manhole  
Remarks: E15-1
