Defect Listing

Pipe Segment Refere... E15-3_E15-2	City Oliver Springs	Street Sleepy Hollow	Material PolyVinyl Chloride		Location C... Easement/R...	Sewer Use Sanitary
Upstream MH E15-3	Total Length 114.6	Year Laid	Shape Circular		Location Details Side of Rd	
DS Manhole E15-2	Length surveyed 114.6	Year Renewed	Height 8	Width 8	Pipe Joint... 13

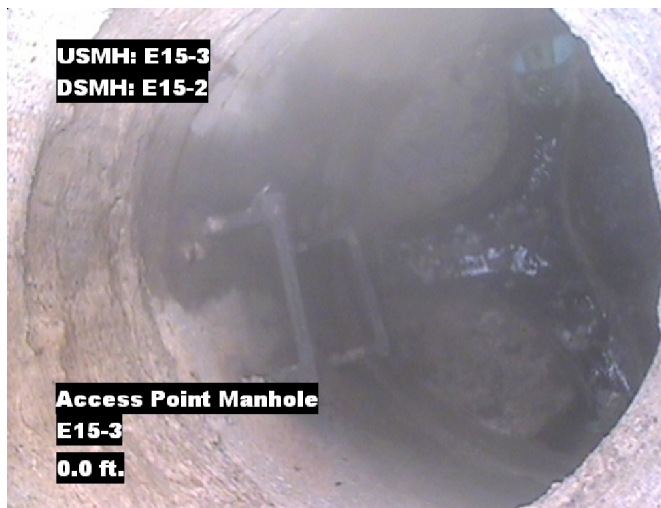
Distance: 0.0 ft. Grade: 0
Condition: Access Point Manhole
Remarks: E15-3

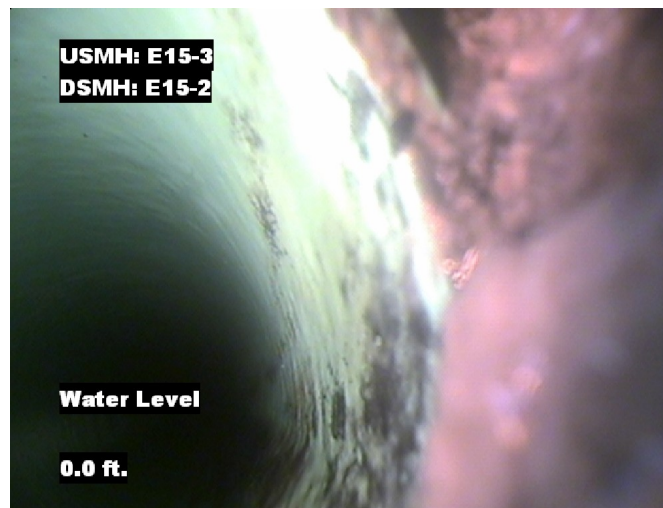
Distance: 0.0 ft. Grade: 0
Condition: Water Level
Remarks: N/A

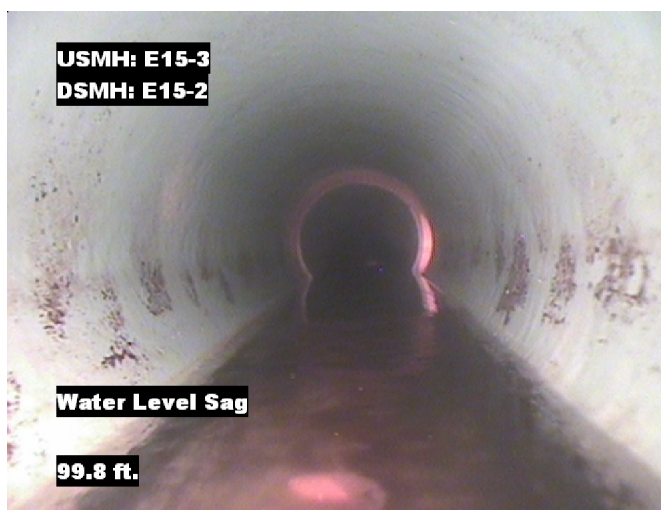
Distance: 99.8 ft. Grade: 2
Condition: Water Level Sag
Remarks: N/A

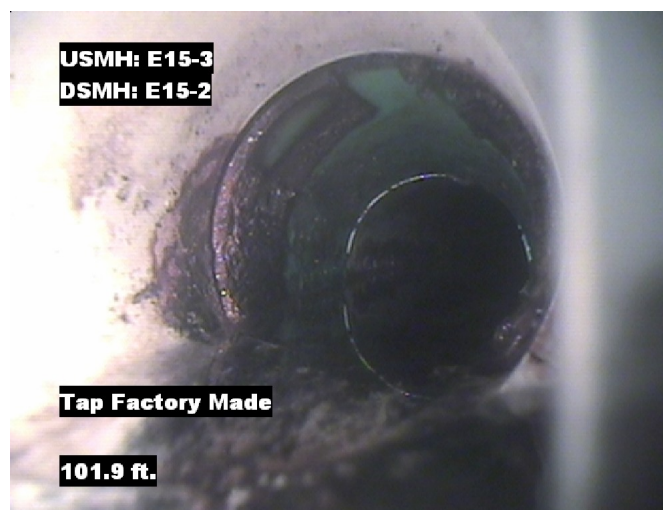
Distance: 101.9 ft. Grade: 0
Condition: Tap Factory Made
Remarks: N/A

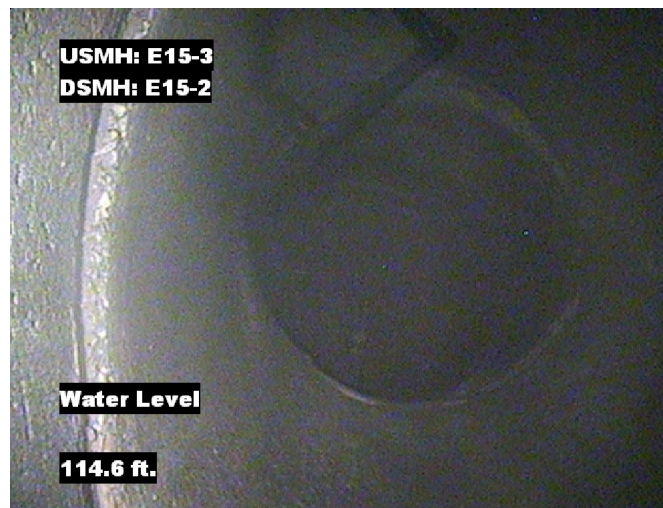
Distance: 114.6 ft. Grade: 0
Condition: Water Level
Remarks: N/A

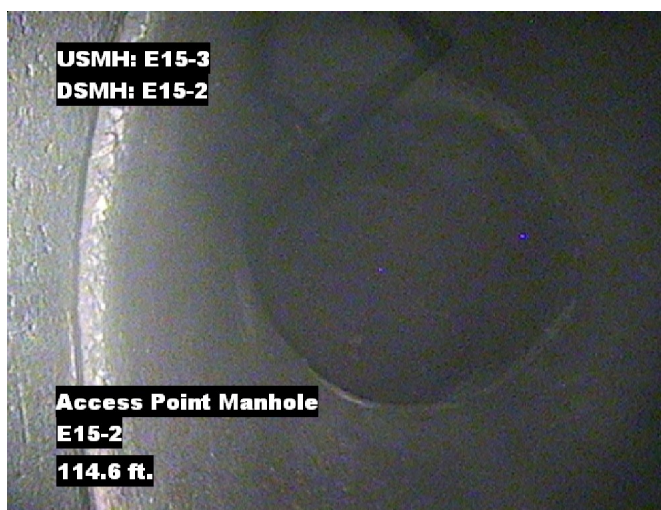
Distance: 114.6 ft. Grade: 0
Condition: Access Point Manhole
Remarks: E15-2
