Defect Listing

Pipe Segment Refere... E15-4_E15-3	City Oliver Springs	Street Sleepy Hollow	Material PolyVinyl Chloride	Location C... Easement/R...	Sewer Use Sanitary
Upstream MH E15-4	Total Length 34.7	Year Laid	Shape Circular	Location Details Side of Rd	
DS Manhole E15-3	Length surveyed 34.7	Year Renewed	Height 8	Width 8	Pipe Joint... 13

SPR N/A	MPR N/A	PO Number 4397-03		Customer GRW	
SPRI N/A	MPRI N/A	Work Order 4397-02		Purpose Pre-Rehabilitation Survey	
QSR N/A	QMR N/A				
OPR N/A	Surveyed By Barry Rogers	Direction Upstream	Date 20150605	Media label	
OPRI N/A	Certificate Number U-1012-16405	Pre-Cleaning Jetting	Time 07:03	Weather Dry	
Date Cleaned 20150604			End Time 07:26	Additional Info

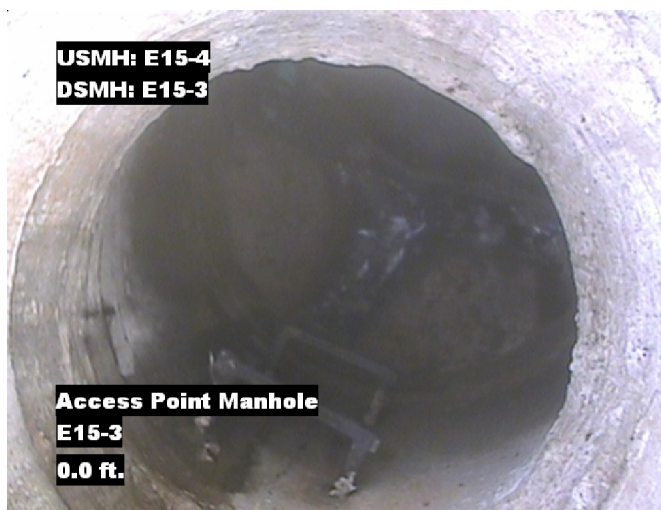
Distance: 0.0 ft. Grade: 0
Condition: Access Point Manhole
Remarks: E15-3

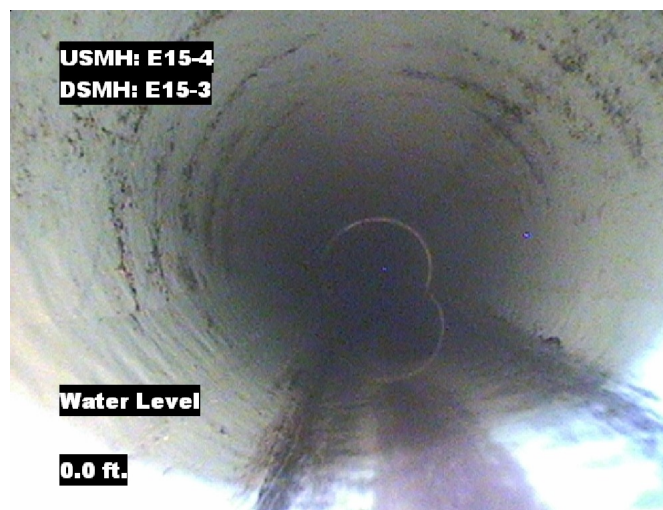
Distance: 0.0 ft. Grade: 0
Condition: Water Level
Remarks: N/A

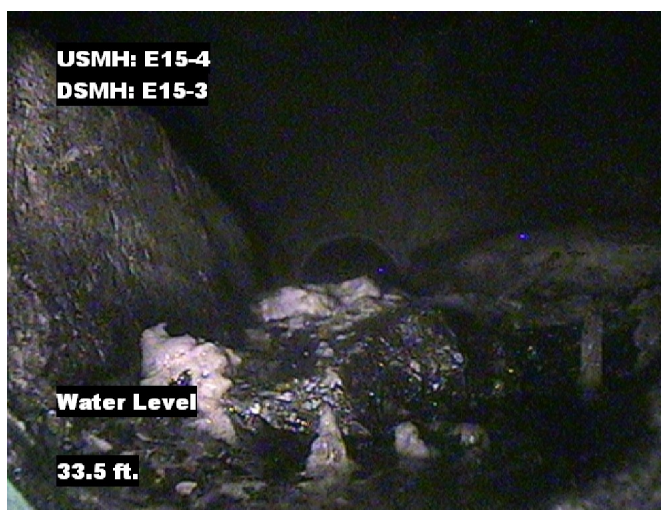
Distance: 33.5 ft. Grade: 0
Condition: Water Level
Remarks: N/A

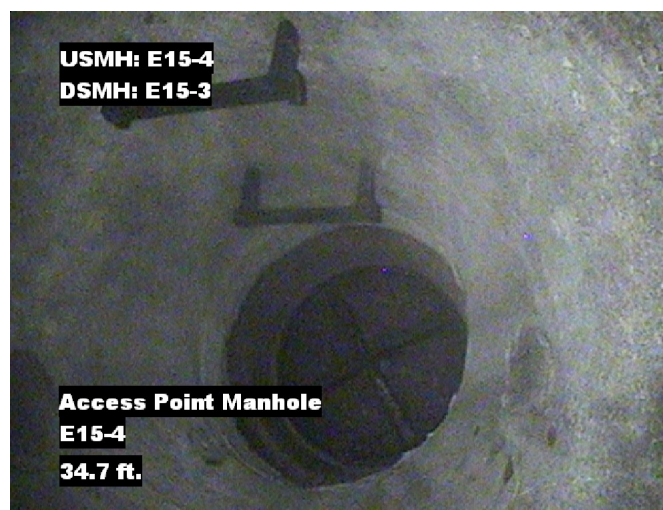
Distance: 34.7 ft. Grade: 0
Condition: Access Point Manhole
Remarks: E15-4
