Defect Listing

Pipe Segment Refere... E15-5_E15-5A	City Oliver Springs	Street Red Bud Ln	Material PolyVinyl Chloride	Location C... Yard	Sewer Use Sanitary
Upstream MH E15-5	Total Length 107.1	Year Laid	Shape Circular	Location Details Side of House runni...	
DS Manhole E15-5A	Length surveyed 107.1	Year Renewed	Height 8	Width 8	Pipe Joint... 13

SPR N/A	MPR 2	PO Number 4397-03	Customer GRW
SPRI N/A	MPRI 2	Work Order 4397-02	Purpose Pre-Rehabilitation Survey
QSR N/A	QMR 2100		
OPR 2	Surveyed By Barry Rogers	Direction Downstream	Date 20150604
OPRI 2	Certificate Number U-1012-16405	Pre-Cleaning Jetting	Time 08:57
	Date Cleaned 20150604	End Time 09:26	Weather Dry
			Additional Info

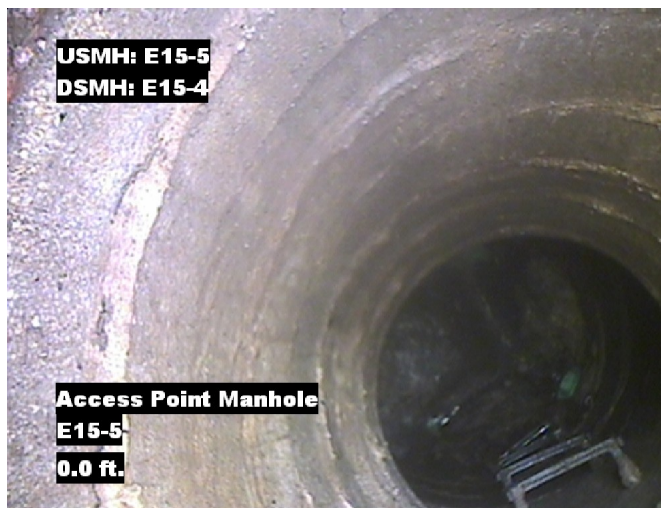
Distance: 0.0 ft. Grade: 0
Condition: Access Point Manhole
Remarks: E15-5

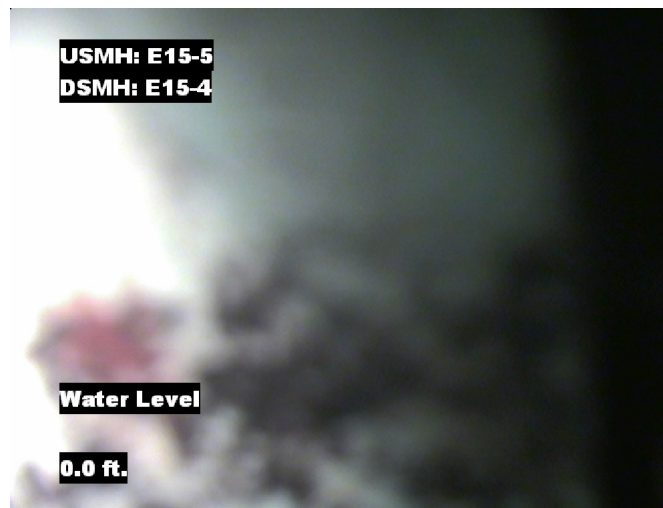
Distance: 0.0 ft. Grade: 0
Condition: Water Level
Remarks: N/A

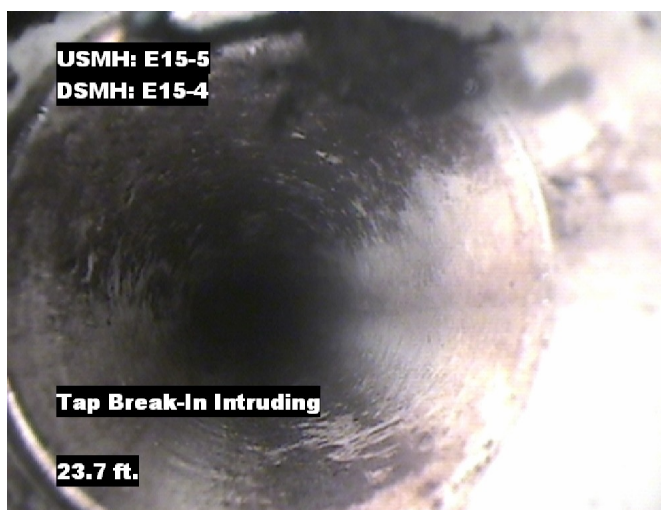
Distance: 23.7 ft. Grade: 2
Condition: Tap Break-In Intruding
Remarks: N/A

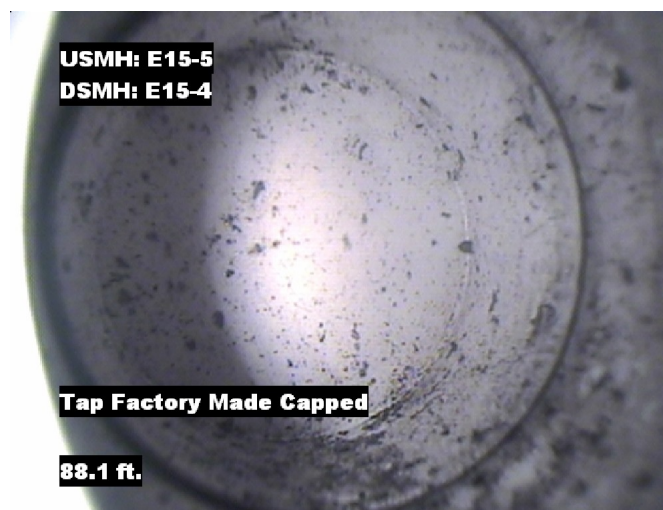
Distance: 88.1 ft. Grade: 0
Condition: Tap Factory Made Capped
Remarks: N/A

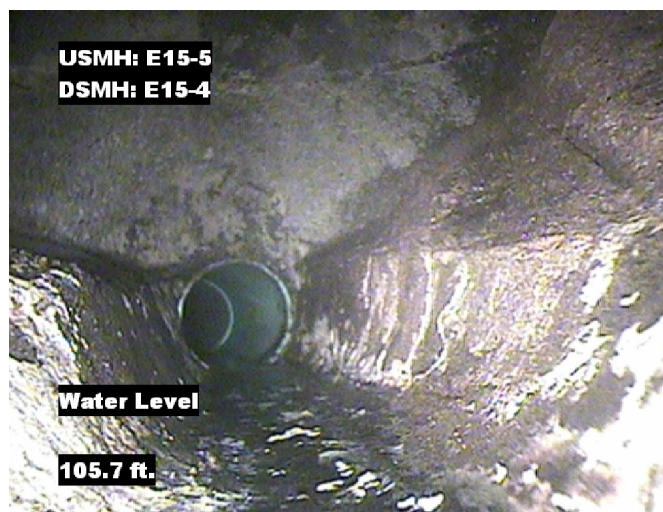
Distance: 105.7 ft. Grade: 0
Condition: Water Level
Remarks: N/A

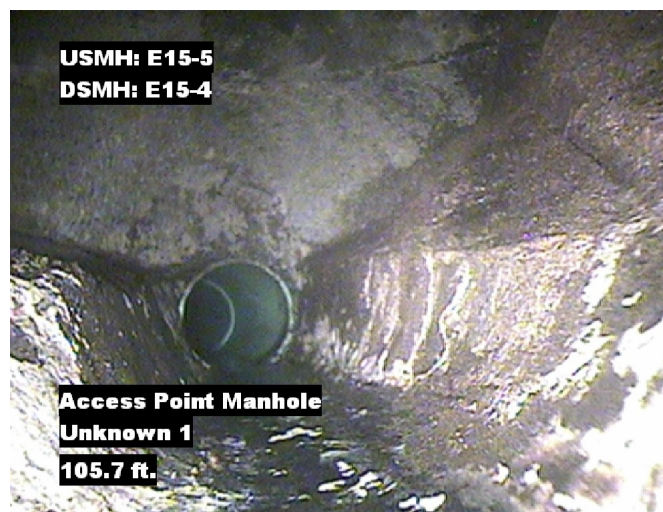
Distance: 107.1 ft. Grade: 0
Condition: Access Point Manhole
Remarks: E15-5A
