Defect Listing

Pipe Segment Refere... E15-5A_E15-4	City Oliver Springs	Street Red Bud Ln	Material PolyVinyl Chloride	Location C... Easement/R...	Sewer Use Sanitary
Upstream MH E15-5A	Total Length 119.7	Year Laid	Shape Circular	Location Details Yards	
DS Manhole E15-4	Length surveyed 119.7	Year Renewed	Height 8	Width 8	Pipe Joint... 13

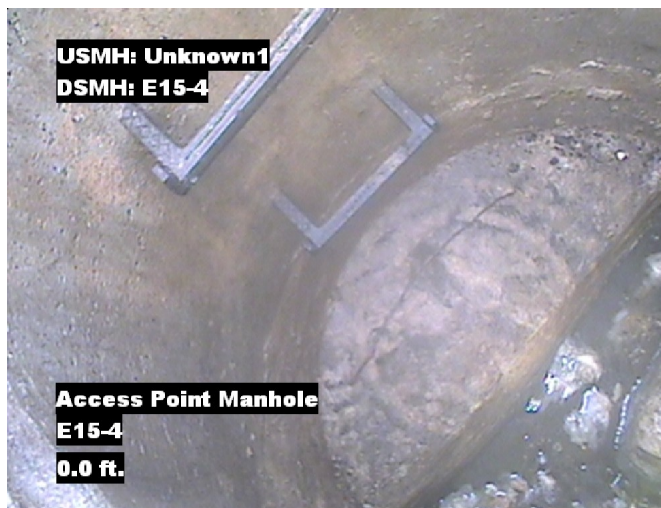
Distance: 0.0 ft. Grade: 0
Condition: Access Point Manhole
Remarks: E15-4

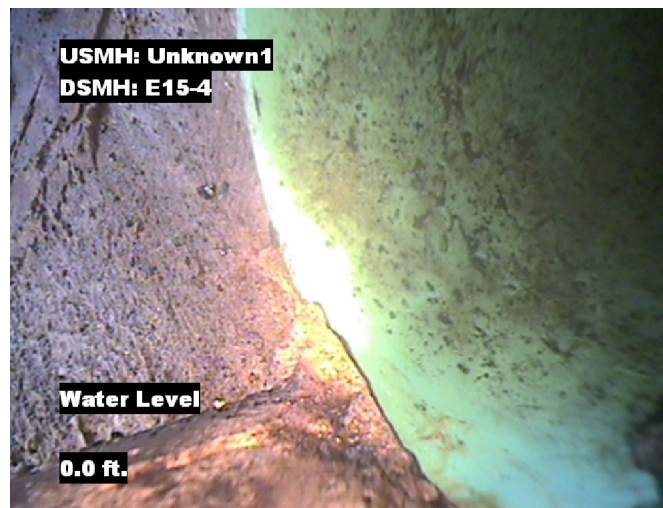
Distance: 0.0 ft. Grade: 0
Condition: Water Level
Remarks: N/A

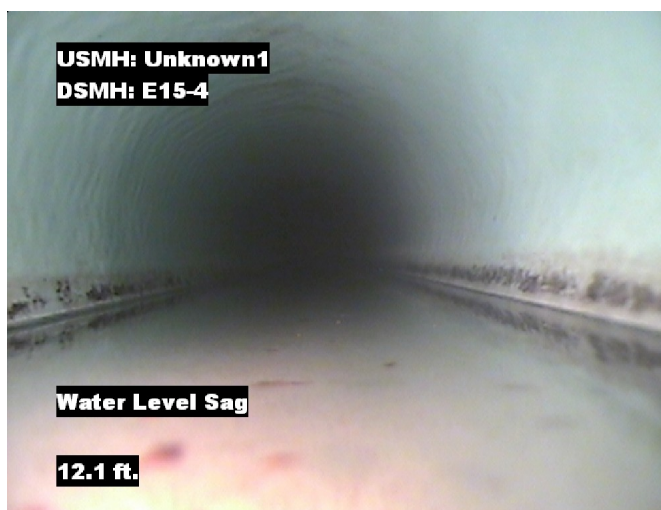
Distance: 12.1 ft. Grade: 2
Condition: Water Level Sag
Remarks: N/A

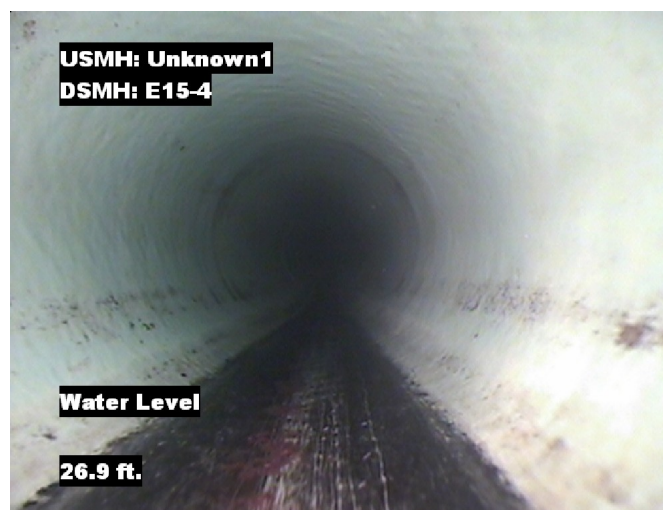
Distance: 26.9 ft. Grade: 0
Condition: Water Level
Remarks: N/A

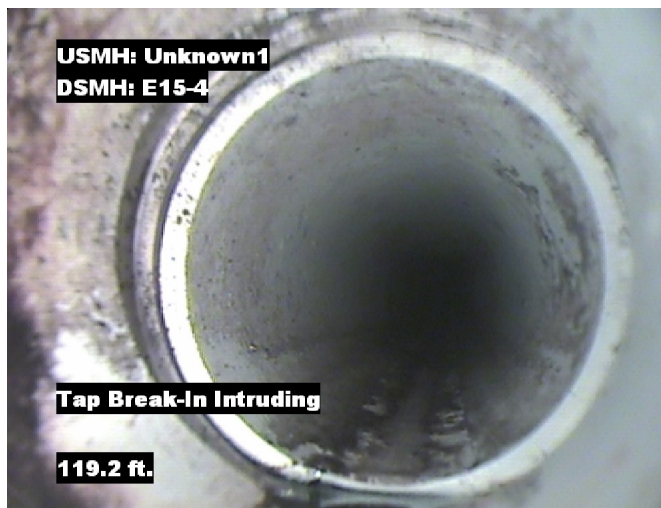
Distance: 119.2 ft. Grade: 2
Condition: Tap Break-In Intruding
Remarks: N/A

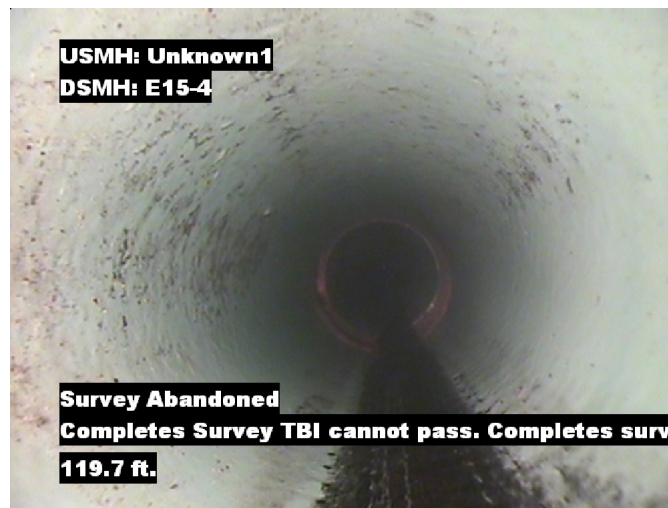
Distance: 119.7 ft. Grade: 0
Condition: Survey Abandoned
Remarks: Completes Survey TBI cannot pass.
Completes survey
