Defect Listing

Pipe Segment Refere... E15-6_E15-5	City Oliver Springs	Street Red Bud Ln	Material PolyVinyl Chloride	Location C... Yard	Sewer Use Sanitary
Upstream MH E15-6	Total Length 140.7	Year Laid	Shape Circular	Location Details Side of rd in front...	
DS Manhole E15-5	Length surveyed 140.7	Year Renewed	Height 8	Width 8	Pipe Joint... 13

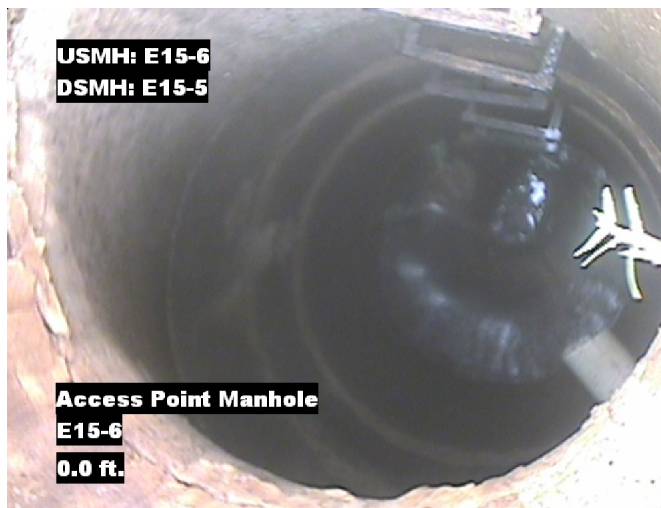
Distance: 0.0 ft. Grade: 0
Condition: Access Point Manhole
Remarks: E15-6

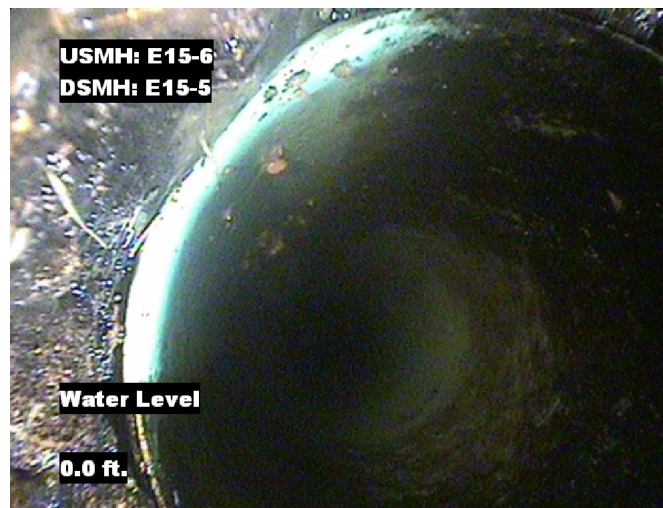
Distance: 0.0 ft. Grade: 0
Condition: Water Level
Remarks: N/A

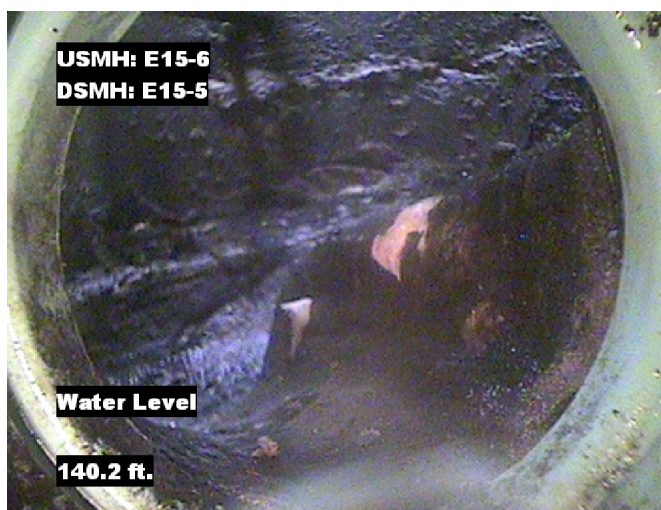
Distance: 140.2 ft. Grade: 0
Condition: Water Level
Remarks: N/A

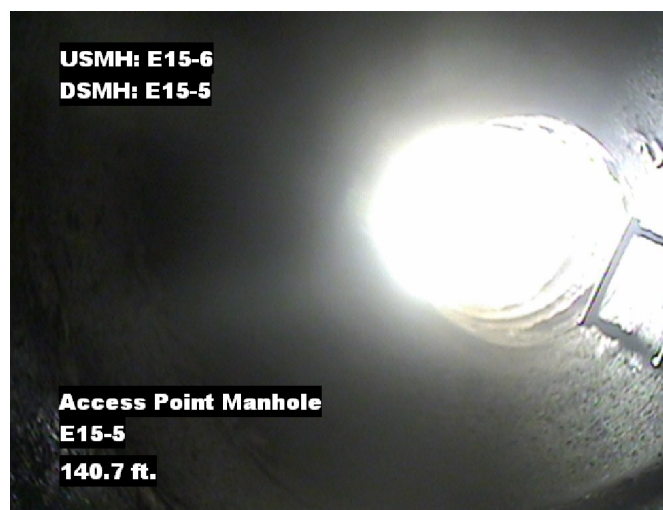
Distance: 140.7 ft. Grade: 0
Condition: Access Point Manhole
Remarks: E15-5
