## Defect Listing

| Pipe Segment Refere...<br><b>E16-1 E15-3</b> | City<br><b>Oliver Springs</b> | Street<br><b>Sleepy Hollow</b> | Material<br><b>PolyVinyl Chloride</b> | Location C...<br><b>Easement/R...</b> | Sewer Use<br><b>Sanitary</b> |

| SPRI<br><b>N/A</b> | MPRI<br><b>N/A</b> | Work Order<br><b>4397-02</b> | | Purpose<br><b>Pre-Rehabilitation Survey</b> | |

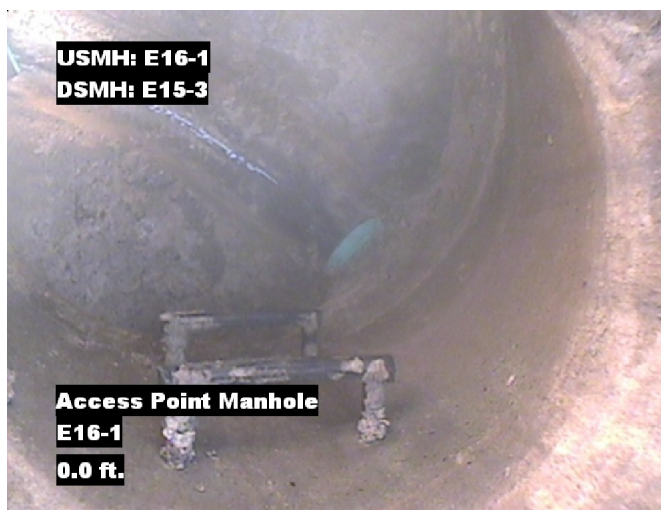
Distance: 0.0 ft. Grade: 0  
Condition: Access Point Manhole  
Remarks: E16-1

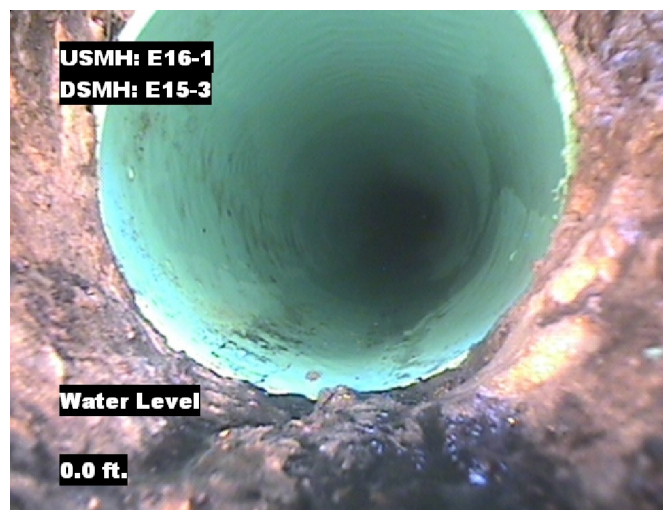
Distance: 0.0 ft. Grade: 0  
Condition: Water Level  
Remarks: N/A

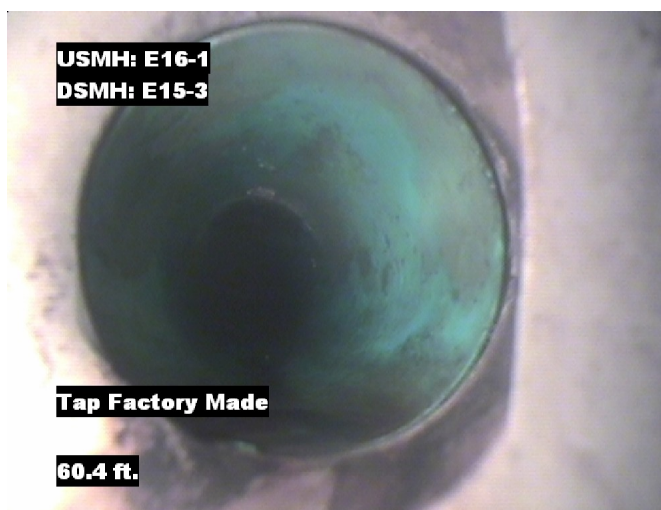
Distance: 60.4 ft. Grade: 0  
Condition: Tap Factory Made  
Remarks: N/A

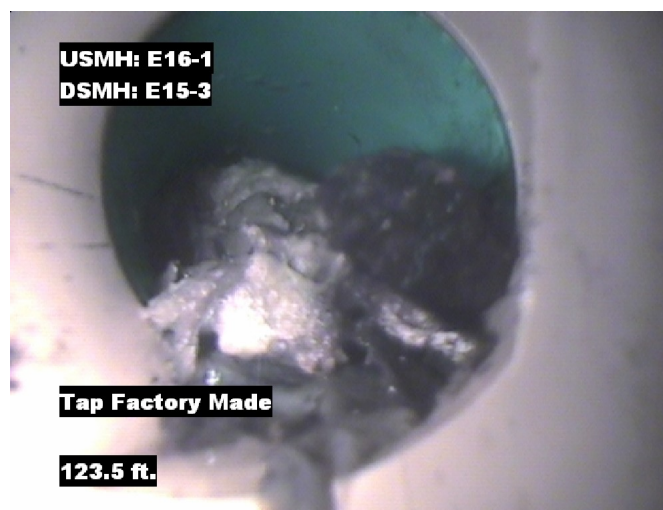
Distance: 123.5 ft. Grade: 0  
Condition: Tap Factory Made  
Remarks: N/A

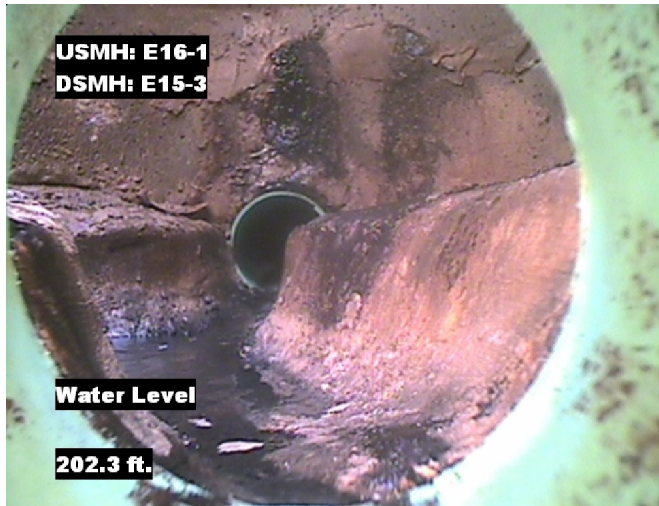
Distance: 202.3 ft. Grade: 0  
Condition: Water Level  
Remarks: N/A

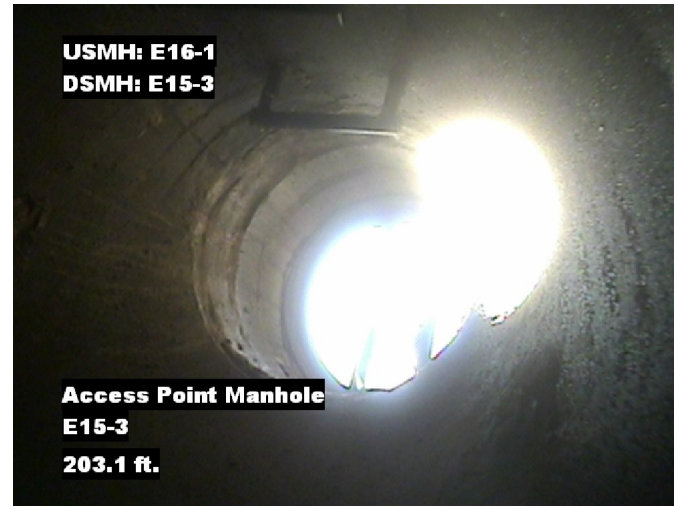
Distance: 203.1 ft. Grade: 0  
Condition: Access Point Manhole  
Remarks: E15-3
