Defect Listing

Pipe Segme	nt Refere	С	ity	Street	Mat	erial	Location C	Sewer Use	
E17-1_	E15-4	Oliver	Springs	Sleepy Hollow rd	PolyViny	PolyVinyl Chloride		Sanitary	
Upstrea	am MH	Total I	_ength	Year Laid	Sh	ape	Locatio	tion Details	
E17	7-1	31	1.6		Circ	cular	Side	of rd	
DS Ma	inhole	Length s	surveyed	Year Renewed	Height	Width	Pipe Joint		
E1:	5-4	31	1.6		8	8	13		
SPR	N/A	MPR	13	PO Number					
ODDI	N1/A	MDDI		4397-03			GRW		
SPRI	N/A	MPRI	2.6	Work Order			Purpose		
QSR	N/A	QMR	4222	4397-02		Pre-	Pre-Rehabilitation Surve		
OF	PR	Surve	yed By	Direction	D	ate	Medi	a label	
1:	3	Barry_	Rogers	Downstream	2015	0604			
OP	RI	Certificat	e Number	Pre-Cleaning	Ti	me	Weather		
2.	6	U-1012	2-16405	Jetting	13:42		Dry		
Date Cleaned			End Time A		Additio	onal Info			
20150604				14	14:09

Image Report 4/Page

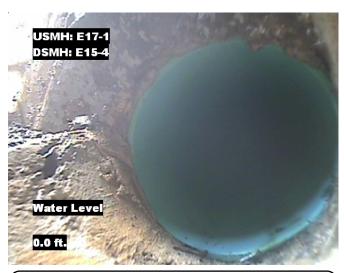
Distance: 0.0 ft. Grade: 0

Condition: Access Point Manhole

Remarks: E17-1

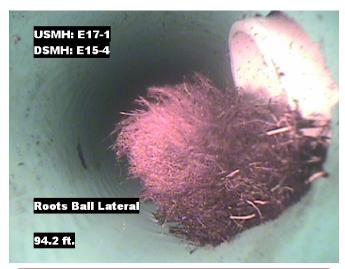
Distance: 94.2 ft. Grade: 4

Condition: Roots Ball Lateral

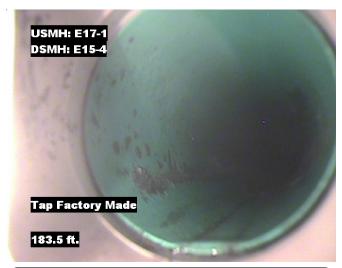
Distance: 183.5 ft. Grade: (

Condition: Tap Factory Made

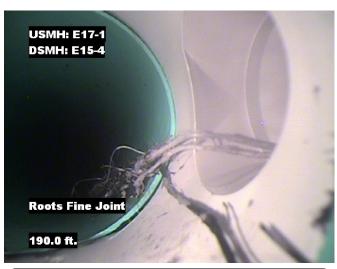
Distance: 190.0 ft. Grade:

Condition: Roots Fine Joint

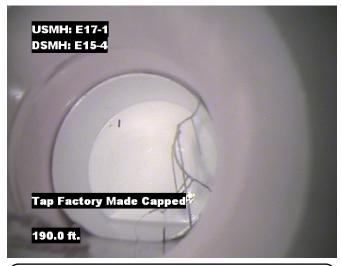
Distance: 190.0 ft. **Grade**: 0 **Condition**: Tap Factory Made Capped

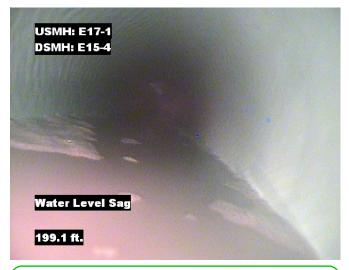
Distance: 199.1 ft. Grade: 2

Condition: Water Level Sag

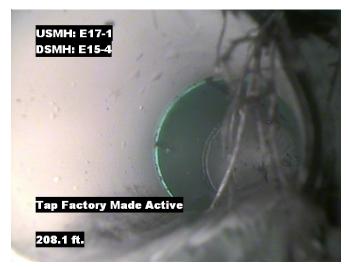
Distance: 208.1 ft. Grade: 0

Condition: Tap Factory Made Active

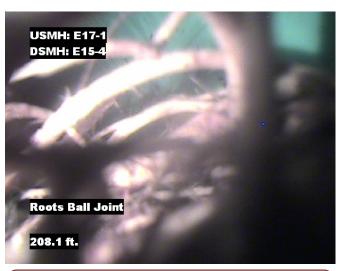
Distance: 208.1 ft. Grade: 4

Condition: Roots Ball Joint

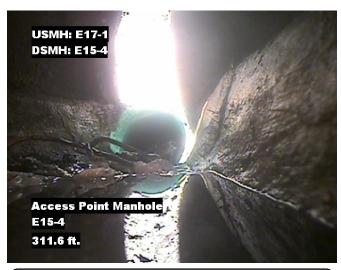
Distance: 311.6 ft. Grade: 0

Condition: Access Point Manhole

Remarks: E15-4
