Defect Listing

Pipe Segment Refere... E18-1_E18-2	City Oliver Springs	Street 716 Sleepy Hollow	Material Concrete Pipe (non-...	Location C... Light High...	Sewer Use Sanitary
Upstream MH E18-1	Total Length 165.2	Year Laid	Shape Circular	Location Details Road	
DS Manhole E18-2	Length surveyed 165.2	Year Renewed	Height 8	Width 8	Pipe Joint... 4

SPR 1	MPR N/A	PO Number 4397-03	Customer GRW
SPRI 1	MPRI N/A	Work Order 4397-02	Purpose Pre-Rehabilitation Survey
QSR 1100	QMR N/A		
OPR 1	Surveyed By Barry Rogers	Direction Downstream	Date 20150608
OPRI 1	Certificate Number U-1012-16405	Pre-Cleaning Jetting	Time 10:50
	Date Cleaned 20150608	End Time 11:02	Weather Dry
			Media label
			Additional Info

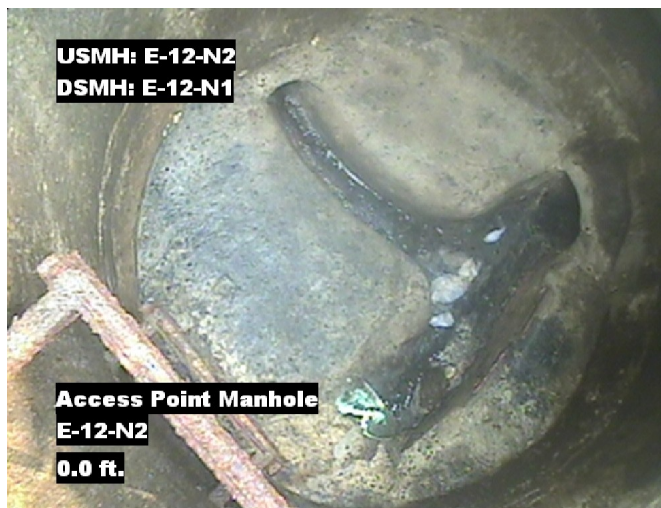
Distance: 0.0 ft. Grade: 0
Condition: Access Point Manhole
Remarks: E18-1

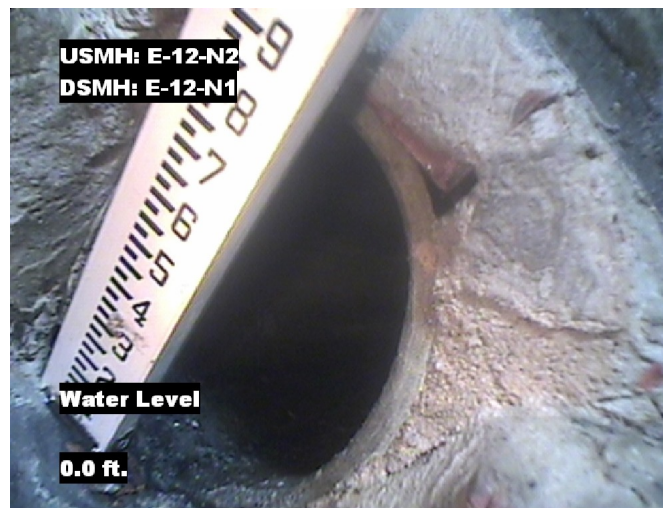
Distance: 0.0 ft. Grade: 0
Condition: Water Level
Remarks: N/A

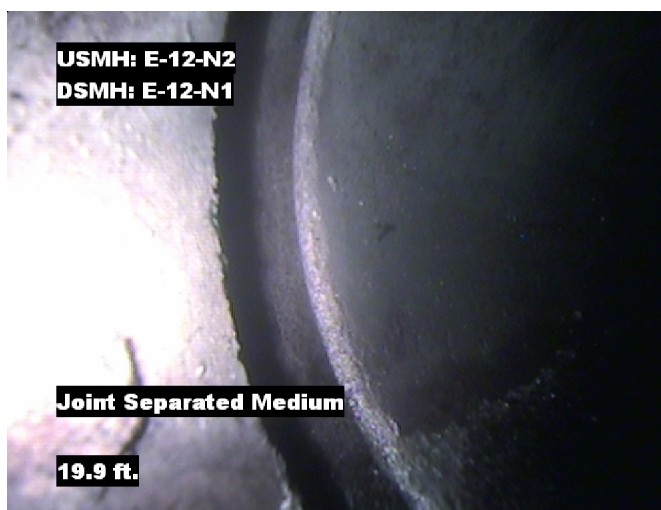
Distance: 19.9 ft. Grade: 1
Condition: Joint Separated Medium
Remarks: N/A

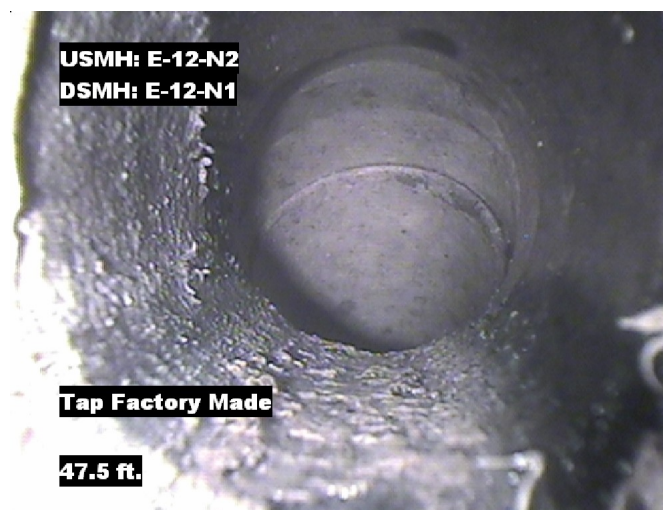
Distance: 47.5 ft. Grade: 0
Condition: Tap Factory Made
Remarks: N/A

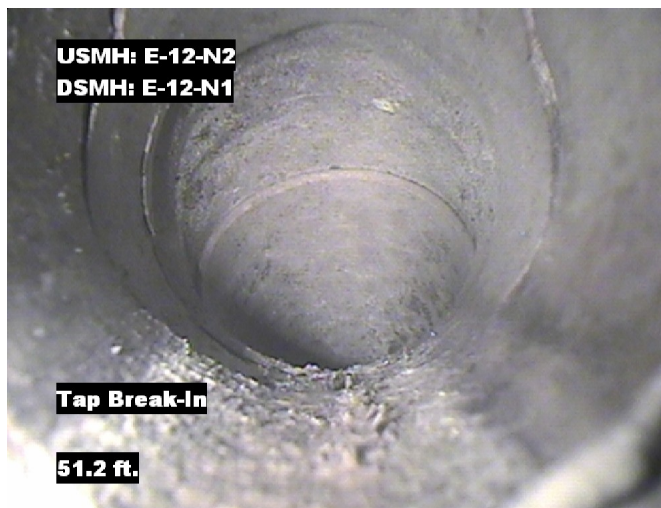
Distance: 51.2 ft. Grade: 0
Condition: Tap Break-In
Remarks: N/A

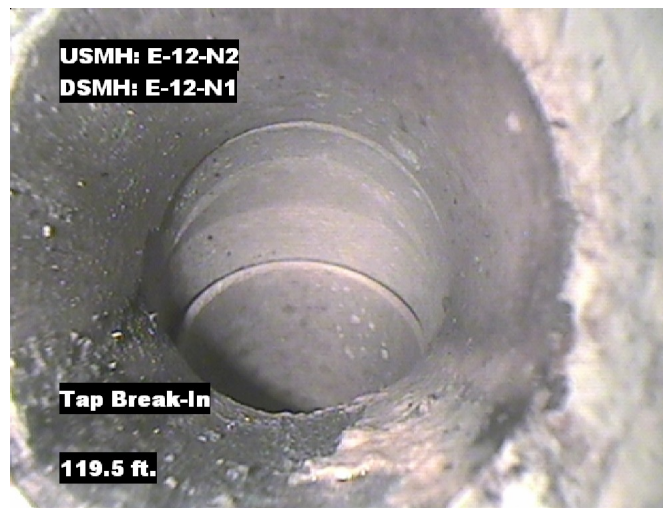
Distance: 119.5 ft. Grade: 0
Condition: Tap Break-In
Remarks: N/A

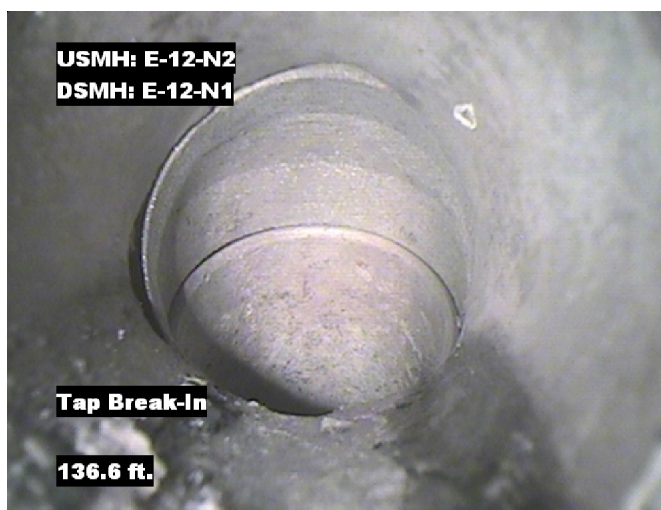
Distance: 136.6 ft. Grade: 0
Condition: Tap Break-In
Remarks: N/A

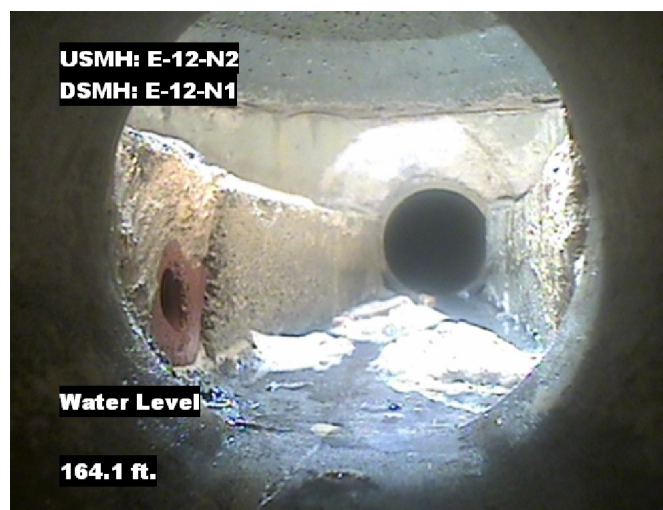
Distance: 164.1 ft. Grade: 0
Condition: Water Level
Remarks: N/A

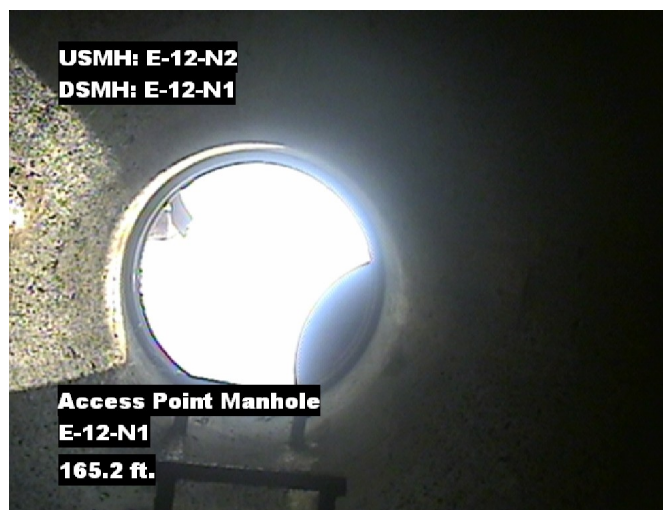
Distance: 165.2 ft. Grade: 0
Condition: Access Point Manhole
Remarks: E18-2
