Defect Listing

| Pipe Segment Refere... E18-2_E-12 | City Oliver Springs | Street 729 Sleepy Hollow | Material Concrete Pipe (non-... | Location C... Light High... | Sewer Use Sanitary |

| SPRI N/A | MPRI 1.5 | Work Order 4397-02 | Purpose Pre-Rehabilitation Survey |

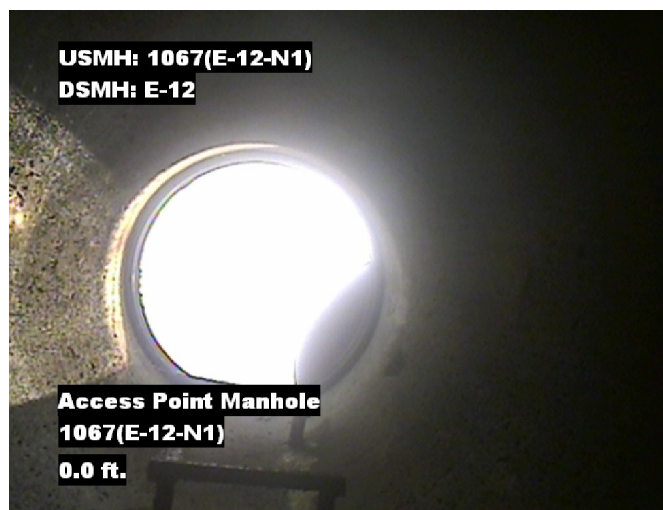
Distance: 0.0 ft. Grade: 0
Condition: Access Point Manhole
Remarks: E18-2

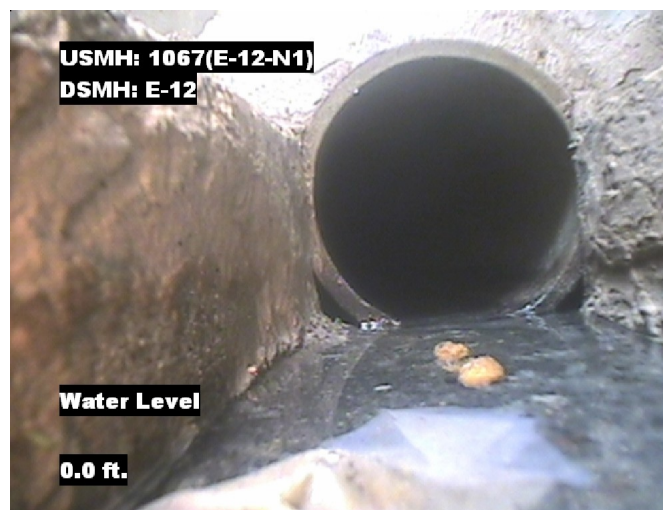
Distance: 0.0 ft. Grade: 0
Condition: Water Level
Remarks: N/A

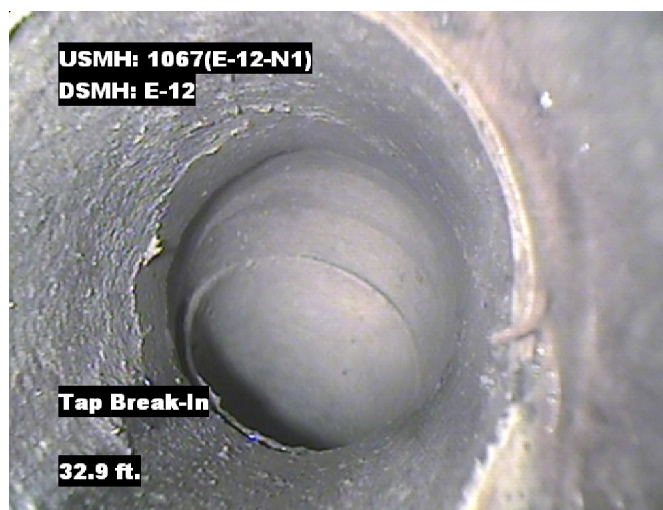
Distance: 32.9 ft. Grade: 0
Condition: Tap Break-In
Remarks: N/A

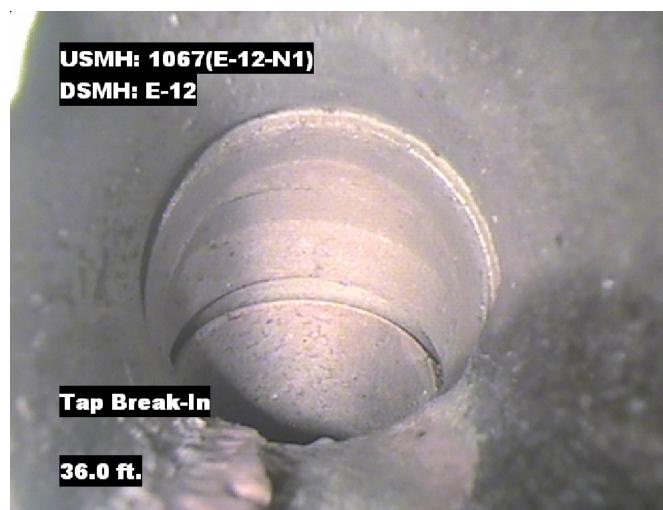
Distance: 36.0 ft. Grade: 0
Condition: Tap Break-In
Remarks: N/A

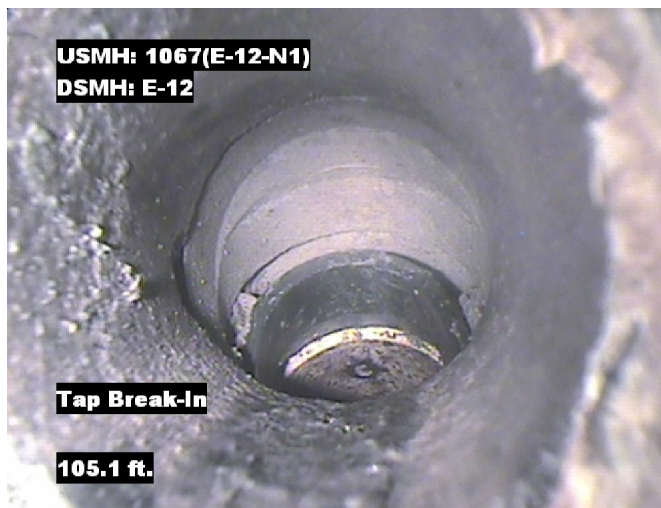
Distance: 105.1 ft. Grade: 0
Condition: Tap Break-In
Remarks: N/A

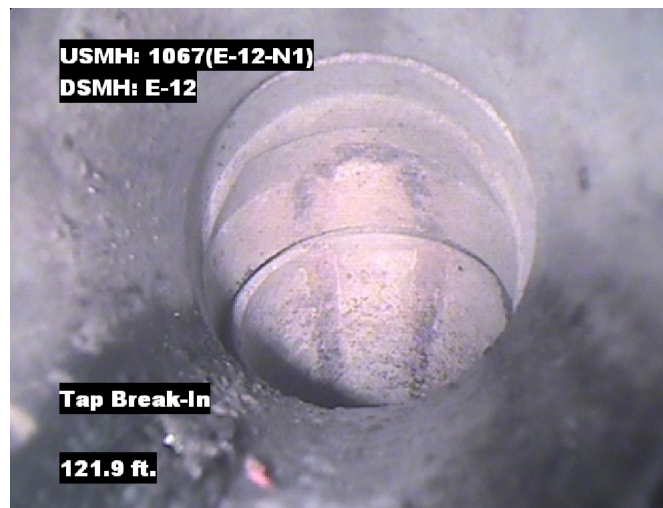
Distance: 121.9 ft. Grade: 0
Condition: Tap Break-In
Remarks: N/A

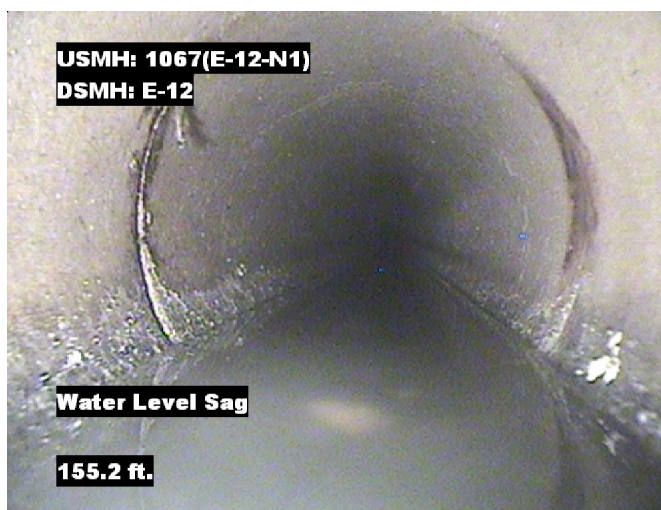
| Distance | Condition | Cont. Dfct. | Values | | | Joint | Clock Position | | Grade |
|---|---|---|---|---|---|---|---|---|---|
| 155.2 ft. | Water Level Sag | | | | 15 | <input type="checkbox"/> | | | 2 |

Distance: 155.2 ft. Grade: 2
Condition: Water Level Sag
Remarks: N/A

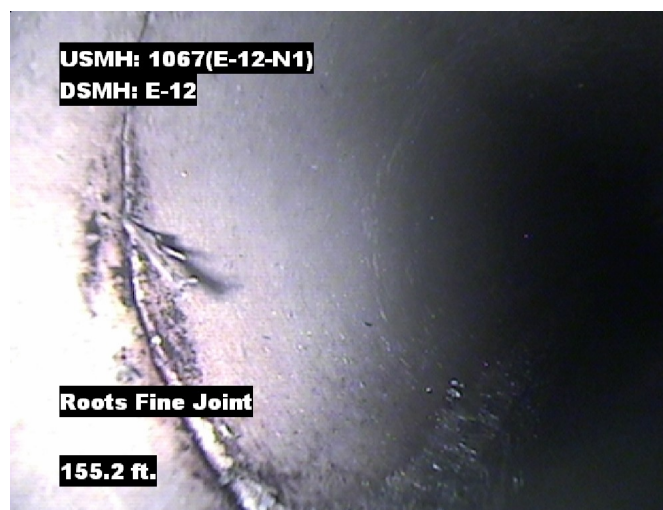
| Distance | Condition | Cont. Dfct. | Values | | | Joint | Clock Position | | Grade |
|---|---|---|---|---|---|---|---|---|---|
| 155.2 ft. | Roots Fine Joint | | | | 0 | <input checked="" type="checkbox"/> | 10 | | 1 |

Distance: 155.2 ft. Grade: 1
Condition: Roots Fine Joint
Remarks: N/A

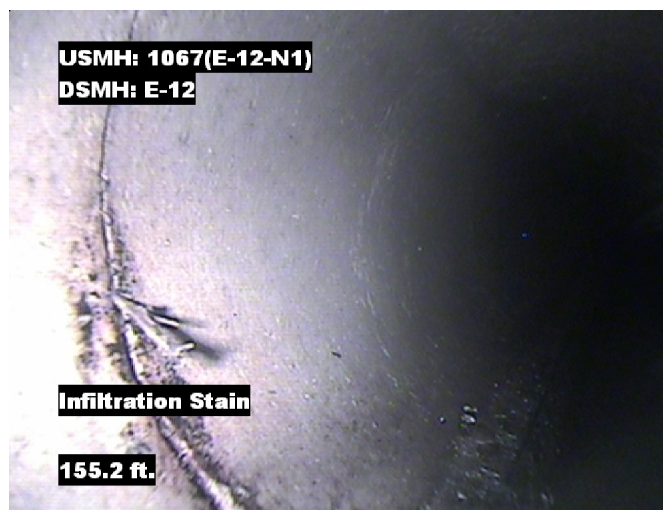
Distance: 155.2 ft. Grade: 0
Condition: Infiltration Stain
Remarks: N/A

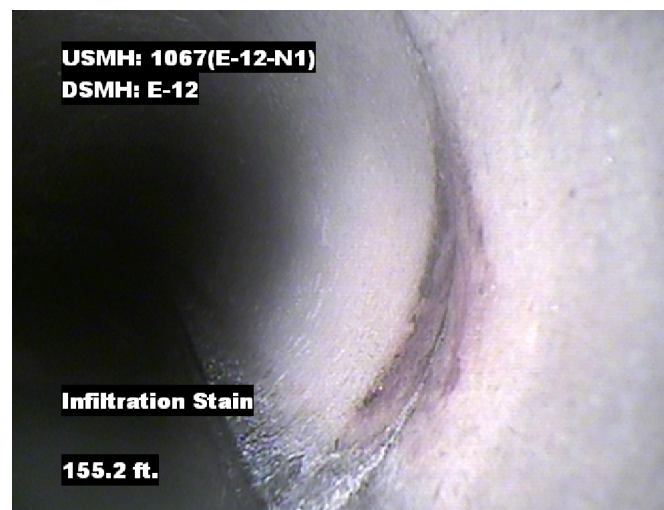
Distance: 155.2 ft. Grade: 0
Condition: Infiltration Stain
Remarks: N/A

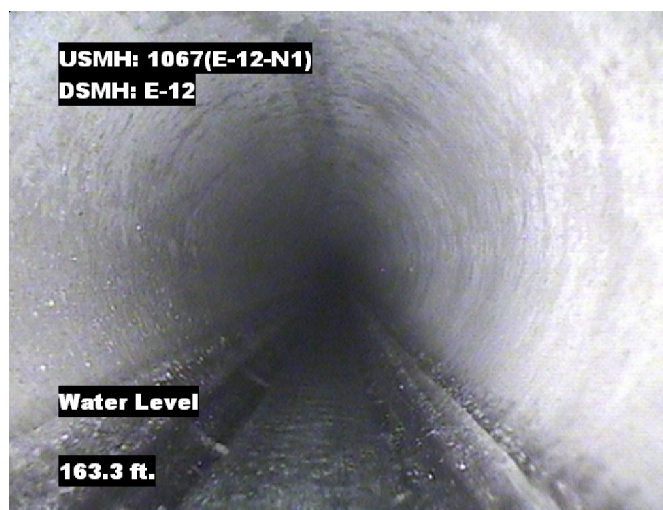
Distance: 163.3 ft. Grade: 0
Condition: Water Level
Remarks: N/A

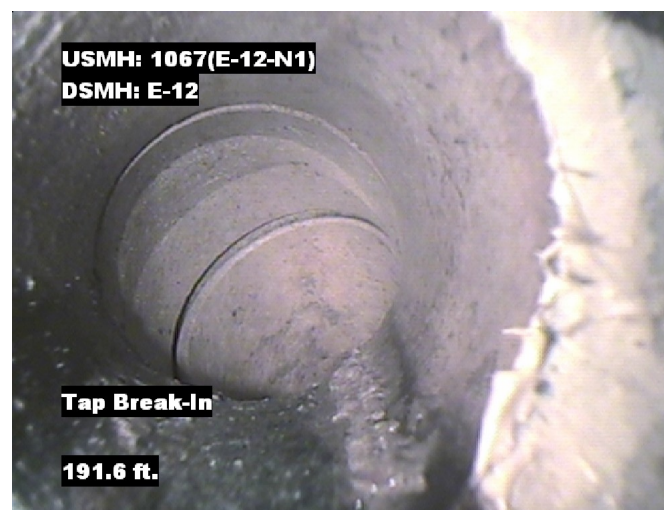
Distance: 191.6 ft. Grade: 0
Condition: Tap Break-In
Remarks: N/A

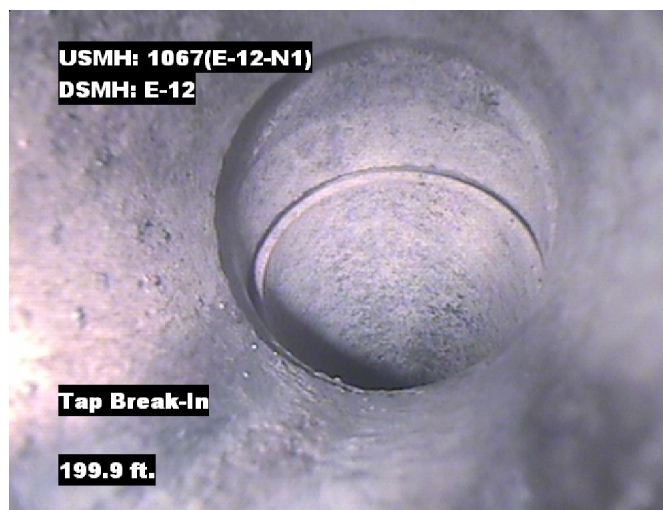
Distance: 199.9 ft. Grade: 0
Condition: Tap Break-In
Remarks: N/A

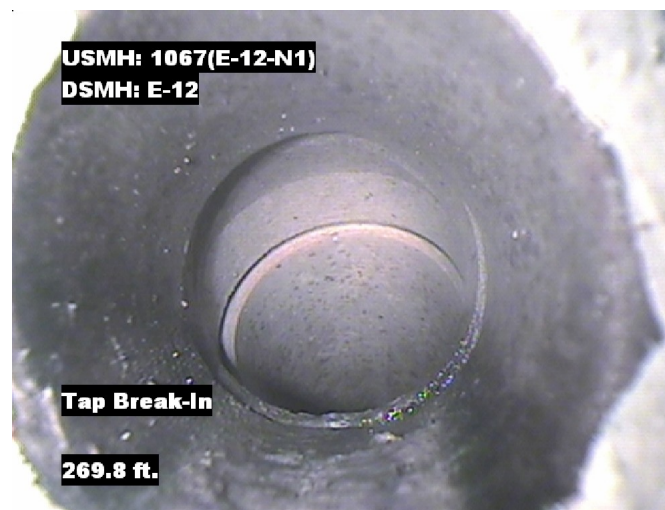
Distance: 269.8 ft. Grade: 0
Condition: Tap Break-In
Remarks: N/A

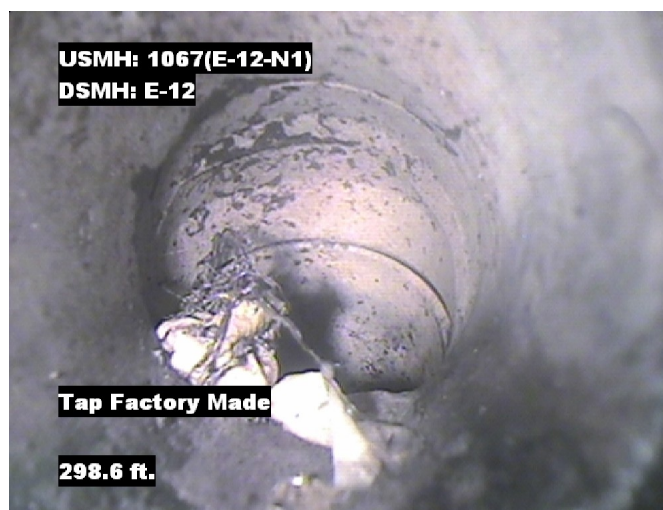
Distance: 298.6 ft. Grade: 0
Condition: Tap Factory Made
Remarks: N/A

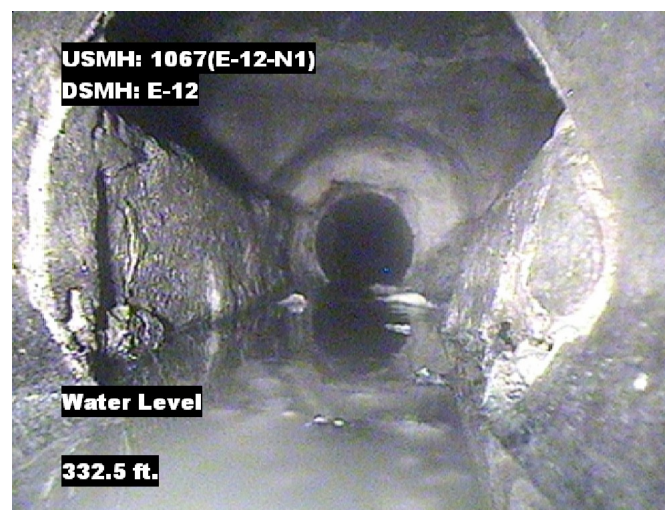
Distance: 332.5 ft. Grade: 0
Condition: Water Level
Remarks: N/A

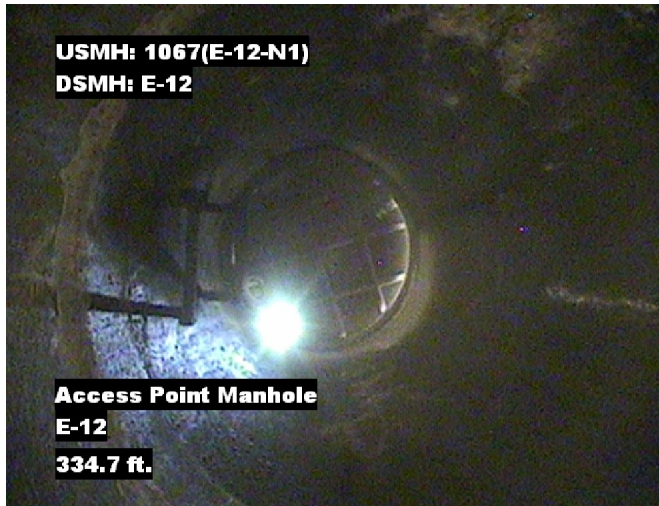
Distance: 334.7 ft. Grade: 0
Condition: Access Point Manhole
Remarks: E-12
