Defect Listing

| Pipe Segment Refere... E19-1_E-12B | City Oliver Springs | Street 429 Valley Dr | Material PolyVinyl Chloride | Location C... Yard | Sewer Use Sanitary |

| SPRI 2 | MPRI 4 | Work Order 4397-02 | Purpose Pre-Rehabilitation Survey |

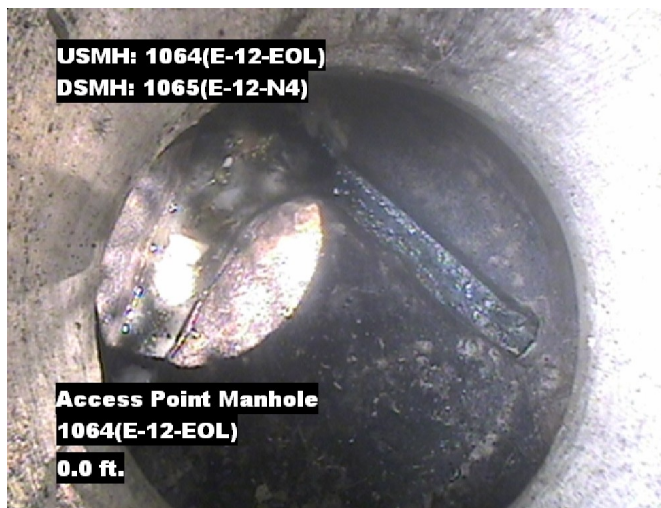
Distance: 0.0 ft. Grade: 0
Condition: Access Point Manhole
Remarks: E19-1

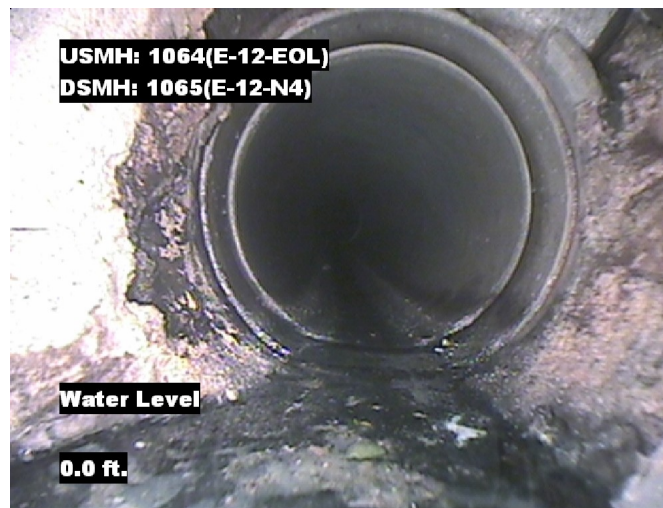
| Distance | Condition | Cont. Dfct. | Values | | | Joint | Clock Position | | Grade |
|---|---|---|---|---|---|---|---|---|---|
| 0.0 ft. | Water Level | | | | 5 | <input type="checkbox"/> | | | |

Distance: 0.0 ft. Grade: 0
Condition: Water Level
Remarks: N/A

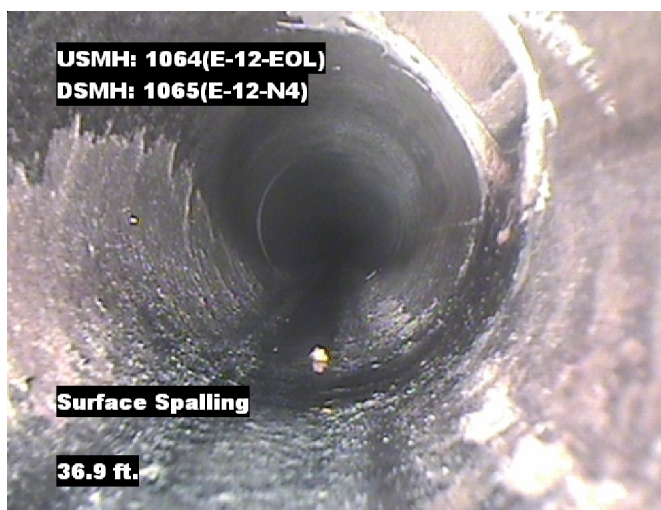
| Distance | Condition | Cont. Dfct. | Values | | | Joint | Clock Position | | Grade |
|---|---|---|---|---|---|---|---|---|---|
| 36.9 ft. | Surface Spalling | | | | 0 | <input type="checkbox"/> | 5 | 10 | 2 |

Distance: 36.9 ft. Grade: 2
Condition: Surface Spalling
Remarks: N/A

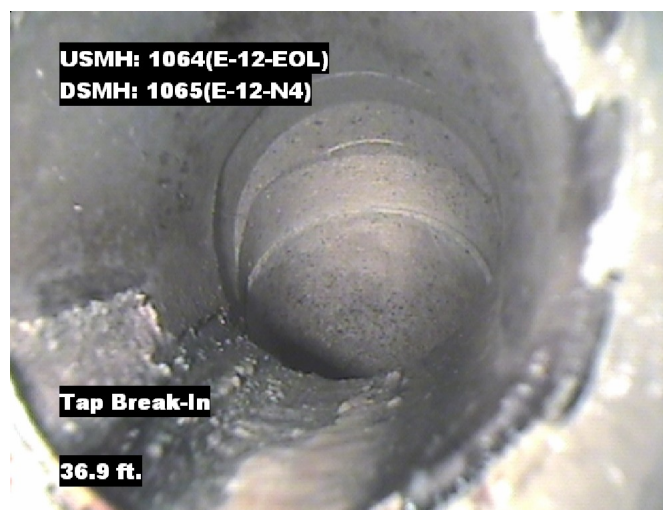
| Distance | Condition | Cont. Dfct. | Values | | | Joint | Clock Position | | Grade |
|---|---|---|---|---|---|---|---|---|---|
| 36.9 ft. | Tap Break-In | | 6 | | 0 | <input type="checkbox"/> | 2 | | |

Distance: 36.9 ft. Grade: 0
Condition: Tap Break-In
Remarks: N/A

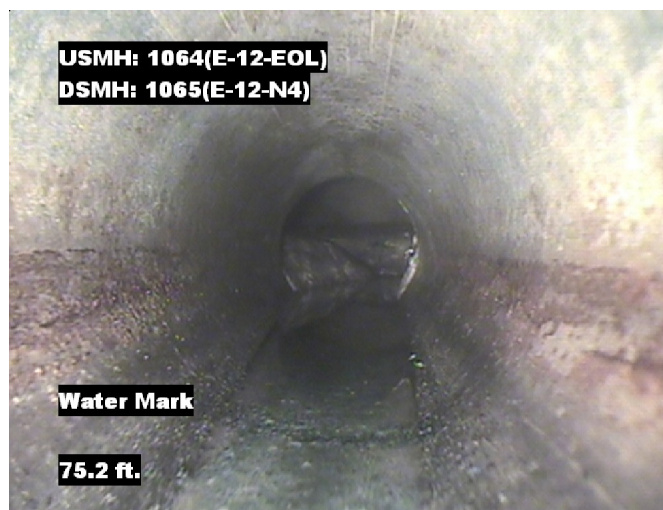
| Distance | Condition | Cont. Dfct. | Values | | | Joint | Clock Position | | Grade |
|---|---|---|---|---|---|---|---|---|---|
| 75.2 ft. | Water Mark | | | | 50 | <input type="checkbox"/> | | | 4 |

Distance: 75.2 ft. Grade: 4
Condition: Water Mark
Remarks: N/A

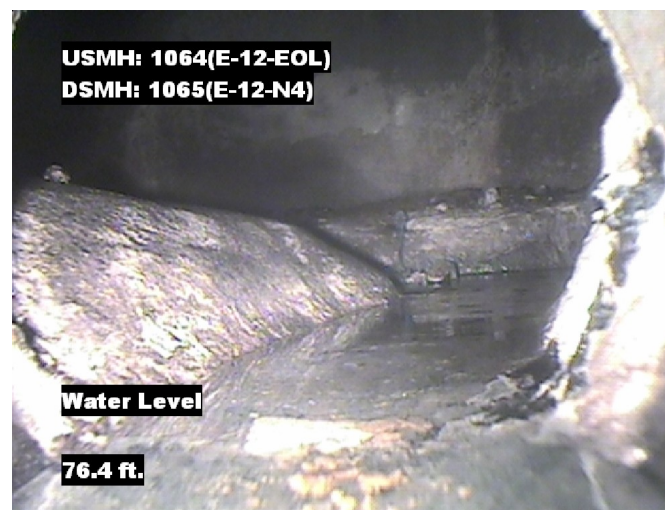
| Distance | Condition | Cont. Dfct. | Values | | | Joint | Clock Position | | Grade |
|---|---|---|---|---|---|---|---|---|---|
| 76.4 ft. | Water Level | | | | 10 | <input type="checkbox"/> | | | |

Distance: 76.4 ft. Grade: 0
Condition: Water Level
Remarks: N/A

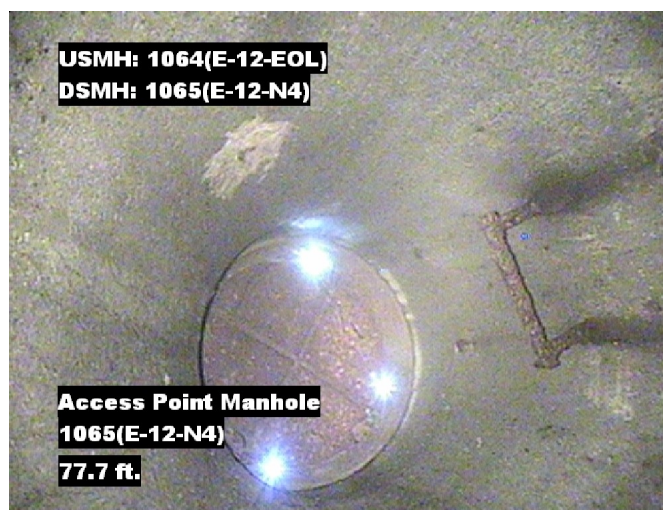
Distance: 77.7 ft. Grade: 0
Condition: Access Point Manhole
Remarks: E-12B
