## Defect Listing

Pipe Segment Refere... <b>E2-4_E2-3</b>	City <b>Oliver Springs</b>	Street <b>HWY 62</b>	Material <b>Other</b>	Location C... <b>Main Highw...</b>	Sewer Use <b>Sanitary</b>
Upstream MH <b>E2-4</b>	Total Length <b>174.3</b>	Year Laid	Shape <b>Circular</b>	Location Details <b>usmh Located in woo...</b>	
DS Manhole <b>E2-3</b>	Length surveyed <b>174.3</b>	Year Renewed	Height <b>8</b>	Width <b>8</b>	Pipe Joint... <b>N/A</b>

SPR <b>3</b>	MPR <b>6</b>	PO Number <b>4397-03</b>	Customer <b>GRW</b>
SPRI <b>3</b>	MPRI <b>2</b>	Work Order <b>4397-02</b>	Purpose <b>Pre-Rehabilitation Survey</b>
QSR <b>3100</b>	QMR <b>2300</b>		
OPR <b>9</b>	Surveyed By <b>David_brown</b>	Direction <b>Downstream</b>	Date <b>20150620</b>
OPRI <b>2.3</b>	Certificate Number <b>U-607-5202</b>	Pre-Cleaning <b>Jetting</b>	Time <b>08:52</b>
	Date Cleaned <b>20150620</b>	End Time <b>09:05</b>	Weather <b>Damp</b>
			Media label
			Additional Info

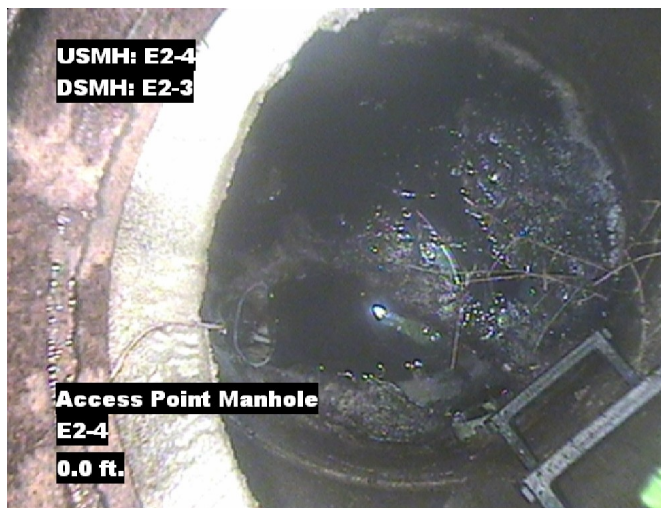
Distance: 0.0 ft. Grade: 0  
Condition: Access Point Manhole  
Remarks: E2-4

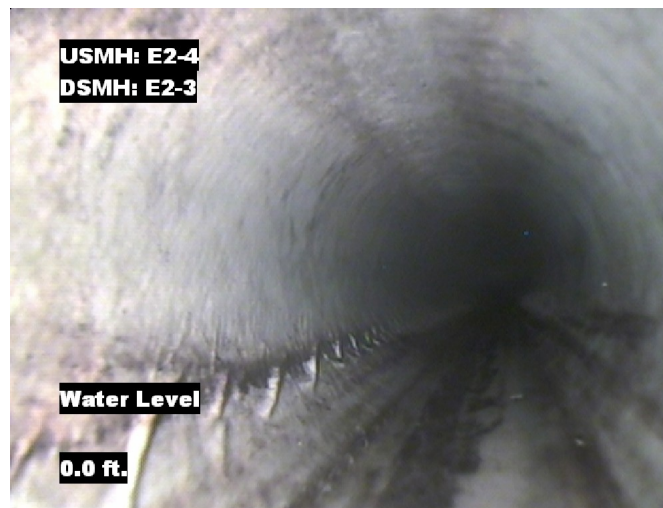
Distance: 0.0 ft. Grade: 0  
Condition: Water Level  
Remarks: N/A

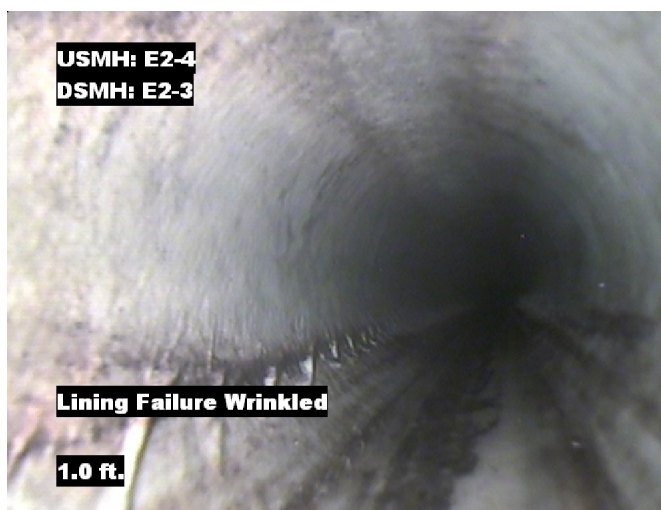
Distance: 1.0 ft. Grade: 3  
Condition: Lining Failure Wrinkled  
Remarks: N/A

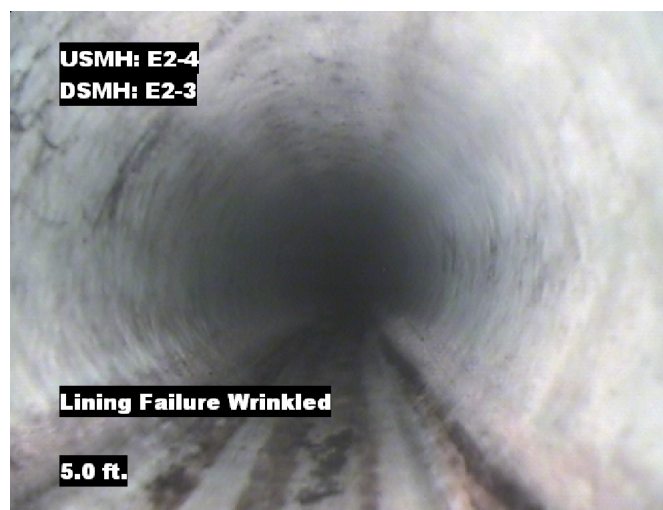
Distance: 5.0 ft. Grade: 3  
Condition: Lining Failure Wrinkled  
Remarks: N/A

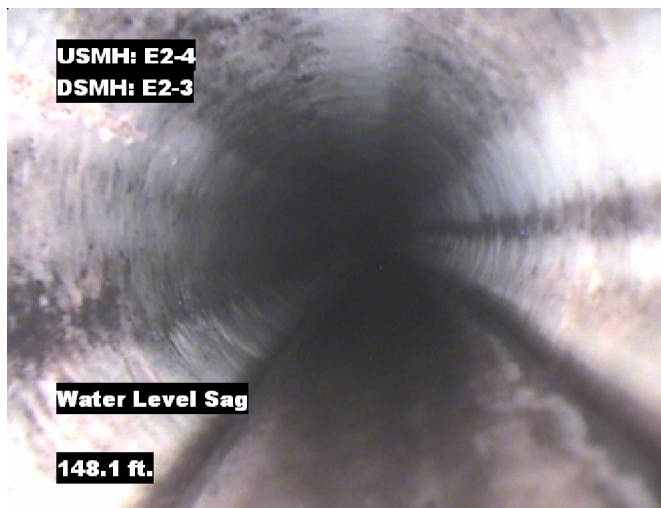
Distance: 148.1 ft. Grade: 2  
Condition: Water Level Sag  
Remarks: N/A

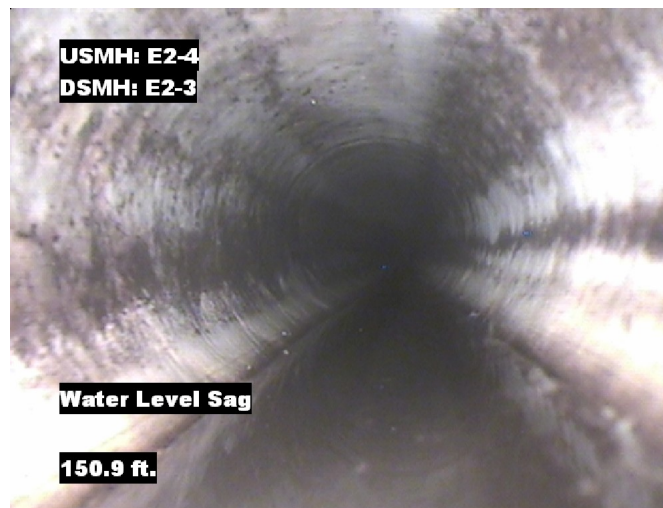
Distance: 150.9 ft. Grade: 2  
Condition: Water Level Sag  
Remarks: N/A

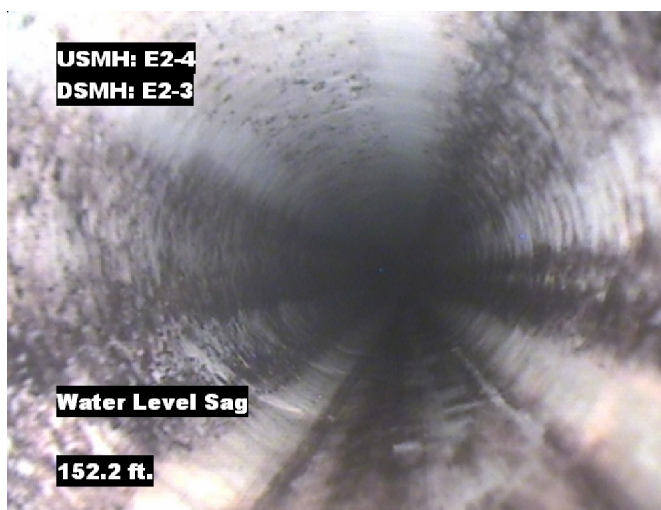
Distance: 152.2 ft. Grade: 2  
Condition: Water Level Sag  
Remarks: N/A

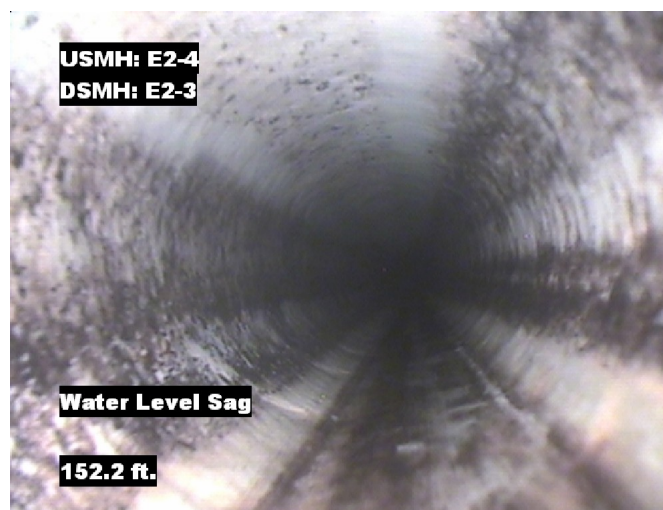
Distance: 152.2 ft. Grade: 2  
Condition: Water Level Sag  
Remarks: N/A

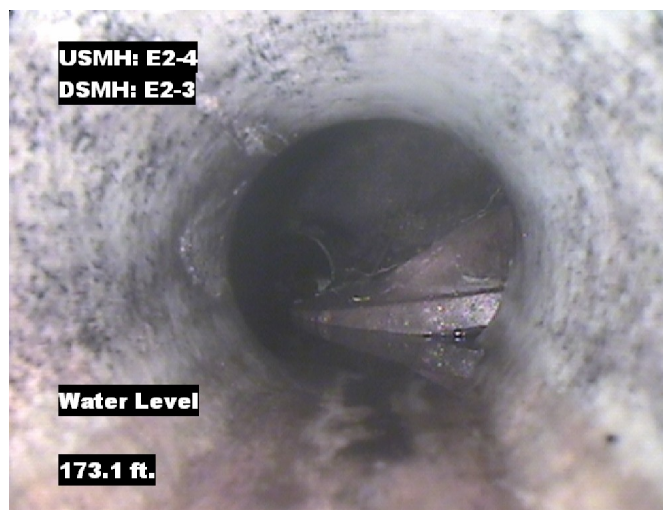
Distance: 173.1 ft.      Grade: 0  
Condition: Water Level  
Remarks: N/A

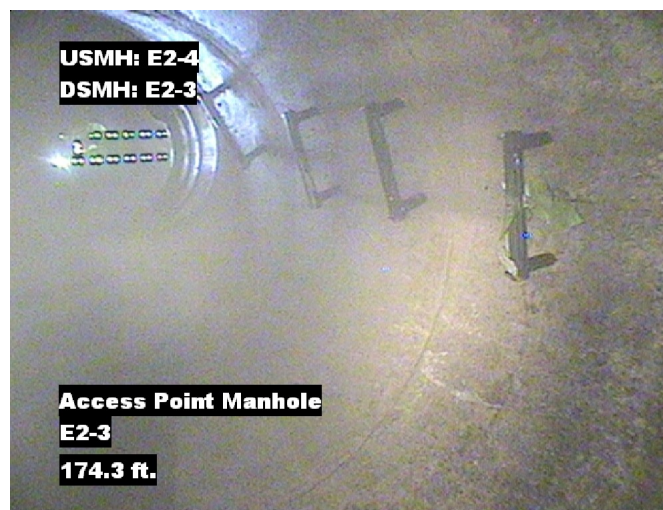
Distance: 174.3 ft.      Grade: 0  
Condition: Access Point Manhole  
Remarks: E2-3
