Defect Listing

Pipe Segment Refere... E2-5_E2-4	City Oliver Springs	Street hwy 62	Material PolyVinyl Chloride	Location C... Yard	Sewer Use Sanitary
Upstream MH E2-5	Total Length 289.2	Year Laid	Shape Circular	Location Details usmh located by dri...	
DS Manhole E2-4	Length surveyed 289.2	Year Renewed	Height 8	Width 8	Pipe Joint... 13

SPR N/A	MPR 13	PO Number 4397-03	Customer GRW
SPRI N/A	MPRI 1.9	Work Order 4397-02	Purpose Pre-Rehabilitation Survey
QSR N/A	QMR 2611		
OPR 13	Surveyed By David_brown	Direction Downstream	Date 20150620
OPRI 1.9	Certificate Number U-607-5202	Pre-Cleaning Heavy Cleaning	Time 10:27
	Date Cleaned 20150620	End Time 10:45	Weather Damp
			Media label
			Additional Info

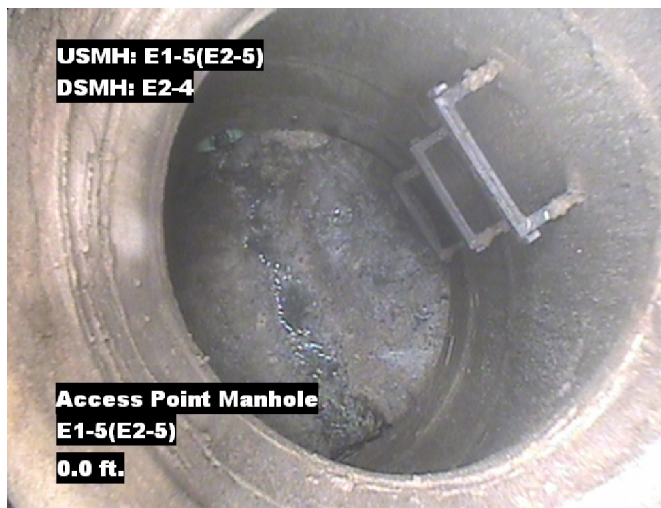
Distance: 0.0 ft. Grade: 0
Condition: Access Point Manhole
Remarks: E2-5

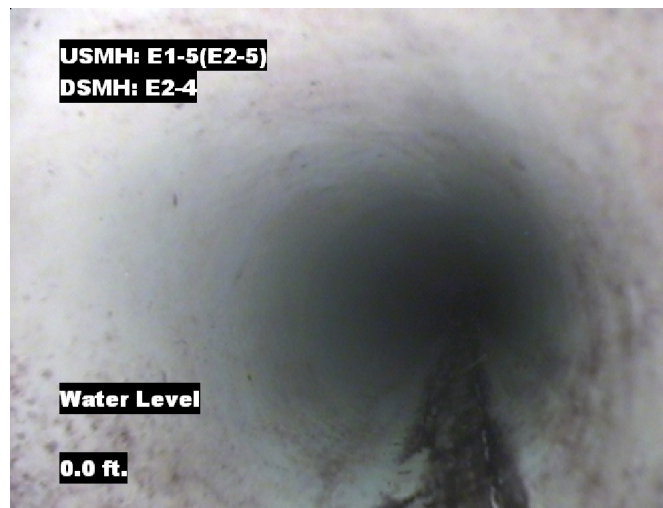
Distance: 0.0 ft. Grade: 0
Condition: Water Level
Remarks: N/A

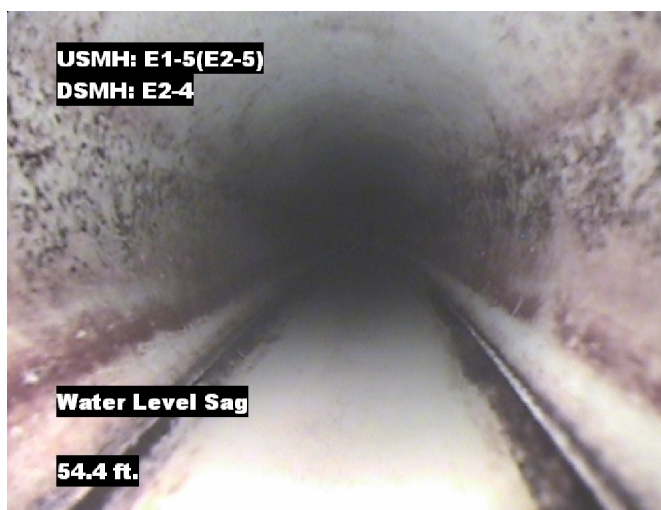
Distance: 54.4 ft. Grade: 2
Condition: Water Level Sag
Remarks: N/A

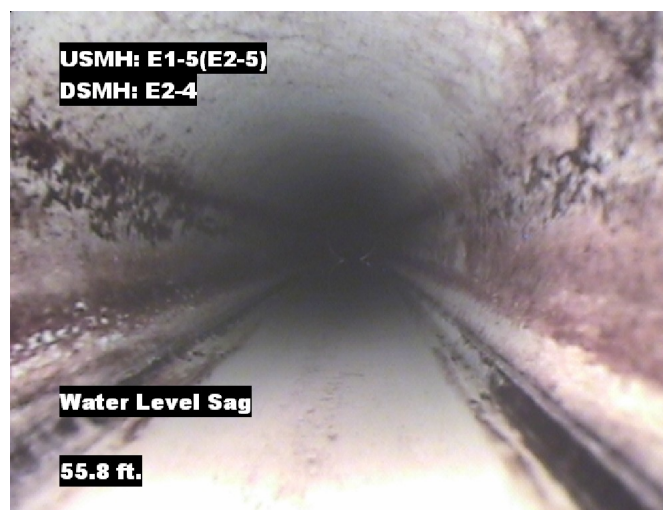
Distance: 55.8 ft. Grade: 2
Condition: Water Level Sag
Remarks: N/A

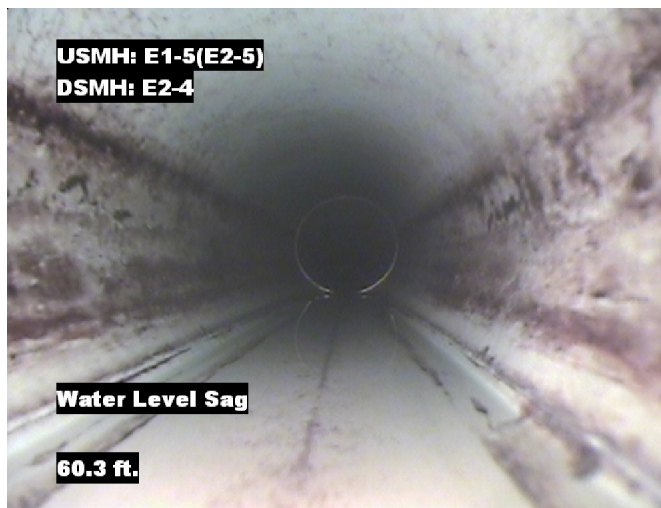
Distance: 60.3 ft. Grade: 2
Condition: Water Level Sag
Remarks: N/A

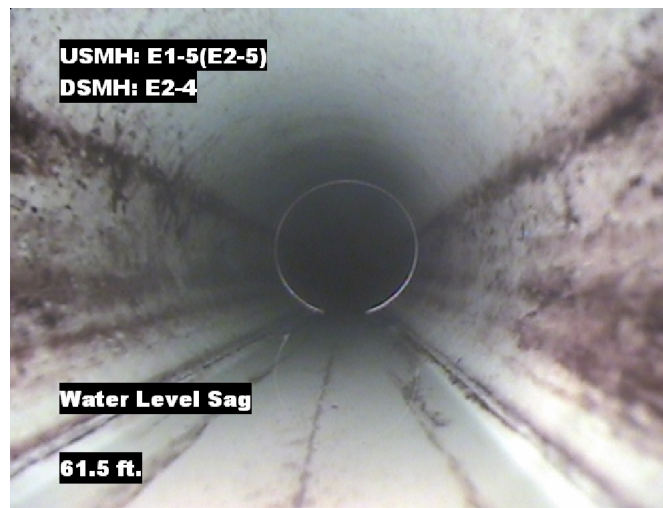
Distance: 61.5 ft. Grade: 2
Condition: Water Level Sag
Remarks: N/A

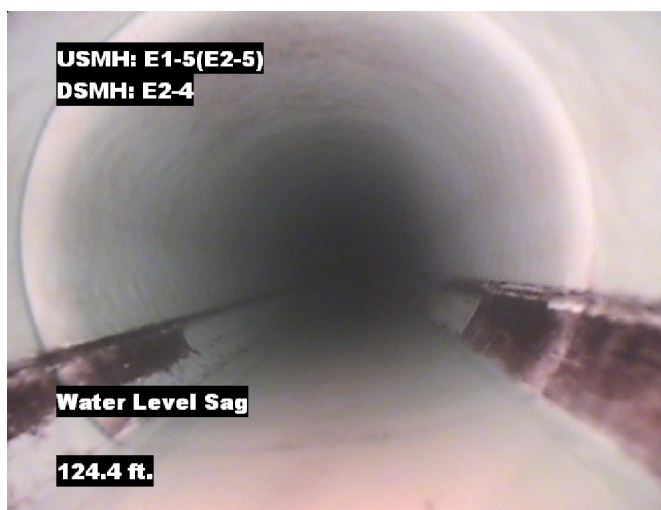
Distance: 124.4 ft. Grade: 2
Condition: Water Level Sag
Remarks: N/A

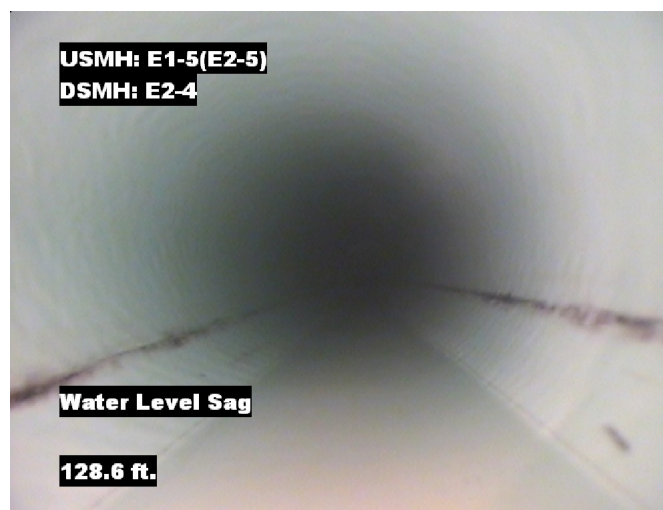
Distance: 128.6 ft. Grade: 2
Condition: Water Level Sag
Remarks: N/A

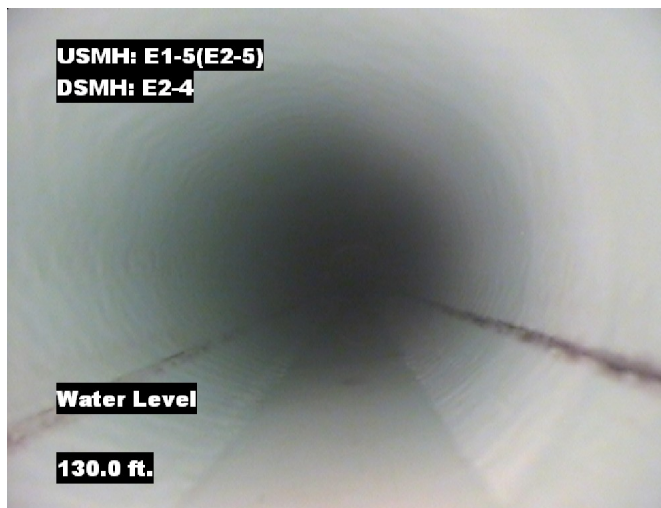
Distance: 130.0 ft. Grade: 0
Condition: Water Level
Remarks: N/A

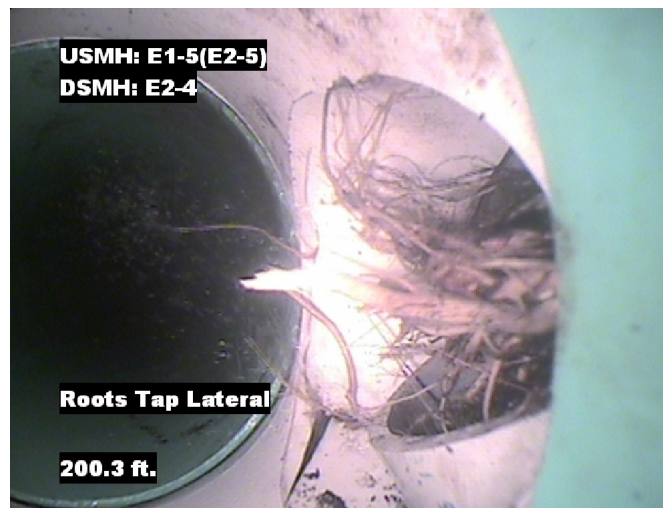
Distance: 200.3 ft. Grade: 2
Condition: Roots Tap Lateral
Remarks: N/A

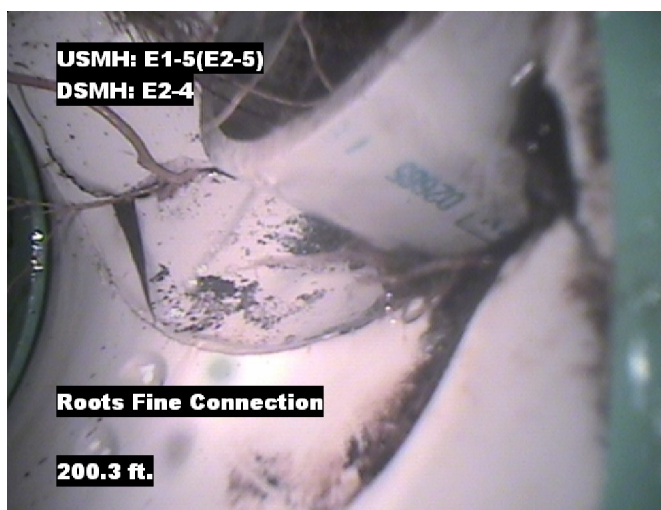
Distance: 200.3 ft. Grade: 1
Condition: Roots Fine Connection
Remarks: N/A

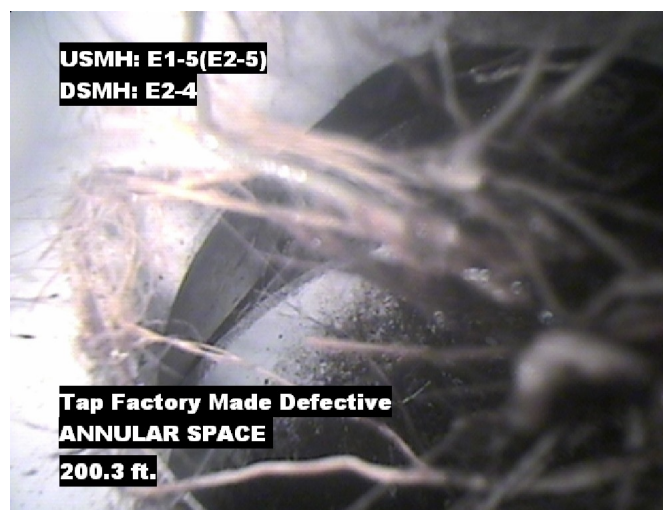
Distance: 200.3 ft. Grade: 2
Condition: Tap Factory Made Defective
Remarks: ANNULAR SPACE

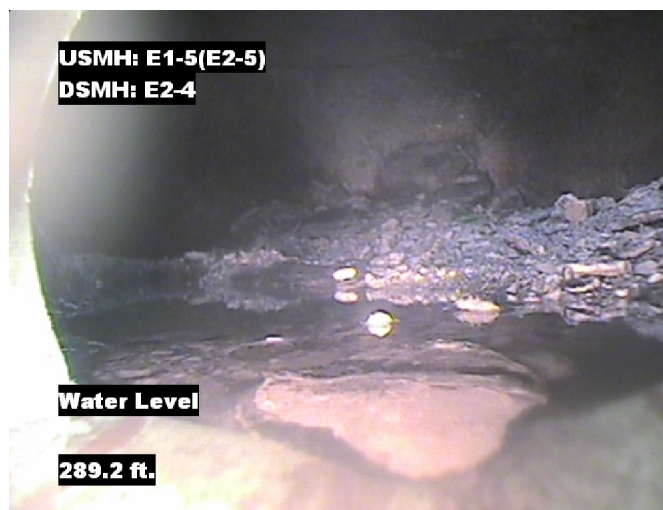
Distance: 289.2 ft. Grade: 0
Condition: Water Level
Remarks: N/A

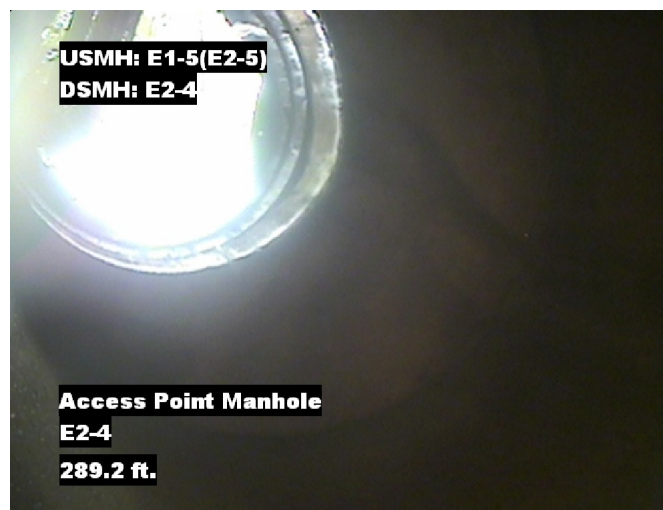
Distance: 289.2 ft. Grade: 0
Condition: Access Point Manhole
Remarks: E2-4
