## Defect Listing

Pipe Segment Refere...	City	Street	Material	Location C...	Sewer Use
<b>E3-1_E3-2</b>	<b>Oliver Springs</b>	<b>Hwy 62</b>	<b>PolyVinyl Chloride</b>	<b>Easement/R...</b>	<b>Sanitary</b>
Upstream MH	Total Length	Year Laid	Shape	Location Details	
<b>E3-1</b>	<b>305.8</b>		<b>Circular</b>	<b>Side of Hwy</b>	
DS Manhole	Length surveyed	Year Renewed	Height	Width	Pipe Joint...
<b>E3-2</b>	<b>305.8</b>		<b>8</b>	<b>8</b>	<b>13</b>

SPR	<b>N/A</b>	MPR	<b>8</b>	PO Number	Customer
SPRI	<b>N/A</b>	MPRI	<b>2.7</b>	<b>4397-03</b>	<b>GRW</b>
QSR	<b>N/A</b>	QMR	<b>4122</b>	Work Order	Purpose
			<b>4397-02</b>	<b>Pre-Rehabilitation Survey</b>	
OPR	Surveyed By	Direction	Date	Media label	
<b>8</b>	<b>Barry Rogers</b>	<b>Downstream</b>	<b>20150619</b>		
OPRI	Certificate Number	Pre-Cleaning	Time	Weather	
<b>2.7</b>	<b>U-1012-16405</b>	<b>Jetting</b>	<b>15:30</b>	<b>Damp</b>	
Date Cleaned			End Time	Additional Info	
<b>20150619</b>			<b>15:41</b>

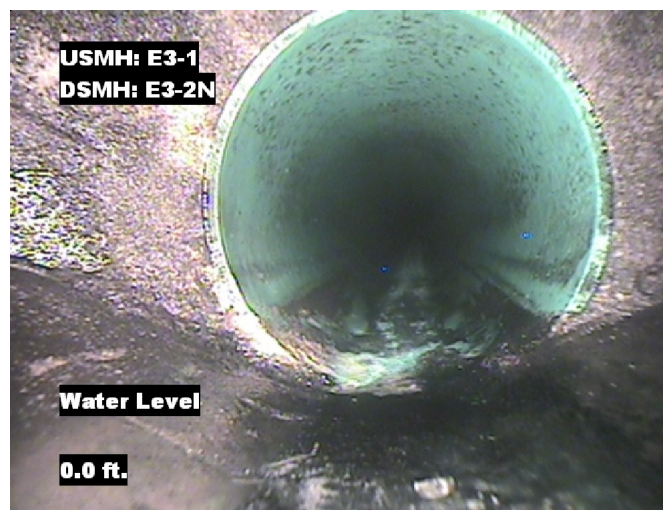
Distance: 0.0 ft. Grade: 0  
Condition: Water Level  
Remarks: N/A

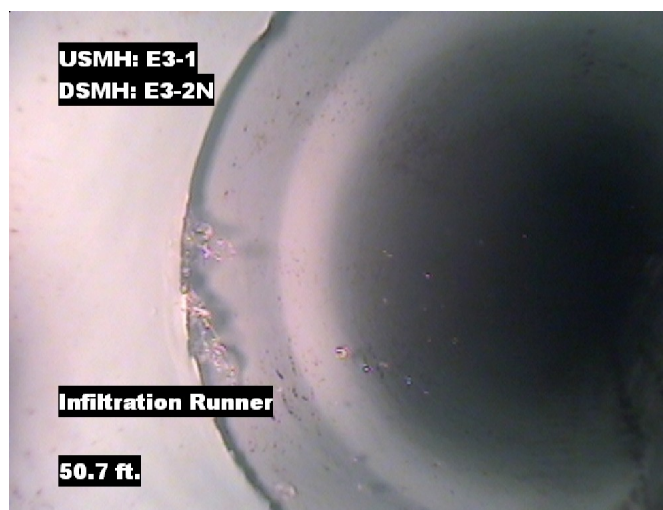
Distance: 50.7 ft. Grade: 4  
Condition: Infiltration Runner  
Remarks: N/A

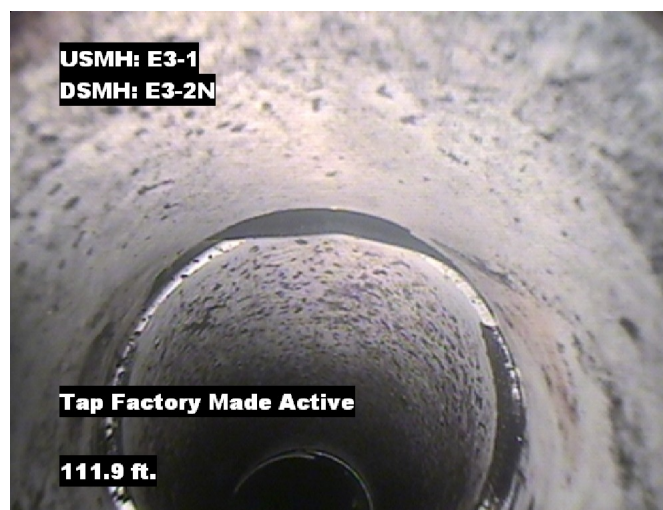
Distance: 111.9 ft. Grade: 0  
Condition: Tap Factory Made Active  
Remarks: N/A

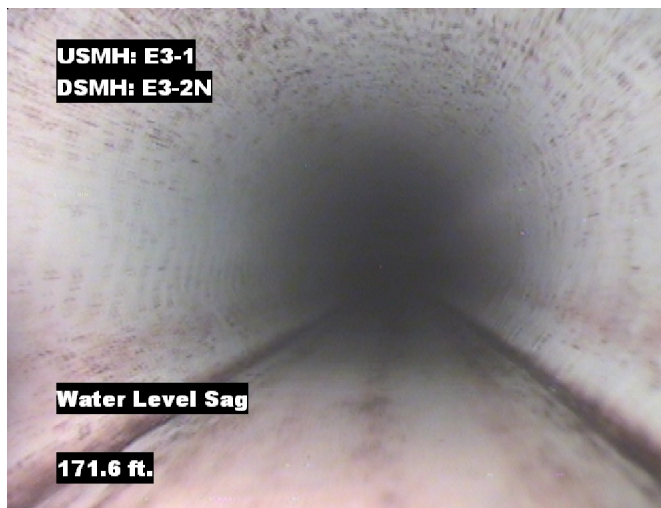
Distance: 171.6 ft. Grade: 2  
Condition: Water Level Sag  
Remarks: N/A

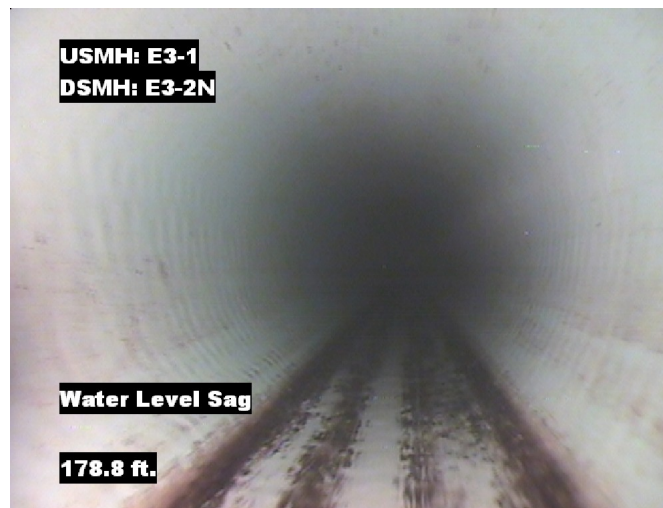
Distance: 178.7 ft. Grade: 2  
Condition: Water Level Sag  
Remarks: N/A

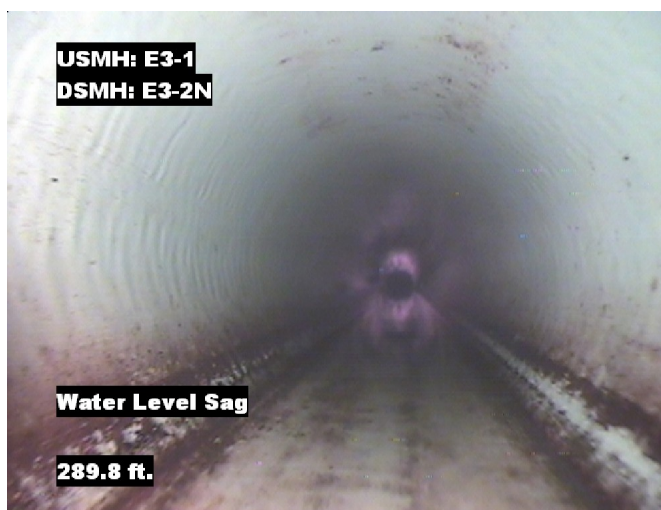
Distance: 289.8 ft. Grade: 2  
Condition: Water Level Sag  
Remarks: N/A

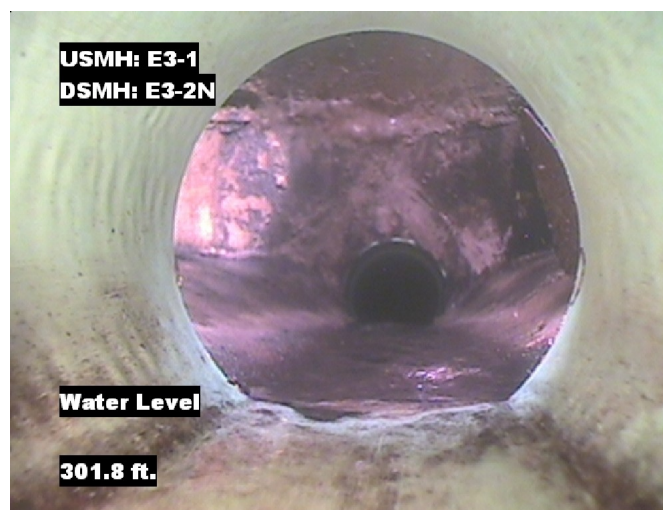
Distance: 301.8 ft. Grade: 0  
Condition: Water Level  
Remarks: N/A
