Defect Listing

Pipe Segment Refere... E3-2 E2-3	City Oliver Springs	Street Hwy 62	Material PolyVinyl Chloride	Location C... Yard	Sewer Use Sanitary
Upstream MH E3-2	Total Length 250.6	Year Laid	Shape Circular	Location Details USMH LOCATED IN GRA...	
DS Manhole E2-3	Length surveyed 250.6	Year Renewed	Height 8	Width 8	Pipe Joint... 13

SPR 5	MPR 6	PO Number 4397-03	Customer GRW
SPRI 5	MPRI 2	Work Order 4397-02	Purpose Pre-Rehabilitation Survey
QSR 5100	QMR 2300		
OPR 11	Surveyed By David_brown	Direction Downstream	Date 20150620
OPRI 2.8	Certificate Number U-607-5202	Pre-Cleaning Jetting	Time 08:06
	Date Cleaned 20150620	End Time 08:21	Weather Damp
			Additional Info

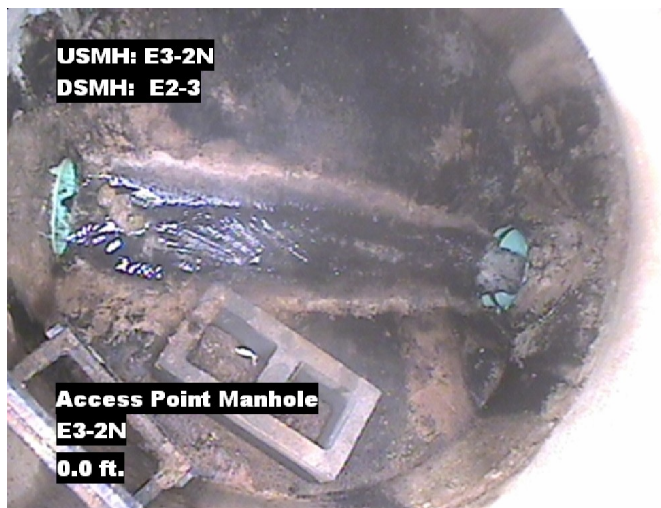
Distance: 0.0 ft. Grade: 0
Condition: Access Point Manhole
Remarks: E3-2

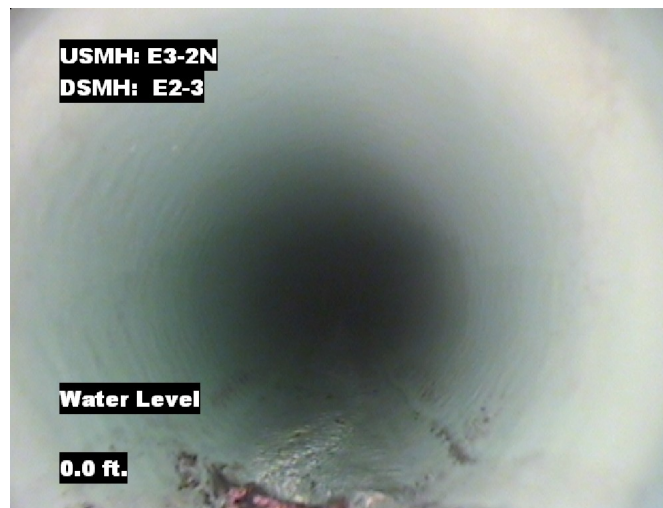
Distance: 0.0 ft. Grade: 0
Condition: Water Level
Remarks: N/A

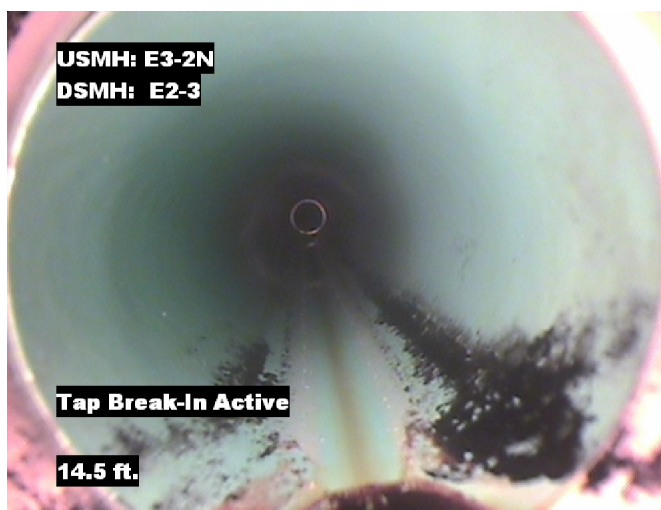
Distance: 14.5 ft. Grade: 0
Condition: Tap Break-In Active
Remarks: N/A

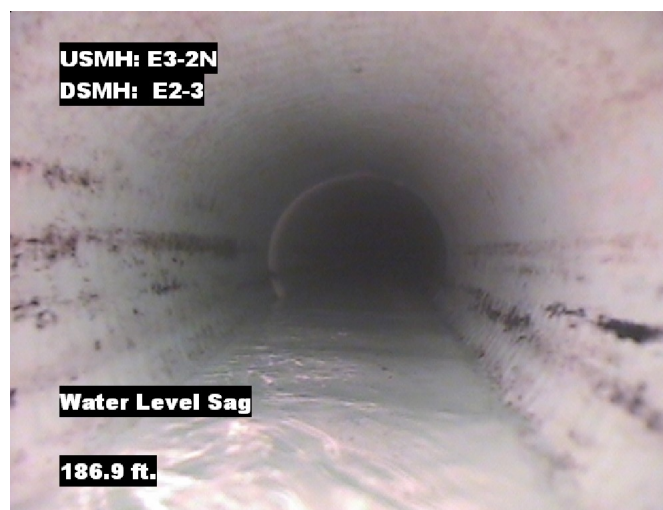
Distance: 186.9 ft. Grade: 2
Condition: Water Level Sag
Remarks: N/A

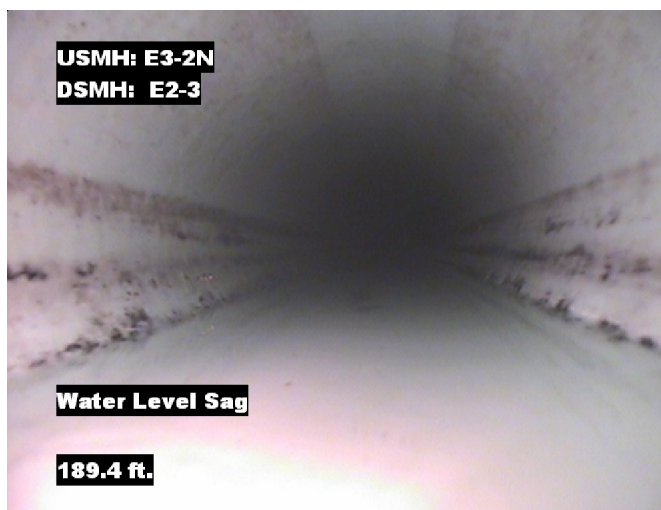
Distance: 189.4 ft. Grade: 2
Condition: Water Level Sag
Remarks: N/A

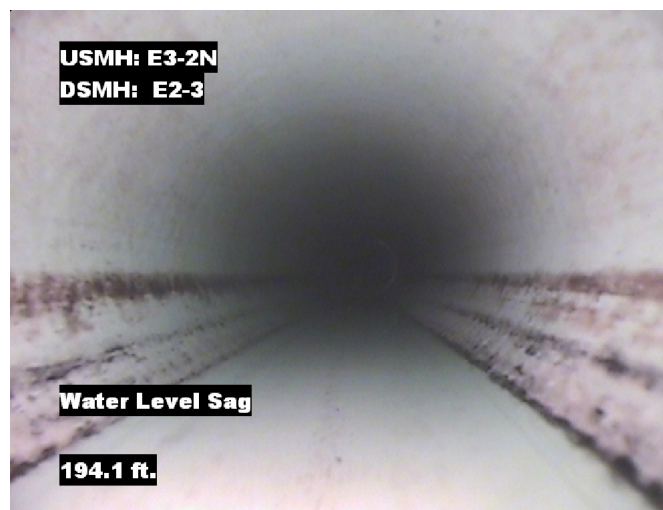
Distance: 194.1 ft. Grade: 2
Condition: Water Level Sag
Remarks: N/A

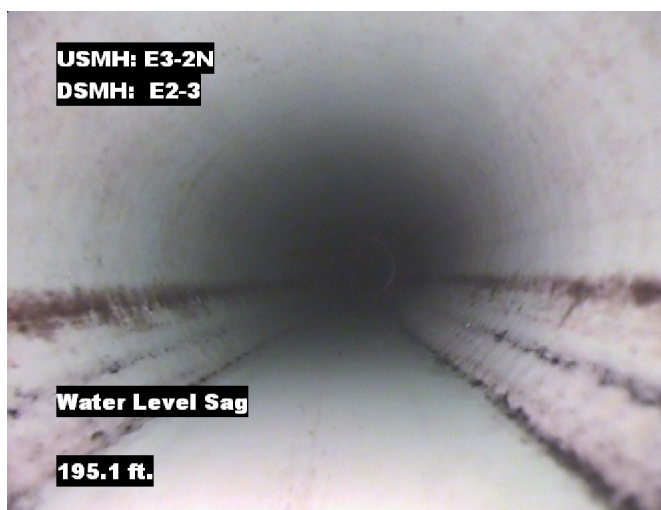
Distance: 195.1 ft. Grade: 2
Condition: Water Level Sag
Remarks: N/A

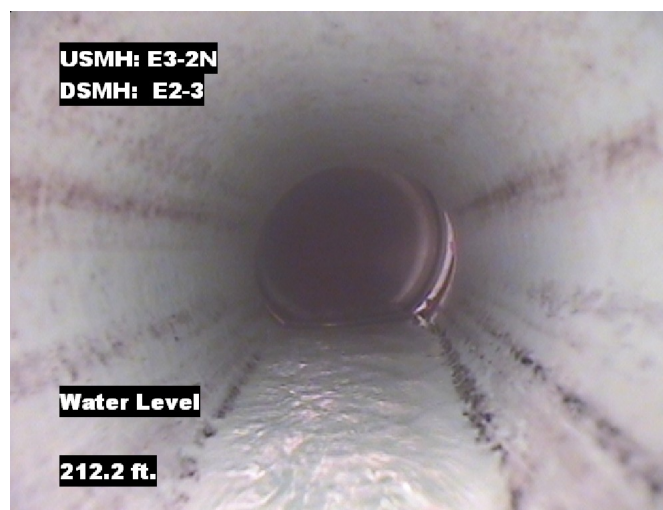
Distance: 212.2 ft. Grade: 0
Condition: Water Level
Remarks: N/A

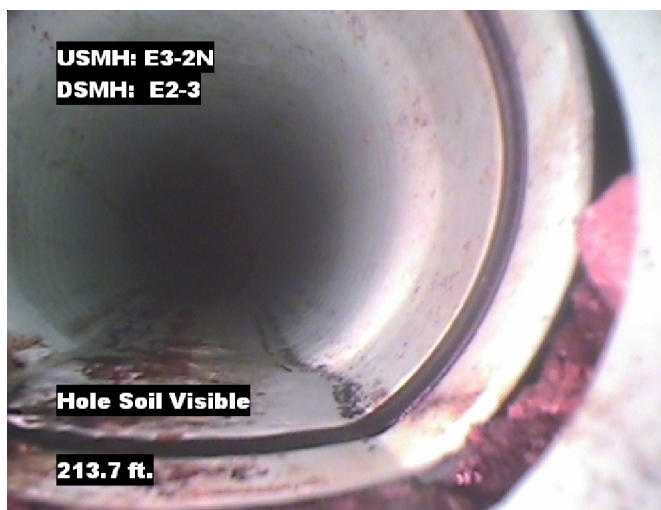
Distance: 213.7 ft. Grade: 5
Condition: Hole Soil Visible
Remarks: N/A

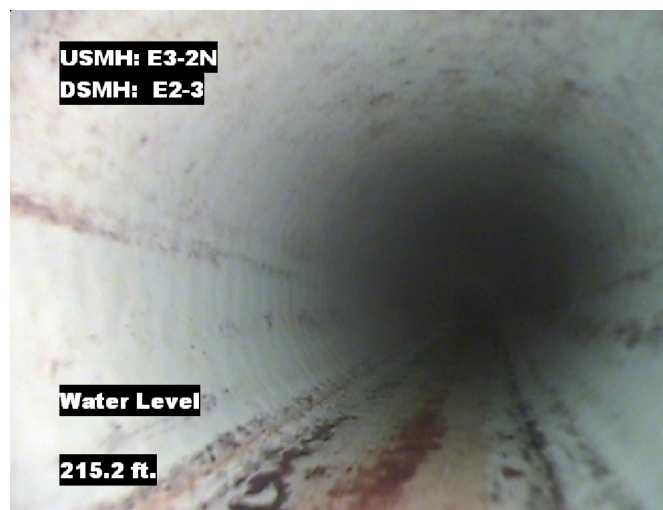
Distance: 215.2 ft. Grade: 0
Condition: Water Level
Remarks: N/A

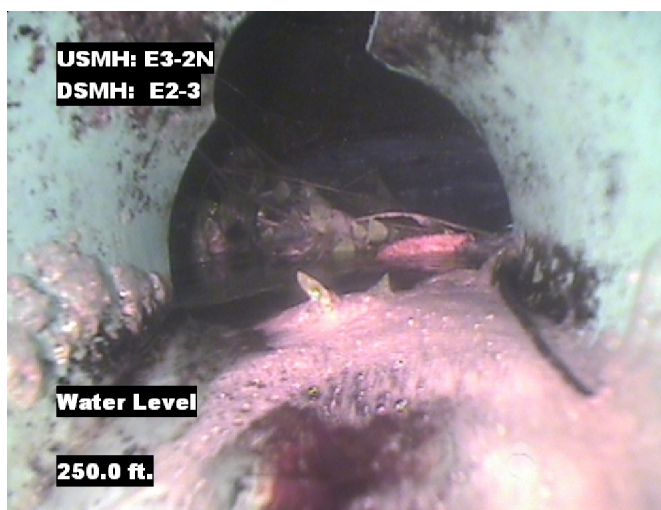
Distance: 250.0 ft. Grade: 0
Condition: Water Level
Remarks: N/A

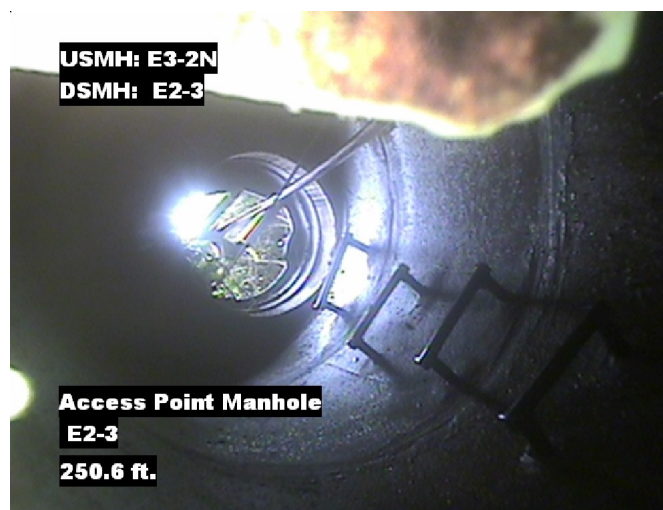
Distance: 250.6 ft. Grade: 0
Condition: Access Point Manhole
Remarks: E2-3
