Defect Listing

Pipe Segment Refere...	City	Street	Material	Location C...	Sewer Use
E4-1_PS-3	Oliver Springs	midway	Concrete Pipe (non-...	Light High...	Sanitary
Upstream MH	Total Length	Year Laid	Shape	Location Details	
E4-1	173.6		Circular		
DS Manhole	Length surveyed	Year Renewed	Height	Width	Pipe Joint...
PS-3	173.6		8	8	4

SPR	N/A	MPR	N/A	PO Number	Customer
				4397-03	GRW
SPRI	N/A	MPRI	N/A	Work Order	Purpose
				4397-02	Pre-Rehabilitation Survey
QSR	N/A	QMR	N/A		
OPR	Surveyed By	Direction	Date	Media label	
N/A	Barry Rogers	Downstream	20150619		
OPRI	Certificate Number	Pre-Cleaning	Time	Weather	
N/A	U-1012-16405	No Pre-Cleaning	11:31	Dry	
	Date Cleaned		End Time	Additional Info	
			11:46

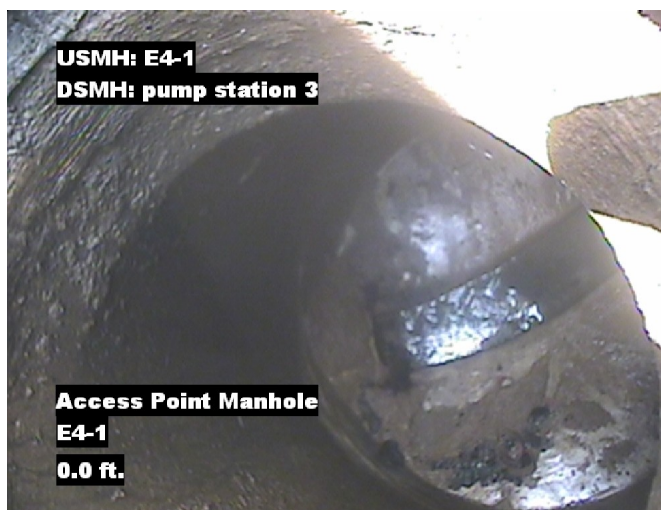
Distance: 0.0 ft. Grade: 0
Condition: Access Point Manhole
Remarks: E4-1

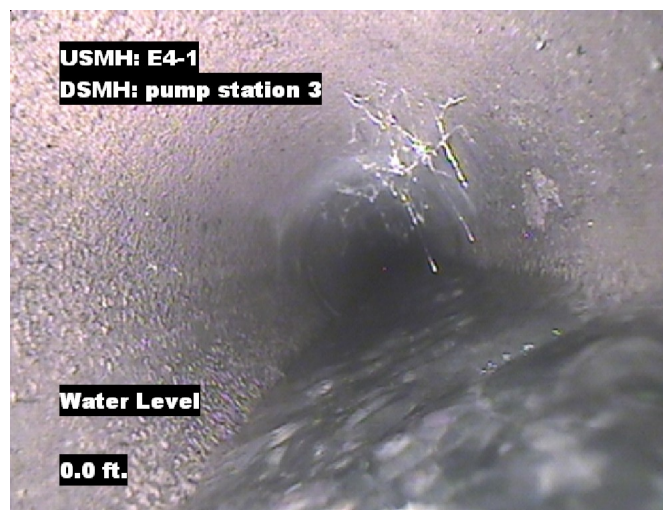
Distance: 0.0 ft. Grade: 0
Condition: Water Level
Remarks: N/A

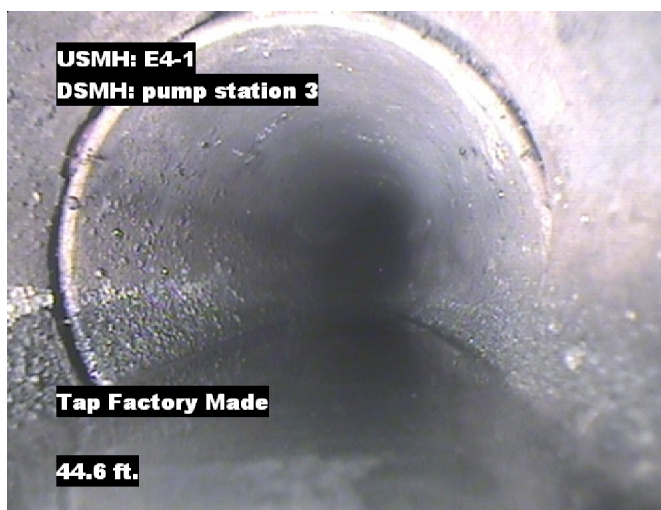
Distance: 44.6 ft. Grade: 0
Condition: Tap Factory Made
Remarks: N/A

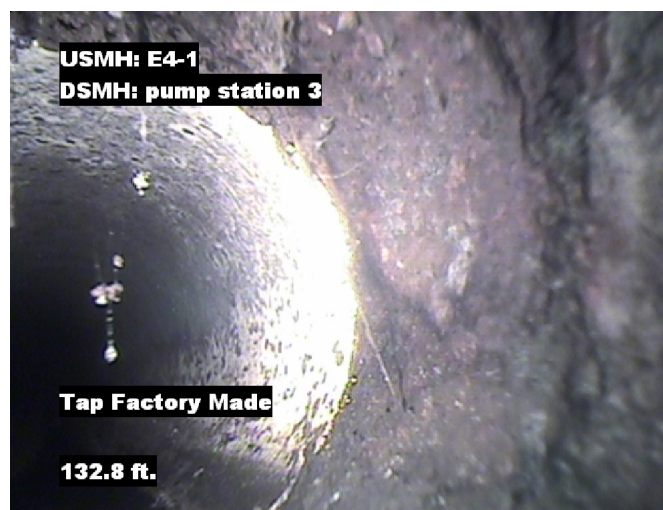
Distance: 132.8 ft. Grade: 0
Condition: Tap Factory Made
Remarks: N/A

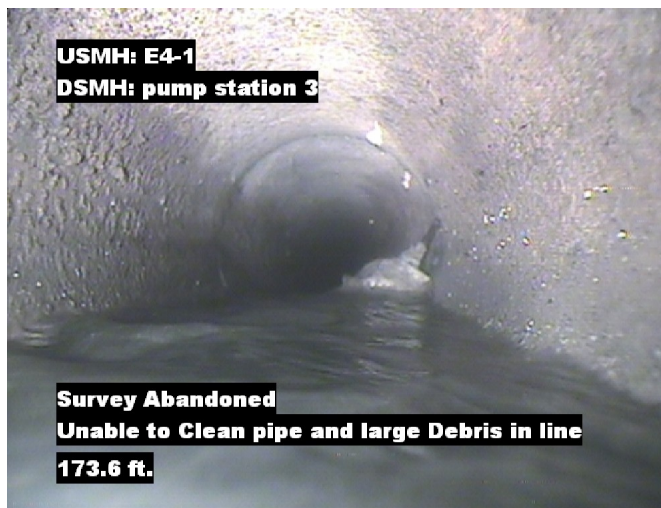
Distance: 173.6 ft. Grade: 0
Condition: Survey Abandoned
Remarks: Unable to Clean pipe and large Debris in line
