Defect Listing

| Pipe Segment Refere... E4-2_E4-1 | City Oliver Springs | Street Midway Dr | Material Concrete Pipe (non-... | Location C... Light High... | Sewer Use Sanitary |

| SPRI N/A | MPRI 3 | Work Order 4397-02 | Purpose Pre-Rehabilitation Survey |

Image Report 4/Page

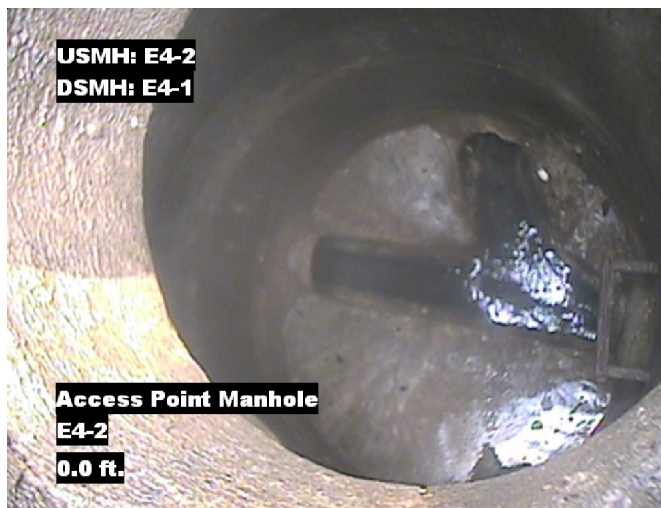
Distance: 0.0 ft. Grade: 0
Condition: Access Point Manhole
Remarks: E4-2

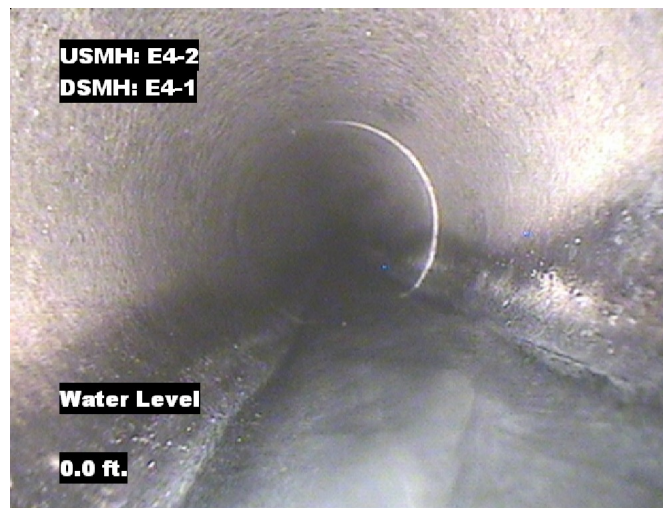
Distance: 0.0 ft. Grade: 0
Condition: Water Level
Remarks: N/A

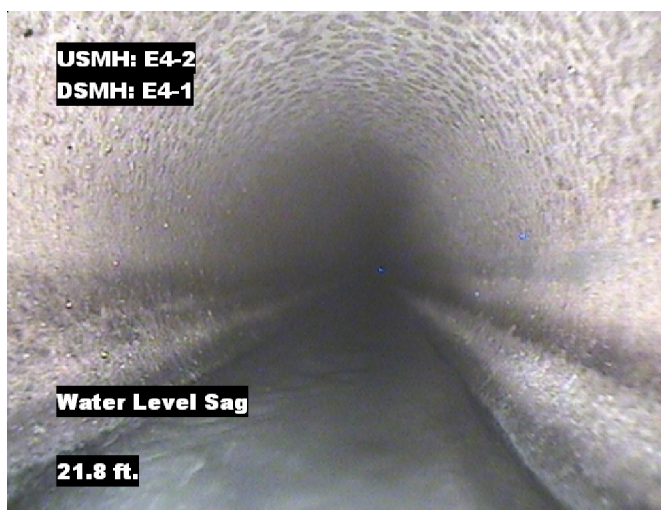
| Distance | Condition | Cont. Dfct. | Values | | | Joint | Clock Position | | Grade |
|---|---|---|---|---|---|---|---|---|---|
| 21.8 ft. | Water Level Sag | | | | 15 | <input type="checkbox"/> | | | 2 |

Distance: 21.8 ft. Grade: 2
Condition: Water Level Sag
Remarks: N/A

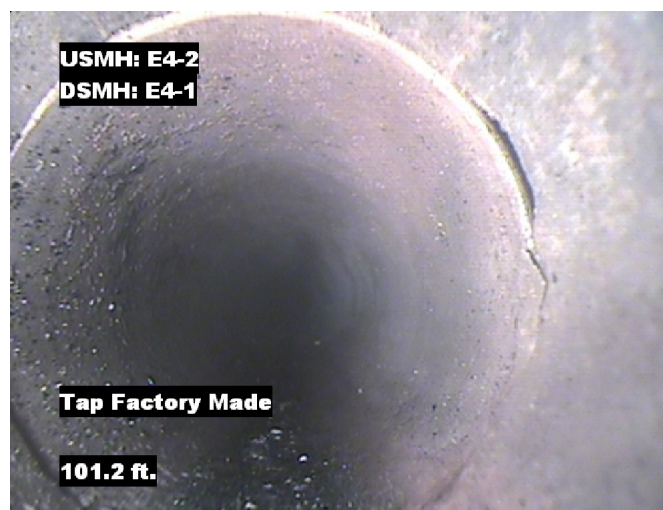
Distance: 101.2 ft. Grade: 0
Condition: Tap Factory Made
Remarks: N/A

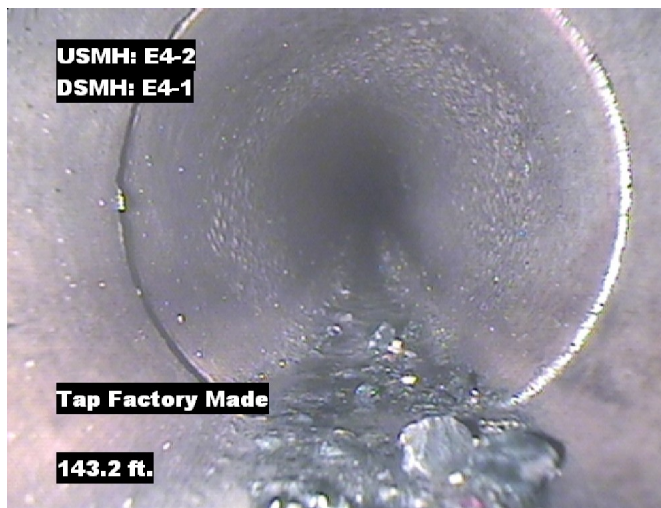
Distance: 143.2 ft. Grade: 0
Condition: Tap Factory Made
Remarks: N/A

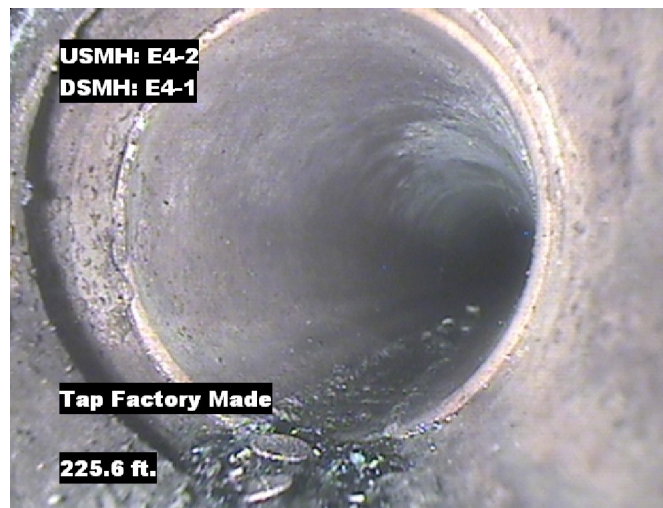
Distance: 225.6 ft. Grade: 0
Condition: Tap Factory Made
Remarks: N/A

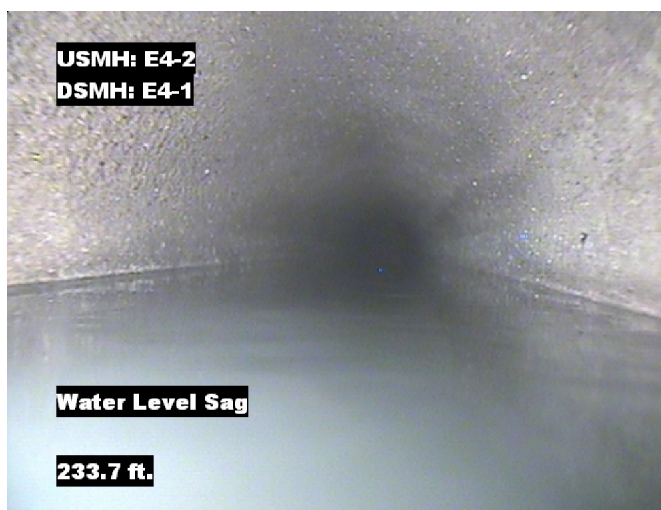
| Distance | Condition | Cont. Dfct. | Values | | | Joint | Clock Position | | Grade |
|---|---|---|---|---|---|---|---|---|---|
| 233.7 ft. | Water Level Sag | | | | 50 | <input type="checkbox"/> | | | 3 |

Distance: 233.7 ft. Grade: 3
Condition: Water Level Sag
Remarks: N/A

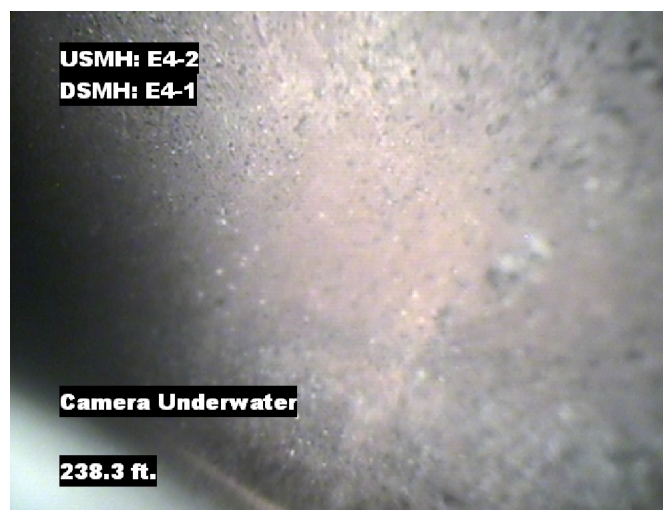
| Distance | Condition | Cont. Dfct. | Values | | | Joint | Clock Position | | Grade |
|---|---|---|---|---|---|---|---|---|---|
| 238.3 ft. | Camera Underwater | | | | 0 | <input type="checkbox"/> | | | 4 |

Distance: 238.3 ft. Grade: 4
Condition: Camera Underwater
Remarks: N/A

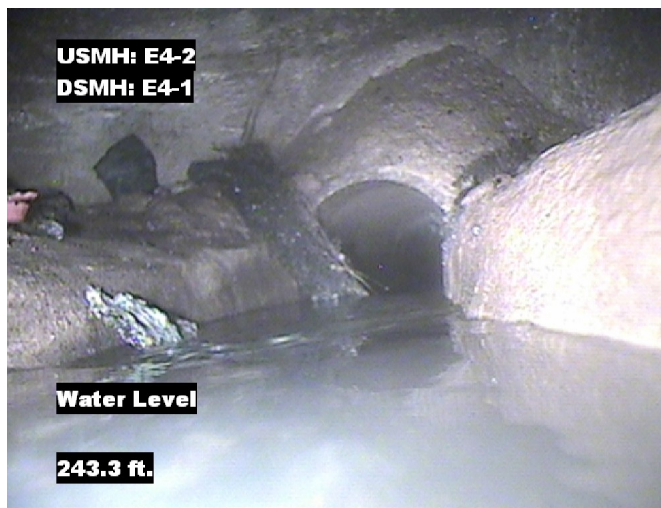
Distance: 243.3 ft. Grade: 0
Condition: Water Level
Remarks: N/A

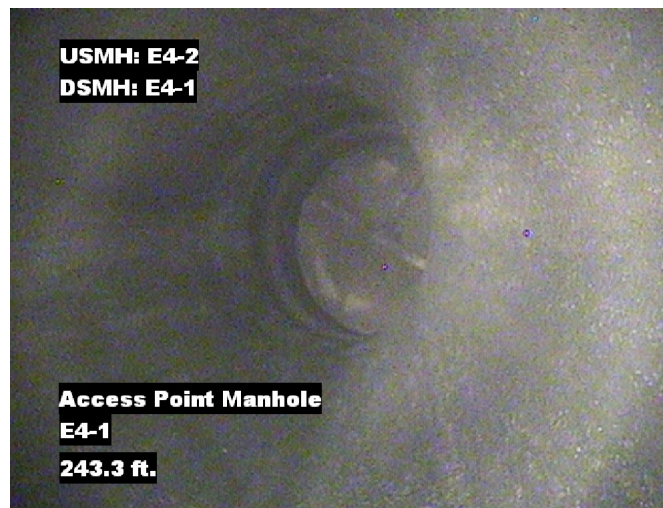
Distance: 243.3 ft. Grade: 0
Condition: Access Point Manhole
Remarks: E4-1
