## Defect Listing

Pipe Segment Refere... <b>E4-3_E4-2</b>	City <b>Oliver Springs</b>	Street <b>Midway Dr</b>	Material <b>Concrete Pipe (non-...</b>	Location C... <b>Light High...</b>	Sewer Use <b>Sanitary</b>
Upstream MH <b>E4-3</b>	Total Length <b>230.6</b>	Year Laid	Shape <b>Circular</b>	Location Details <b>174 Midway Dr</b>	
DS Manhole <b>E4-2</b>	Length surveyed <b>230.6</b>	Year Renewed	Height <b>8</b>	Width <b>8</b>	Pipe Joint... <b>4</b>

SPR <b>N/A</b>	MPR <b>2</b>	PO Number <b>4397-03</b>	Customer <b>GRW</b>
SPRI <b>N/A</b>	MPRI <b>2</b>	Work Order <b>4397-02</b>	Purpose <b>Pre-Rehabilitation Survey</b>
QSR <b>N/A</b>	QMR <b>2100</b>		
OPR <b>2</b>	Surveyed By <b>Barry Rogers</b>	Direction <b>Downstream</b>	Date <b>20150619</b>
OPRI <b>2</b>	Certificate Number <b>U-1012-16405</b>	Pre-Cleaning <b>Jetting</b>	Time <b>08:06</b>
	Date Cleaned <b>20150619</b>	End Time <b>08:20</b>	Weather <b>Damp</b>
			Additional Info

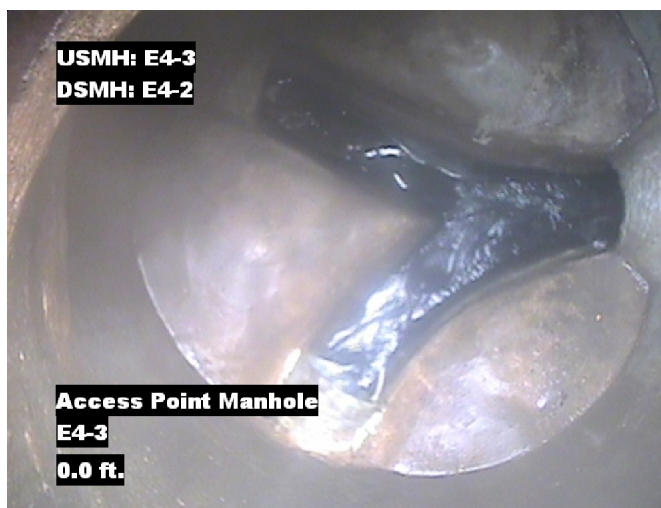
Distance: 0.0 ft. Grade: 0  
Condition: Access Point Manhole  
Remarks: E4-3

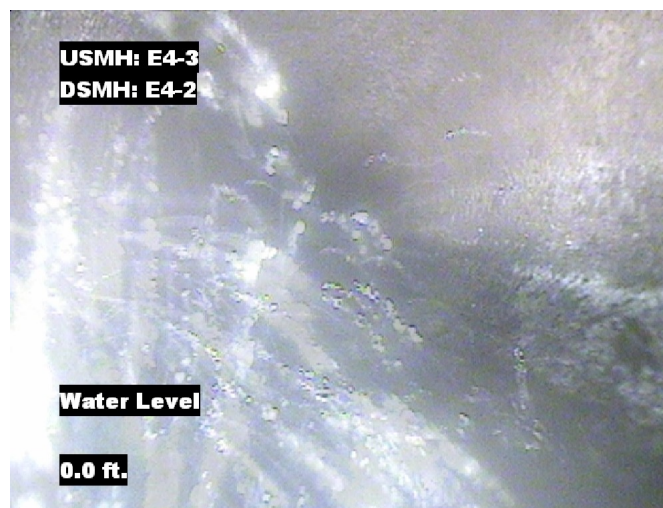
Distance: 0.0 ft. Grade: 0  
Condition: Water Level  
Remarks: N/A

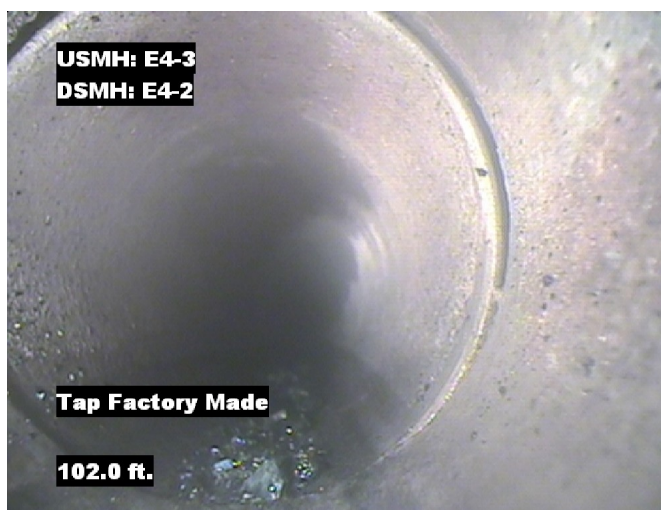
Distance: 102.0 ft. Grade: 0  
Condition: Tap Factory Made  
Remarks: N/A

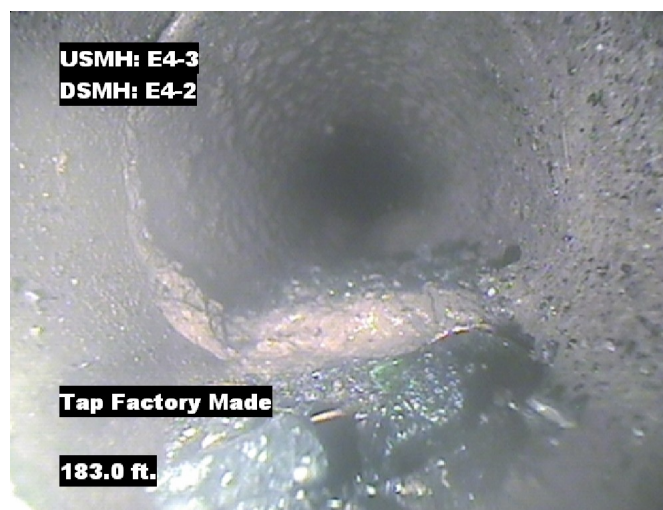
Distance: 183.0 ft. Grade: 0  
Condition: Tap Factory Made  
Remarks: N/A

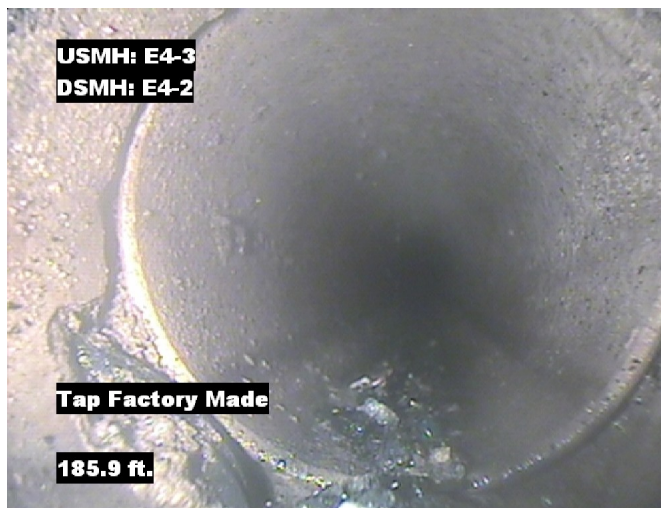
Distance: 185.9 ft. Grade: 0  
Condition: Tap Factory Made  
Remarks: N/A

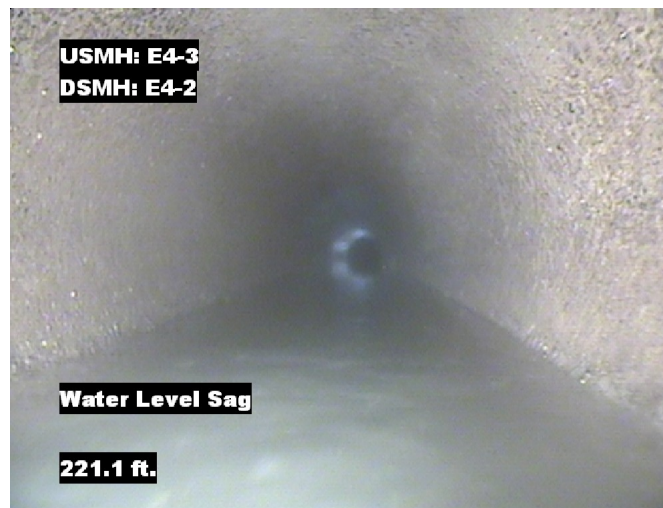
Distance: 221.1 ft. Grade: 2  
Condition: Water Level Sag  
Remarks: N/A

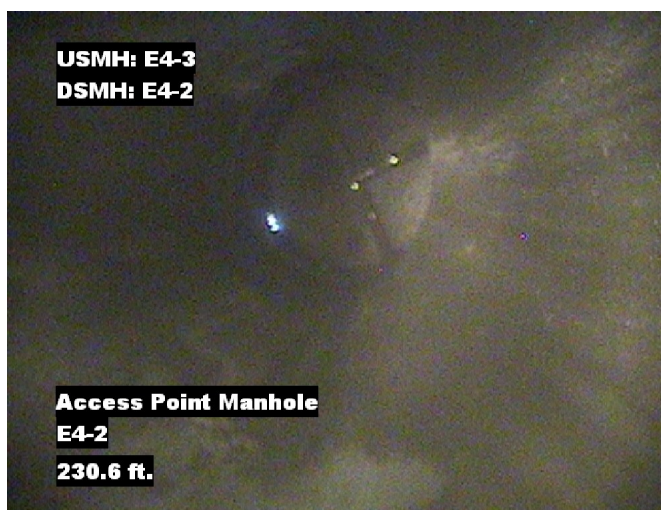
Distance: 230.6 ft. Grade: 0  
Condition: Access Point Manhole  
Remarks: E4-2
