Defect Listing

Pipe Segment Refere... E4-4_E4-3	City Oliver Springs	Street Midway Dr	Material Concrete Pipe (non-...	Location C... Light High...	Sewer Use Sanitary
Upstream MH E4-4	Total Length 270.5	Year Laid	Shape Circular	Location Details 168 Midway Dr	
DS Manhole E4-3	Length surveyed 270.5	Year Renewed	Height 8	Width 8	Pipe Joint... 4

SPR 5	MPR 6	PO Number 4397-03	Customer GRW
SPRI 5	MPRI 3	Work Order 4397-02	Purpose Pre-Rehabilitation Survey
QSR 5100	QMR 3200		
OPR 11	Surveyed By Barry Rogers	Direction Downstream	Date 20150617
OPRI 3.7	Certificate Number U-1012-16405	Pre-Cleaning Jetting	Time 15:15
	Date Cleaned 20150617	End Time 15:27	Weather Very Dry
			Media label
			Additional Info

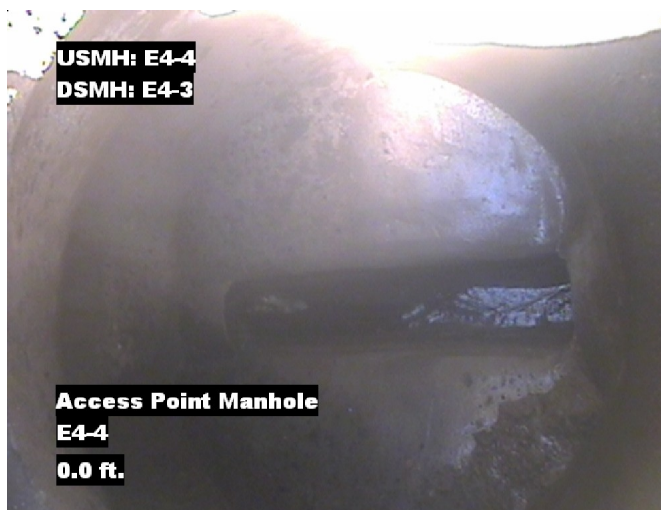
Distance: 0.0 ft. Grade: 0
Condition: Access Point Manhole
Remarks: E4-4

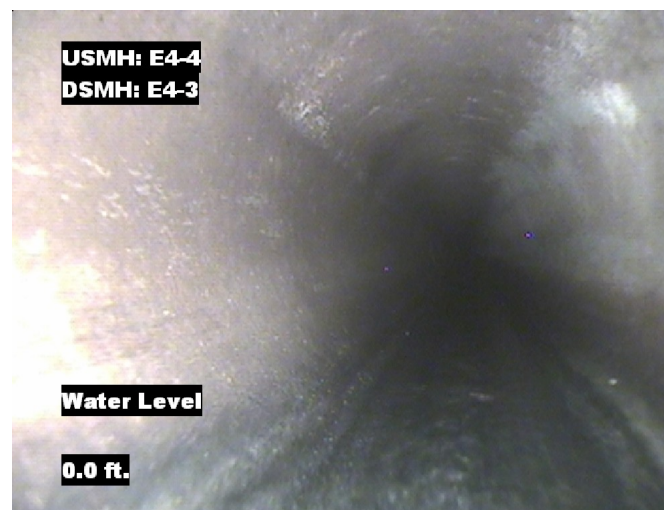
Distance: 0.0 ft. Grade: 0
Condition: Water Level
Remarks: N/A

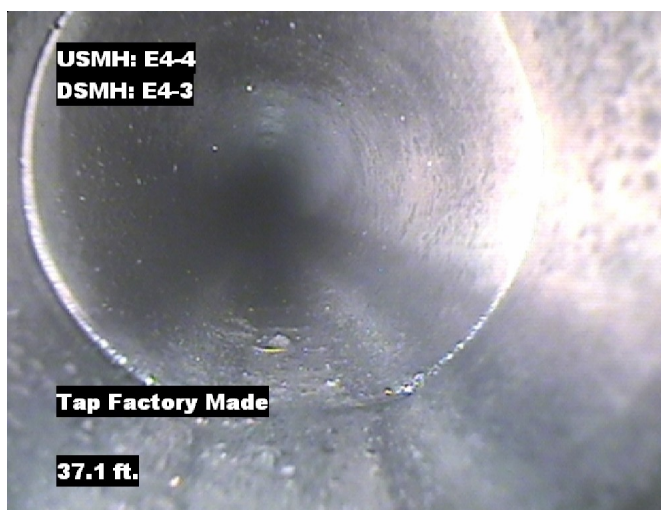
Distance: 37.1 ft. Grade: 0
Condition: Tap Factory Made
Remarks: N/A

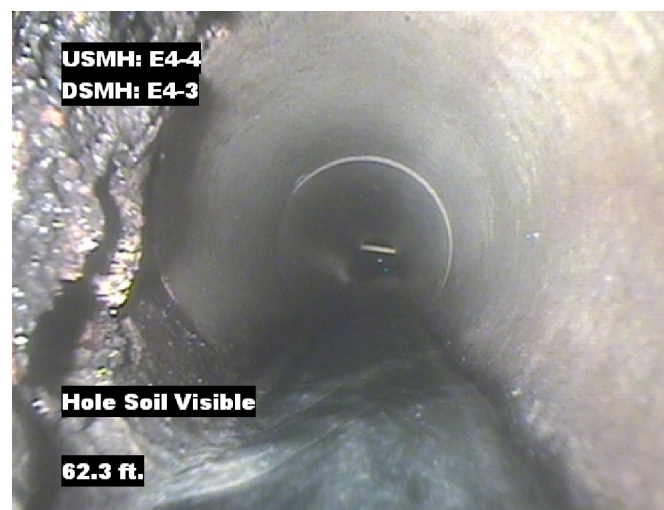
Distance: 62.3 ft. Grade: 5
Condition: Hole Soil Visible
Remarks: N/A

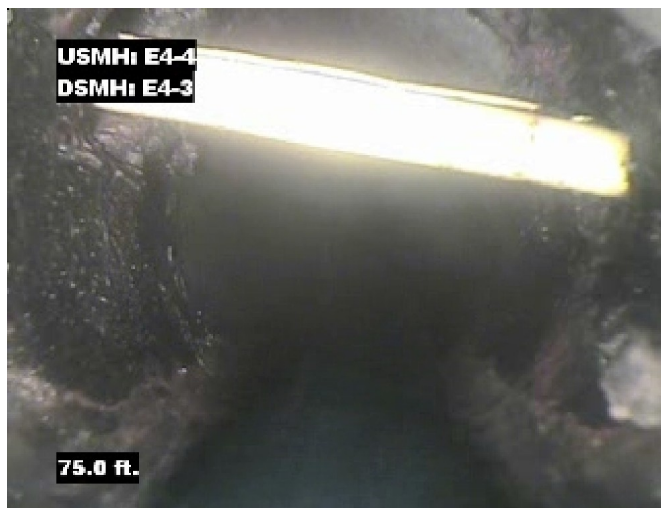
Distance: 75.0 ft. Grade: 3
Condition: Obstacle External Pipe or Cable
Remarks: Gas Line

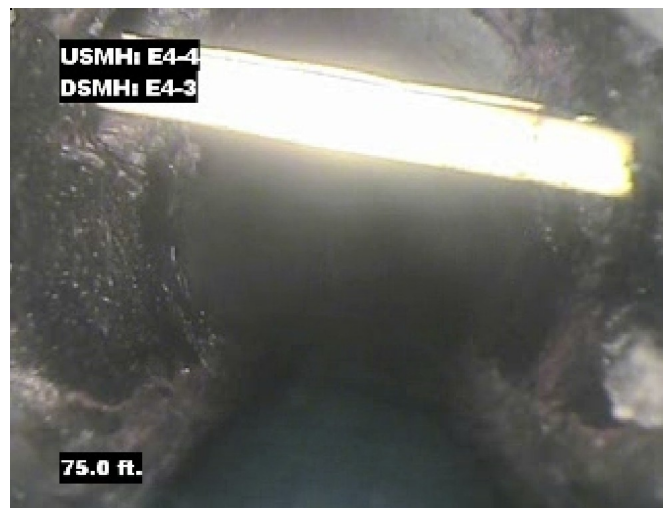
Distance: 75.0 ft. Grade: 0
Condition: Infiltration Stain
Remarks: N/A

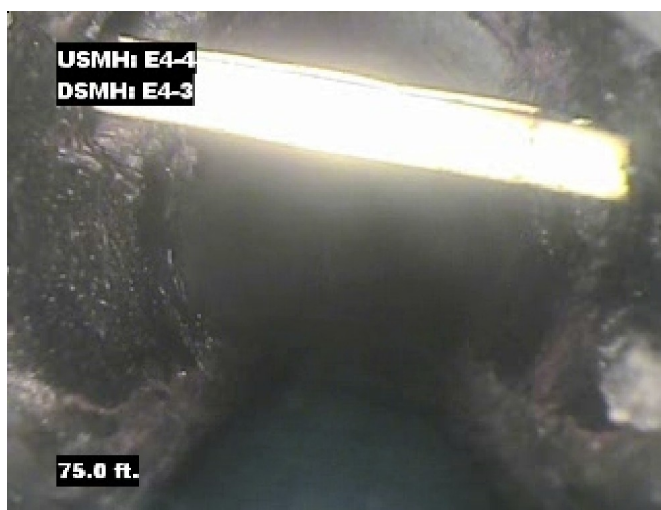
Distance: 75.0 ft. Grade: 0
Condition: Infiltration Stain
Remarks: N/A

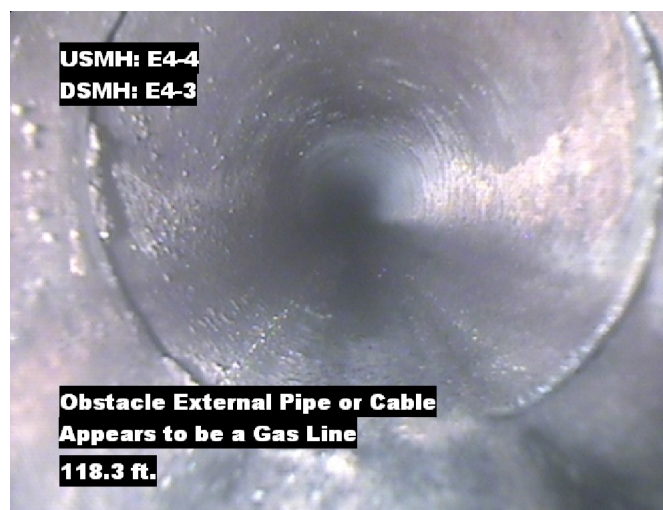
Distance: 118.3 ft. Grade: 3
Condition: Obstacle External Pipe or Cable
Remarks: Appears to be a Gas Line

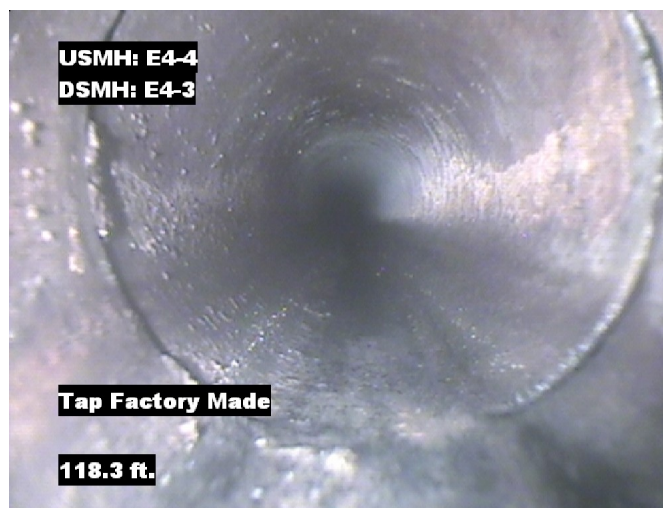
Distance: 118.3 ft. Grade: 0
Condition: Tap Factory Made
Remarks: N/A

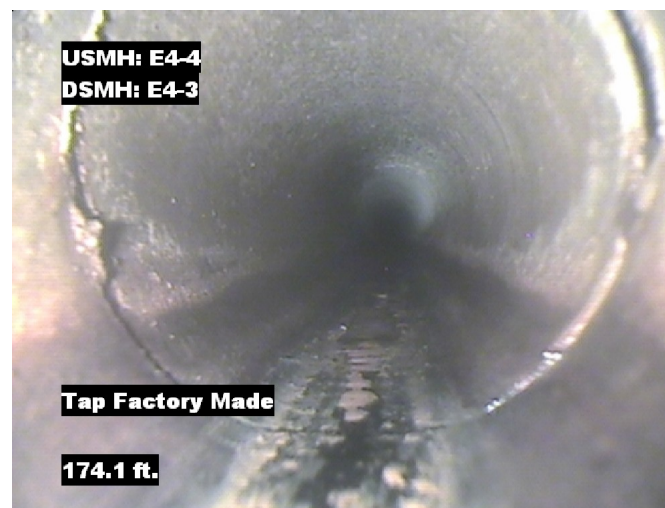
Distance: 174.1 ft. Grade: 0
Condition: Tap Factory Made
Remarks: N/A

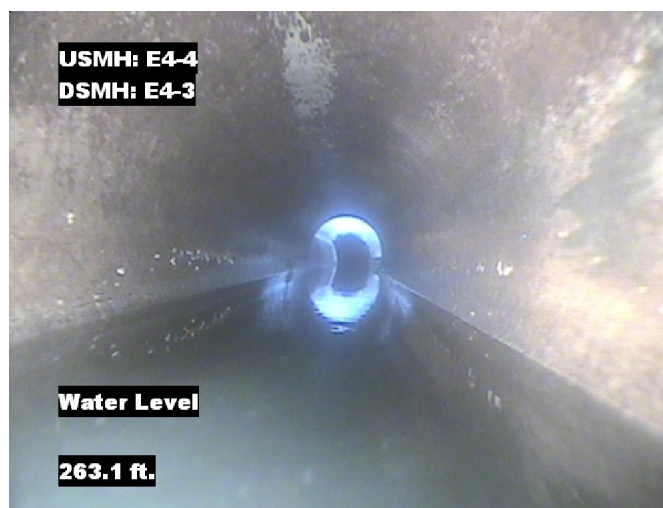
Distance: 263.1 ft. Grade: 0
Condition: Water Level
Remarks: N/A

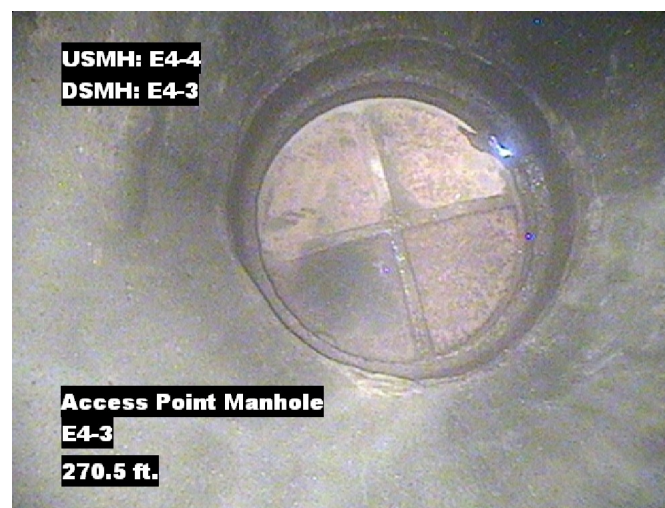
Distance: 270.5 ft. Grade: 0
Condition: Access Point Manhole
Remarks: E4-3
