Defect Listing

Pipe Segment Refere... E4-5_E4-4	City Oliver Springs	Street Midway dr	Material Concrete Pipe (non-...	Location C... Light High...	Sewer Use Sanitary
Upstream MH E4-5	Total Length 304.2	Year Laid	Shape Circular	Location Details Street	
DS Manhole E4-4	Length surveyed 304.2	Year Renewed	Height 8	Width 8	Pipe Joint... 4

SPR N/A	MPR 2	PO Number 4397-03	Customer GRW
SPRI N/A	MPRI 2	Work Order 4397-02	Purpose Pre-Rehabilitation Survey
QSR N/A	QMR 2100		
OPR 2	Surveyed By Barry Rogers	Direction Downstream	Date 20150612
OPRI 2	Certificate Number U-1012-16405	Pre-Cleaning Jetting	Time 15:14
	Date Cleaned 20150612	End Time 15:28	Weather Damp
			Media label
			Additional Info

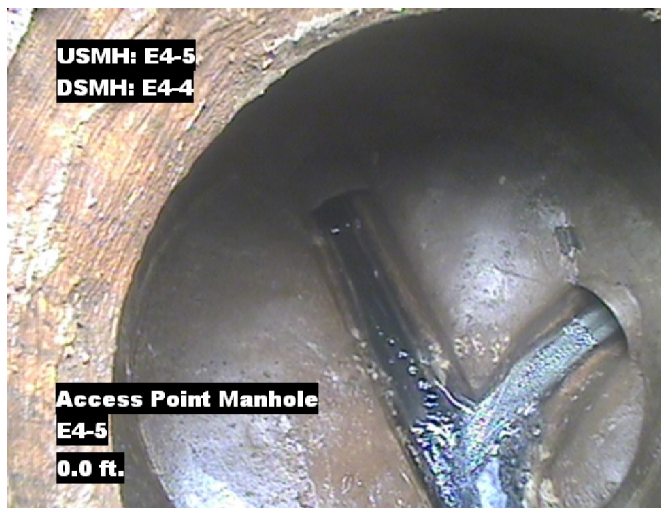
Distance: 0.0 ft. Grade: 0
Condition: Access Point Manhole
Remarks: E4-5

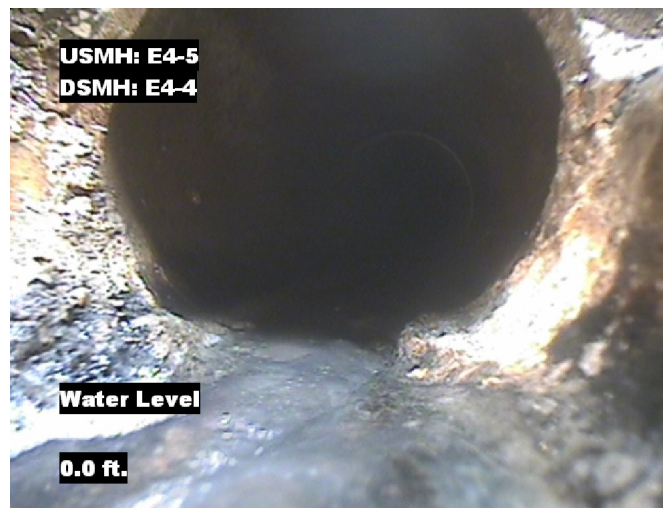
Distance: 0.0 ft. Grade: 0
Condition: Water Level
Remarks: N/A

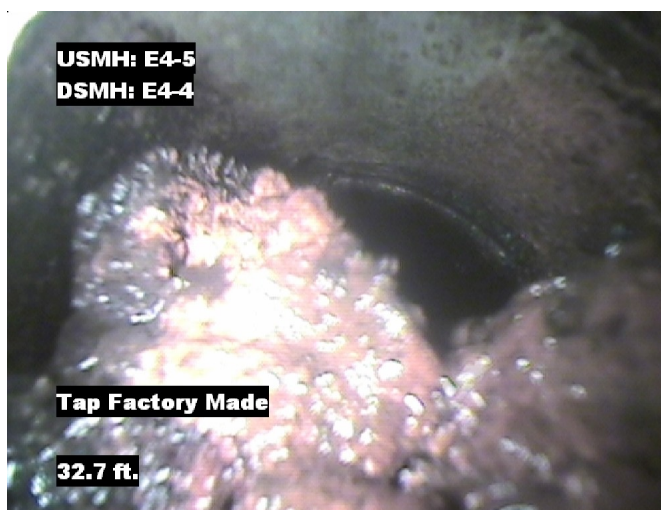
Distance: 32.7 ft. Grade: 0
Condition: Tap Factory Made
Remarks: N/A

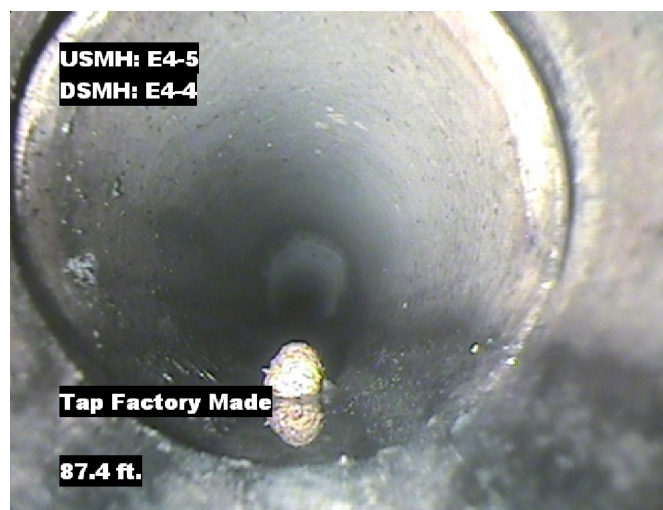
Distance: 87.4 ft. Grade: 0
Condition: Tap Factory Made
Remarks: N/A

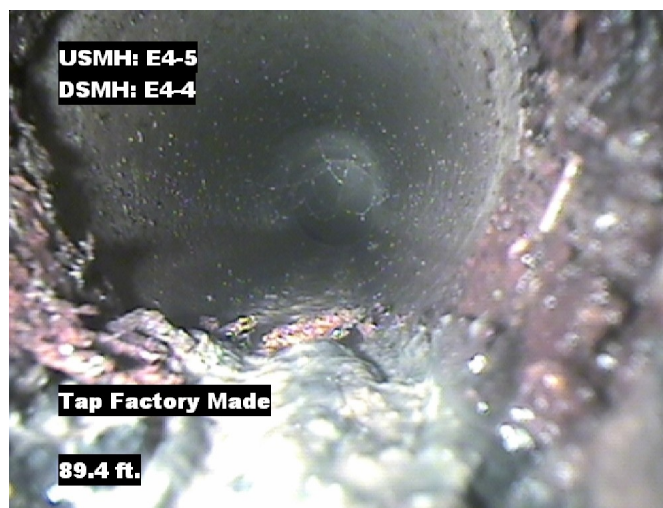
Distance: 89.4 ft. Grade: 0
Condition: Tap Factory Made
Remarks: N/A

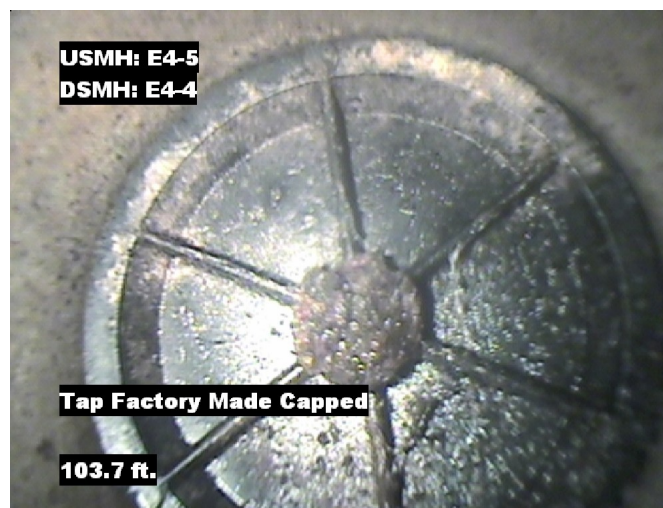
Distance: 103.7 ft. Grade: 0
Condition: Tap Factory Made Capped
Remarks: N/A

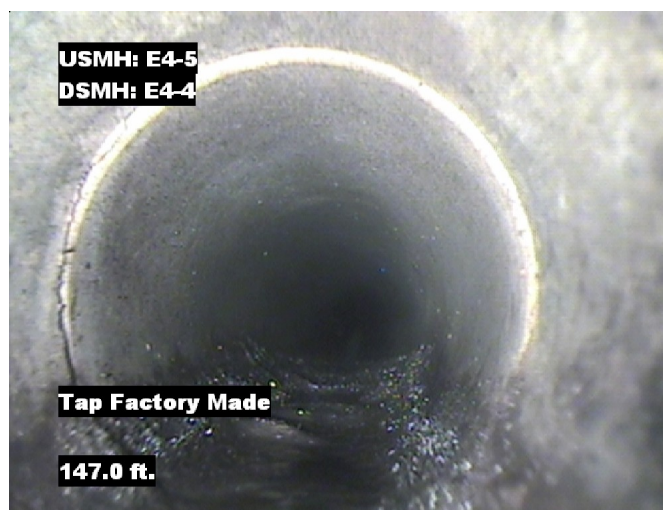
Distance: 147.0 ft. Grade: 0
Condition: Tap Factory Made
Remarks: N/A

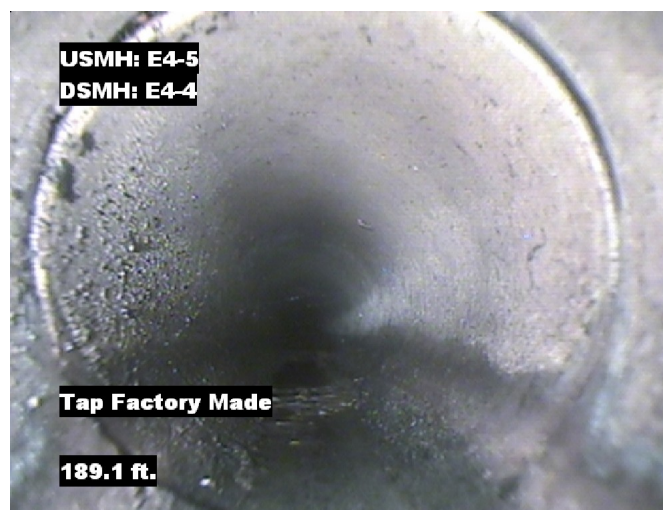
Distance: 189.1 ft. Grade: 0
Condition: Tap Factory Made
Remarks: N/A

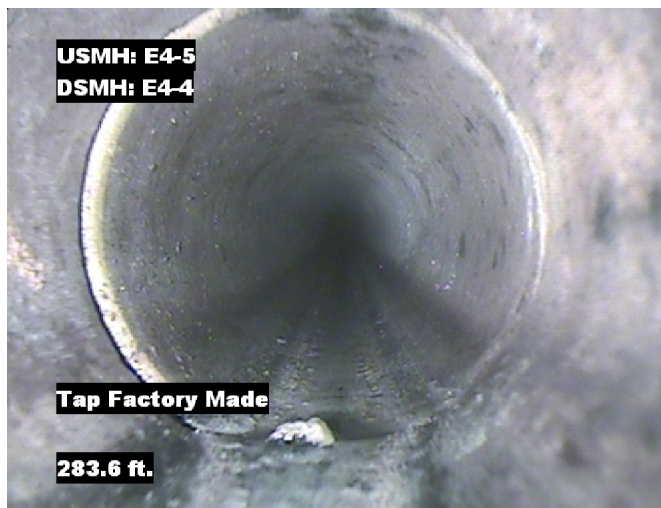
Distance: 283.6 ft. Grade: 0
Condition: Tap Factory Made
Remarks: N/A

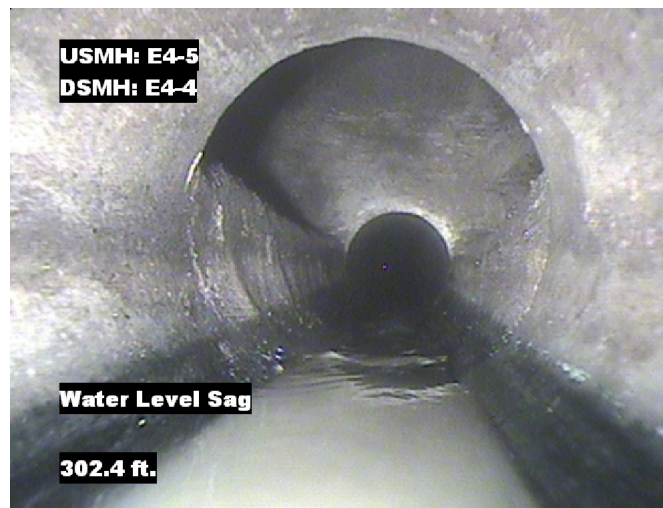
Distance: 302.4 ft. Grade: 2
Condition: Water Level Sag
Remarks: N/A

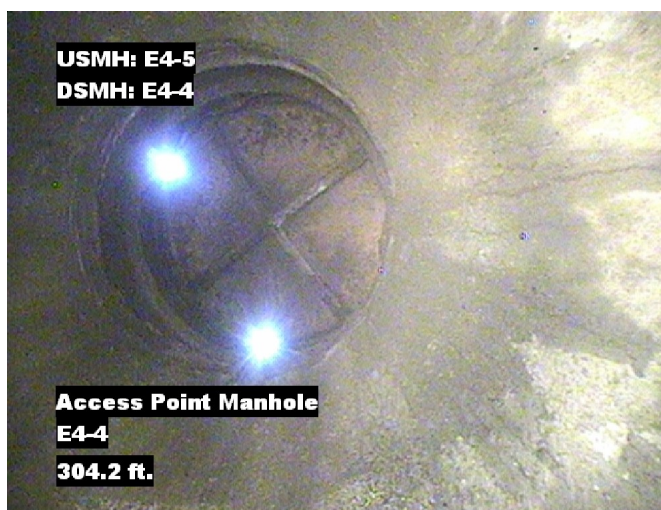
Distance: 304.2 ft. Grade: 0
Condition: Access Point Manhole
Remarks: E4-4
