## Defect Listing

Pipe Segment Refere... <b>E4-6_E4-5</b>	City <b>Oliver Springs</b>	Street <b>Midway</b>	Material <b>Concrete Pipe (non-...</b>	Location C... <b>Light High...</b>	Sewer Use <b>Sanitary</b>
Upstream MH <b>E4-6</b>	Total Length <b>393.4</b>	Year Laid	Shape <b>Circular</b>	Location Details <b>Street</b>	
DS Manhole <b>E4-5</b>	Length surveyed <b>393.4</b>	Year Renewed	Height <b>8</b>	Width <b>8</b>	Pipe Joint... <b>4</b>

SPR <b>N/A</b>	MPR <b>N/A</b>	PO Number <b>4397-03</b>		Customer <b>GRW</b>	
SPRI <b>N/A</b>	MPRI <b>N/A</b>	Work Order <b>4397-02</b>		Purpose <b>Pre-Rehabilitation Survey</b>	
QSR <b>N/A</b>	QMR <b>N/A</b>				
OPR <b>N/A</b>	Surveyed By <b>Barry Rogers</b>	Direction <b>Downstream</b>	Date <b>20150612</b>	Media label	
OPRI <b>N/A</b>	Certificate Number <b>U-1012-16405</b>	Pre-Cleaning <b>Jetting</b>	Time <b>14:06</b>	Weather <b>Dry</b>	
Date Cleaned <b>20150612</b>			End Time <b>14:27</b>	Additional Info

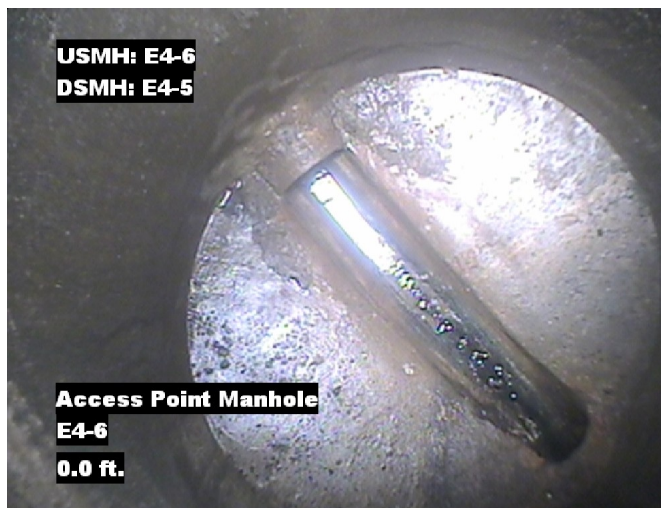
Distance: 0.0 ft. Grade: 0  
Condition: Access Point Manhole  
Remarks: E4-6

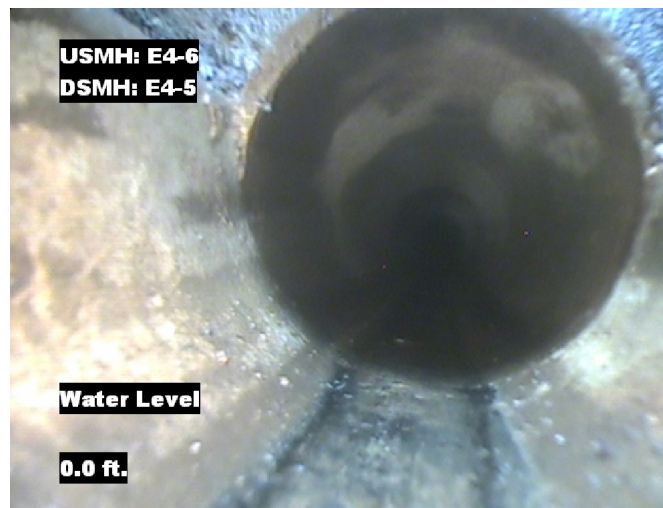
Distance: 0.0 ft. Grade: 0  
Condition: Water Level  
Remarks: N/A

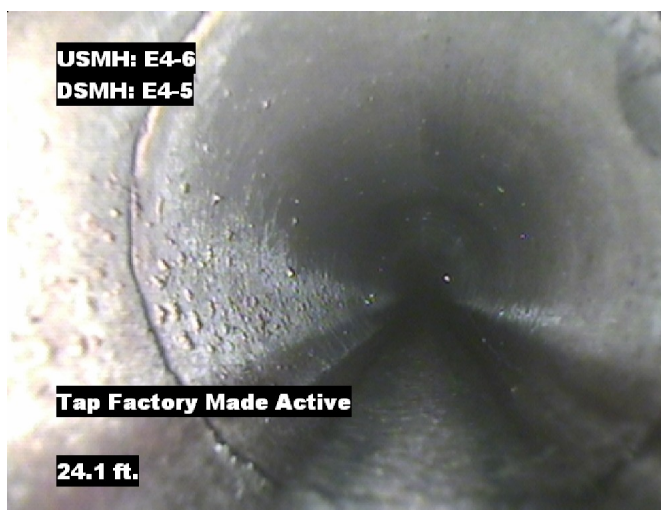
Distance: 24.1 ft. Grade: 0  
Condition: Tap Factory Made Active  
Remarks: N/A

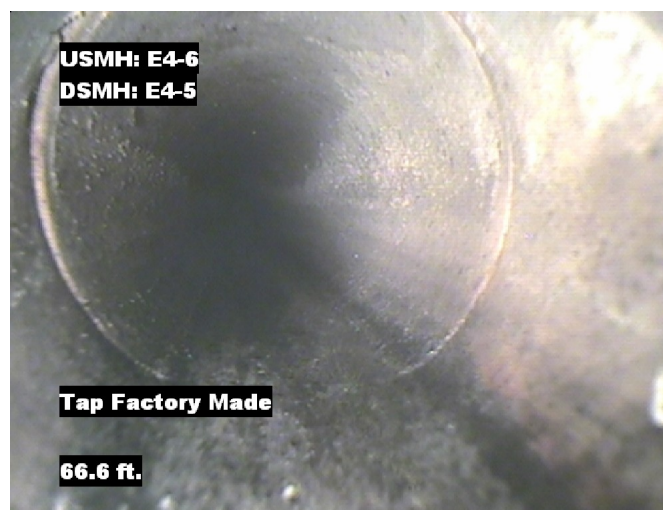
Distance: 66.6 ft. Grade: 0  
Condition: Tap Factory Made  
Remarks: N/A

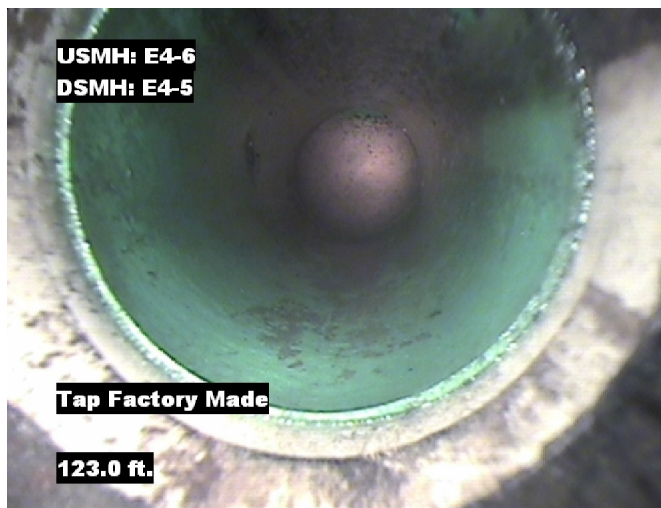
Distance: 123.0 ft. Grade: 0  
Condition: Tap Factory Made  
Remarks: N/A

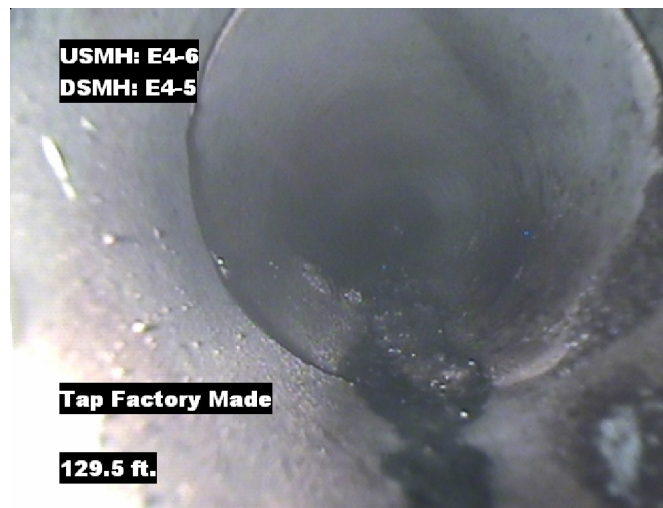
Distance: 129.5 ft. Grade: 0  
Condition: Tap Factory Made  
Remarks: N/A

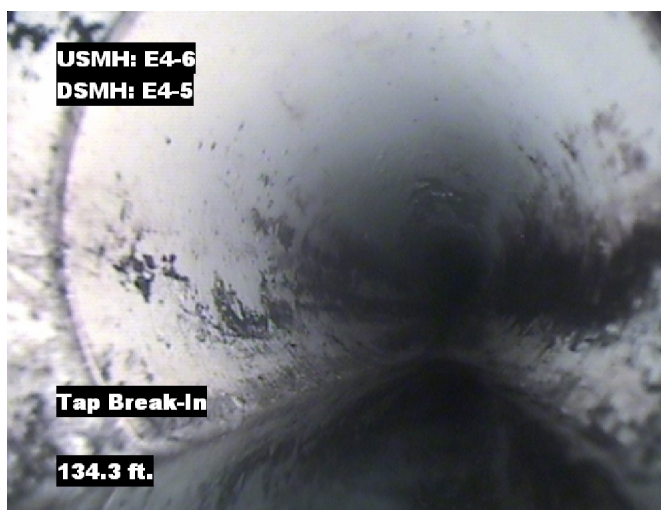
Distance: 134.3 ft. Grade: 0  
Condition: Tap Break-In  
Remarks: N/A

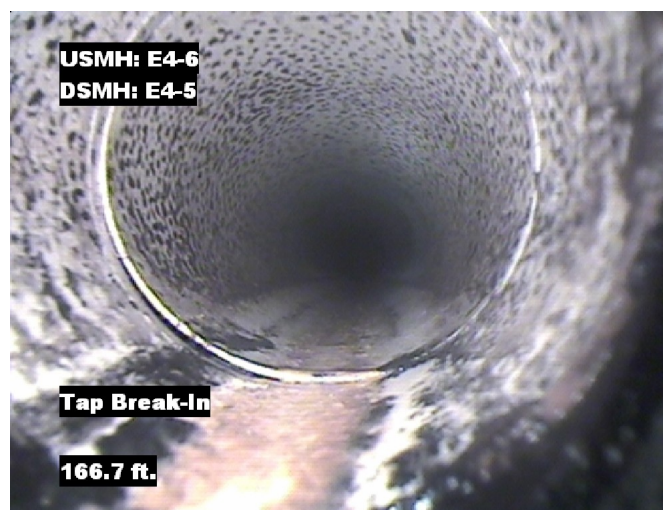
Distance: 166.7 ft. Grade: 0  
Condition: Tap Break-In  
Remarks: N/A

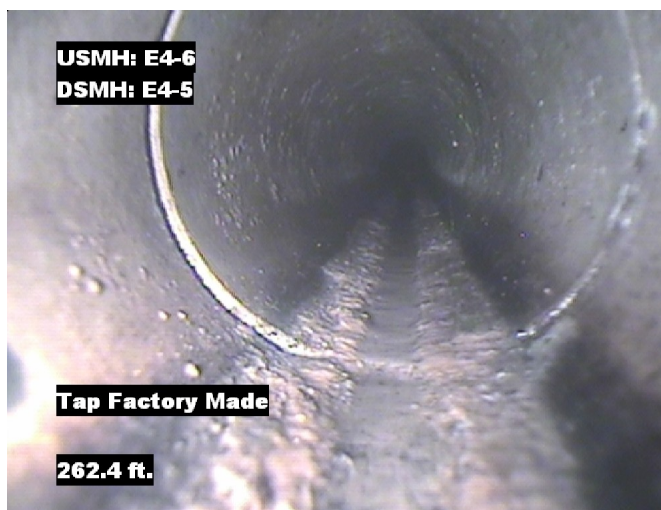
Distance: 262.4 ft. Grade: 0  
Condition: Tap Factory Made  
Remarks: N/A

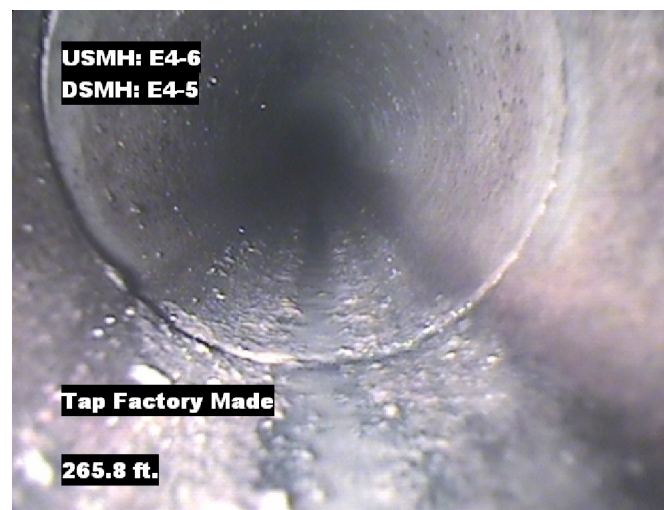
Distance: 265.8 ft. Grade: 0  
Condition: Tap Factory Made  
Remarks: N/A

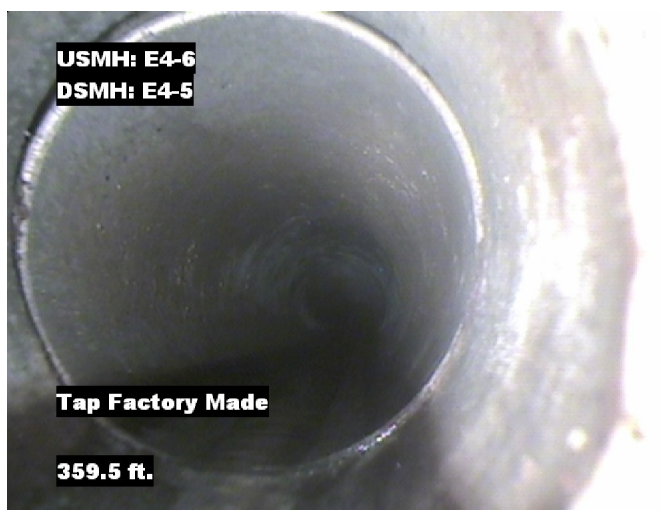
Distance: 359.5 ft. Grade: 0  
Condition: Tap Factory Made  
Remarks: N/A

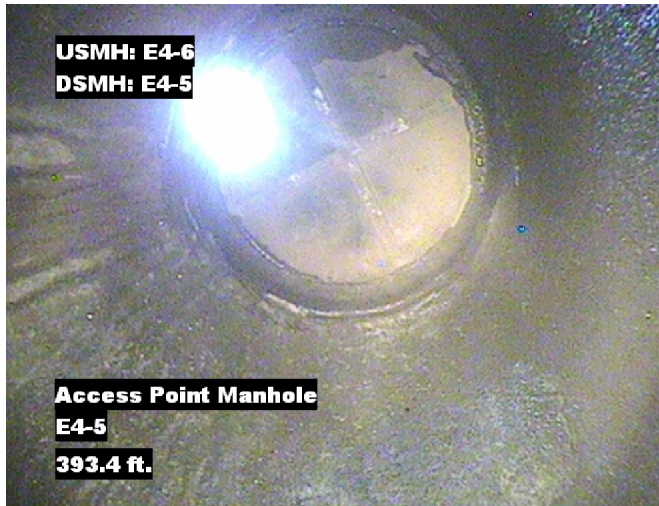
Distance: 393.4 ft. Grade: 0  
Condition: Access Point Manhole  
Remarks: E4-5
