Defect Listing

Pipe Segment Refere... E4-7_E4-6	City Oliver Springs	Street Midway Dr	Material Concrete Pipe (non-...	Location C... Light High...	Sewer Use Sanitary
Upstream MH E4-7	Total Length 160.4	Year Laid	Shape Circular	Location Details Street	
DS Manhole E4-6	Length surveyed 160.4	Year Renewed	Height 8	Width 8	Pipe Joint... 4

SPR N/A	MPR N/A	PO Number 4397-03	Customer GRW
SPRI N/A	MPRI N/A	Work Order 4397-02	Purpose Pre-Rehabilitation Survey
QSR N/A	QMR N/A		
OPR N/A	Surveyed By Barry Rogers	Direction Downstream	Date 20150612
OPRI N/A	Certificate Number U-1012-16405	Pre-Cleaning Jetting	Time 13:01
	Date Cleaned 20150612	End Time 13:11	Weather Dry
			Additional Info

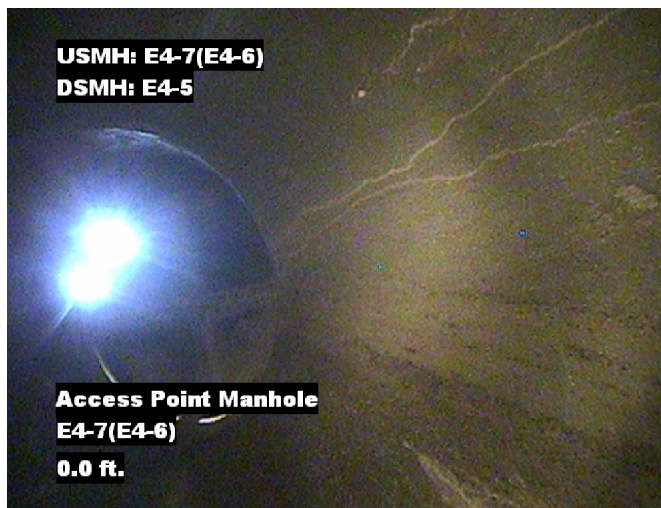
Distance: 0.0 ft. Grade: 0
Condition: Access Point Manhole
Remarks: E4-7

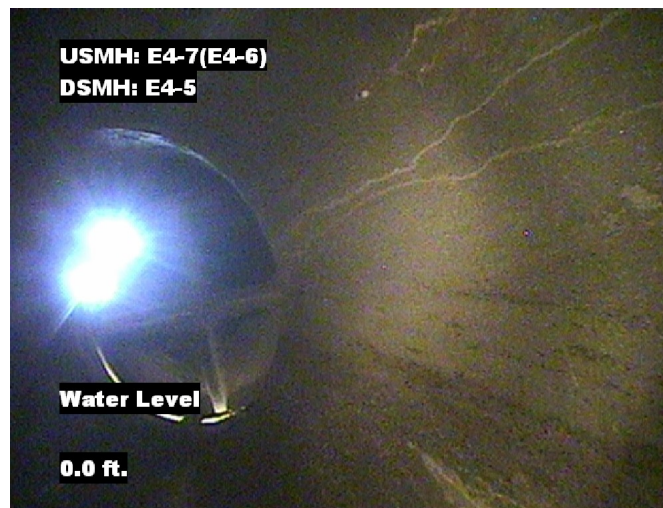
Distance: 0.0 ft. Grade: 0
Condition: Water Level
Remarks: N/A

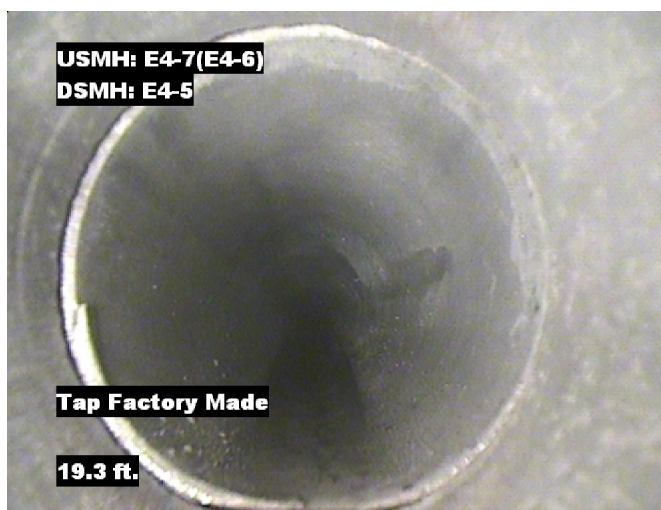
Distance: 19.3 ft. Grade: 0
Condition: Tap Factory Made
Remarks: N/A

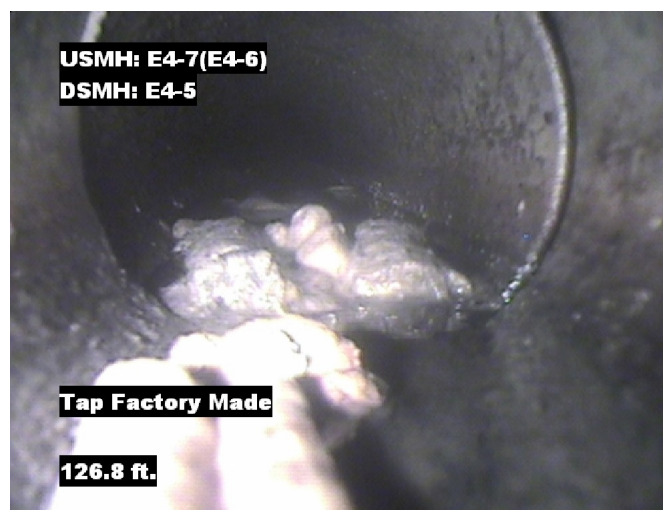
Distance: 126.8 ft. Grade: 0
Condition: Tap Factory Made
Remarks: N/A

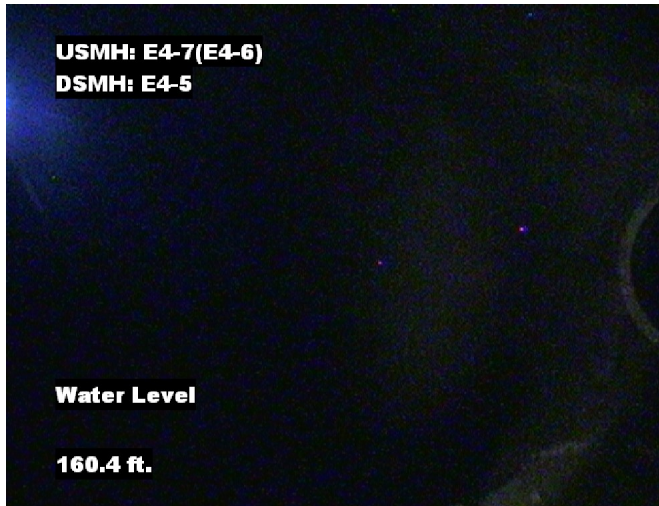
Distance: 160.4 ft. Grade: 0
Condition: Water Level
Remarks: N/A

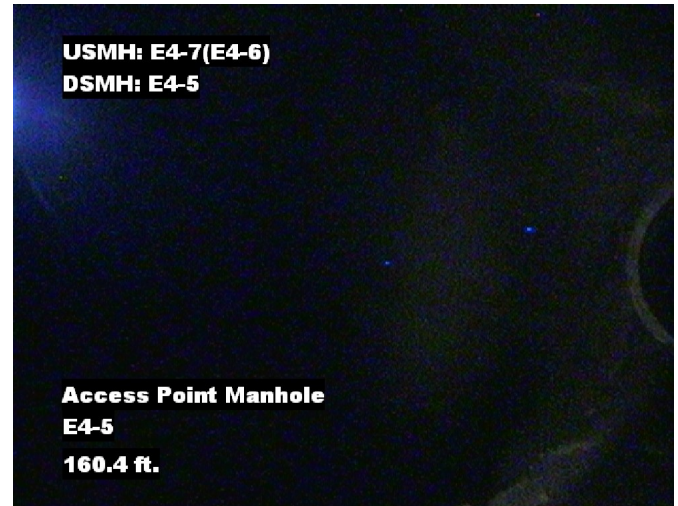
Distance: 160.4 ft. Grade: 0
Condition: Access Point Manhole
Remarks: E4-6
