## Defect Listing

Pipe Segment Refere... <b>E4-8_E4-7</b>	City <b>Oliver Springs</b>	Street <b>Midway Dr</b>	Material <b>Concrete Pipe (non-...</b>	Location C... <b>Light High...</b>	Sewer Use <b>Sanitary</b>
Upstream MH <b>E4-8</b>	Total Length <b>114.4</b>	Year Laid	Shape <b>Circular</b>	Location Details <b>Street</b>	
DS Manhole <b>E4-7</b>	Length surveyed <b>114.4</b>	Year Renewed	Height <b>8</b>	Width <b>8</b>	Pipe Joint... <b>4</b>

SPR <b>N/A</b>	MPR <b>2</b>	PO Number <b>4397-03</b>	Customer <b>GRW</b>
SPRI <b>N/A</b>	MPRI <b>2</b>	Work Order <b>4397-02</b>	Purpose <b>Pre-Rehabilitation Survey</b>
QSR <b>N/A</b>	QMR <b>2100</b>		
OPR <b>2</b>	Surveyed By <b>Barry Rogers</b>	Direction <b>Downstream</b>	Date <b>20150612</b>
OPRI <b>2</b>	Certificate Number <b>U-1012-16405</b>	Pre-Cleaning <b>Jetting</b>	Time <b>12:50</b>
	Date Cleaned <b>20150612</b>	End Time <b>12:58</b>	Weather <b>Dry</b>
			Additional Info

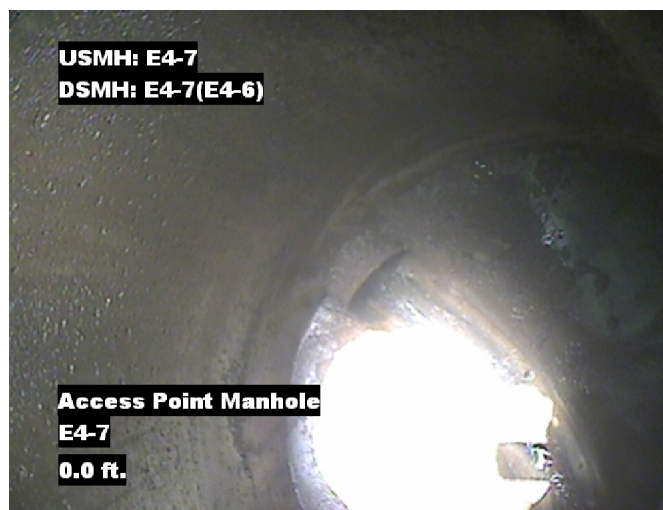
Distance: 0.0 ft. Grade: 0  
Condition: Access Point Manhole  
Remarks: E4-8

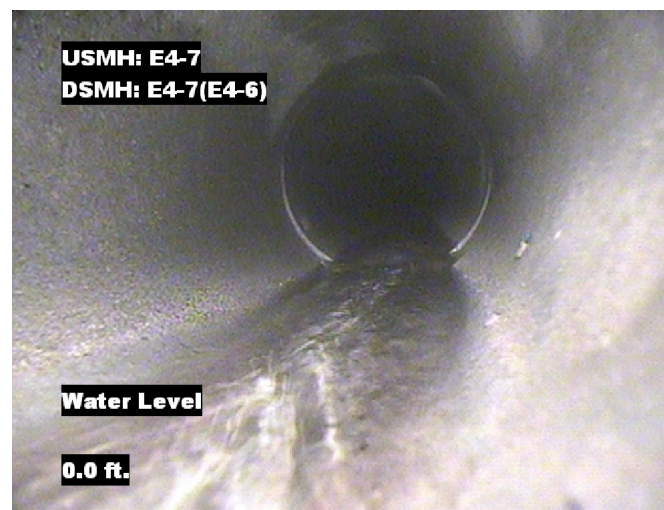
Distance: 0.0 ft. Grade: 0  
Condition: Water Level  
Remarks: N/A

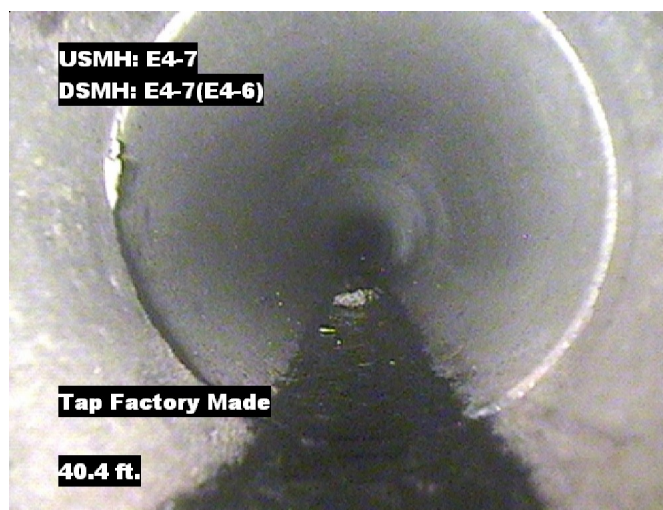
Distance: 40.4 ft. Grade: 0  
Condition: Tap Factory Made  
Remarks: N/A

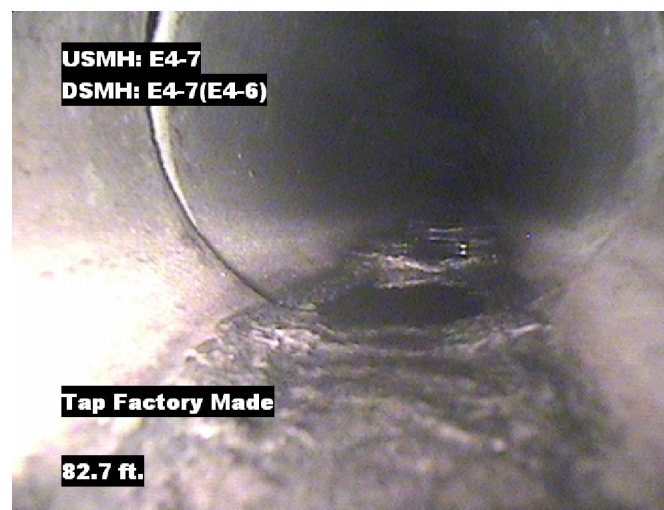
Distance: 82.7 ft. Grade: 0  
Condition: Tap Factory Made  
Remarks: N/A

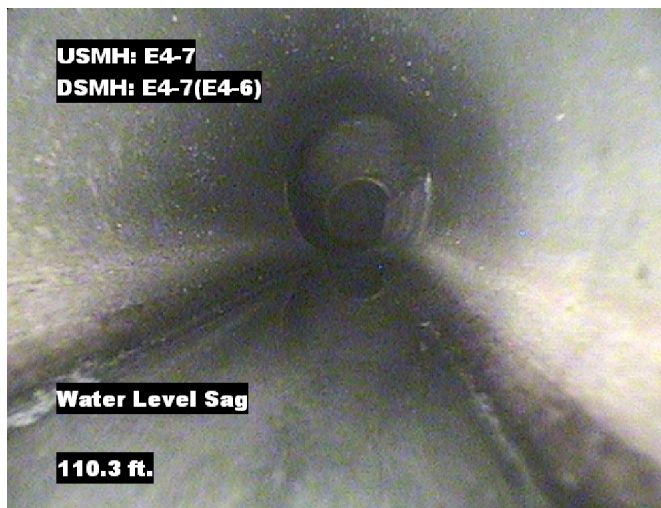
Distance: 110.2 ft.      Grade: 2  
Condition: Water Level Sag  
Remarks: N/A

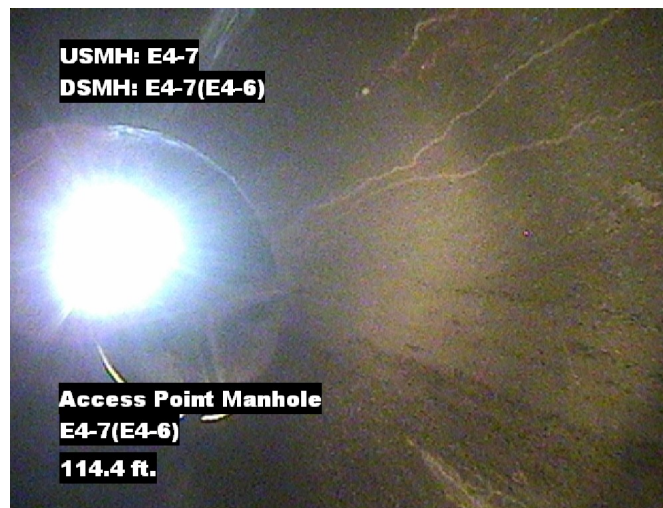
Distance: 114.4 ft.      Grade: 0  
Condition: Access Point Manhole  
Remarks: E4-7
