Defect Listing

Pipe Segment Refere... E5-1_E4-5	City Oliver Springs	Street Ridge View	Material Concrete Pipe (non-...		Location C... Light High...	Sewer Use Sanitary
Upstream MH E5-1	Total Length 344.7	Year Laid	Shape Circular		Location Details Street	
DS Manhole E4-5	Length surveyed 344.7	Year Renewed	Height 8	Width 8	Pipe Joint... 4

SPR	N/A	MPR	N/A	PO Number 4397-03	Customer GRW
SPRI	N/A	MPRI	N/A	Work Order 4397-02	Purpose Pre-Rehabilitation Survey
QSR	N/A	QMR	N/A		
OPR N/A	Surveyed By Barry Rogers	Direction Downstream	Date 20150612		Media label
OPRI N/A	Certificate Number U-1012-16405	Pre-Cleaning Jetting	Time 10:51		Weather Dry
Date Cleaned 20150612			End Time 11:09		Additional Info

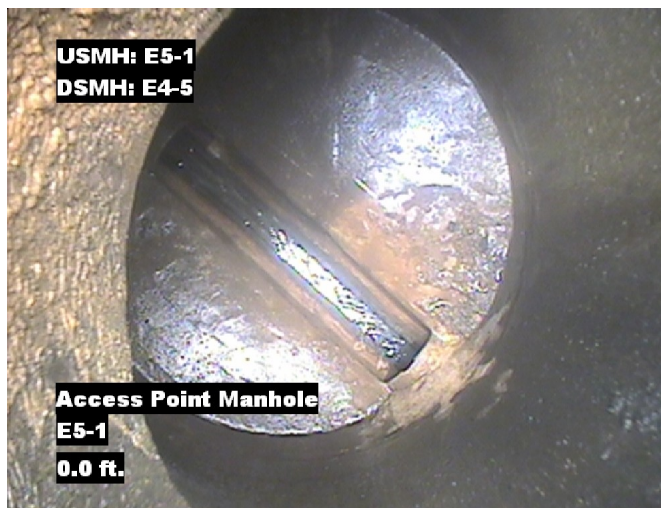
Distance: 0.0 ft. Grade: 0
Condition: Access Point Manhole
Remarks: E5-1

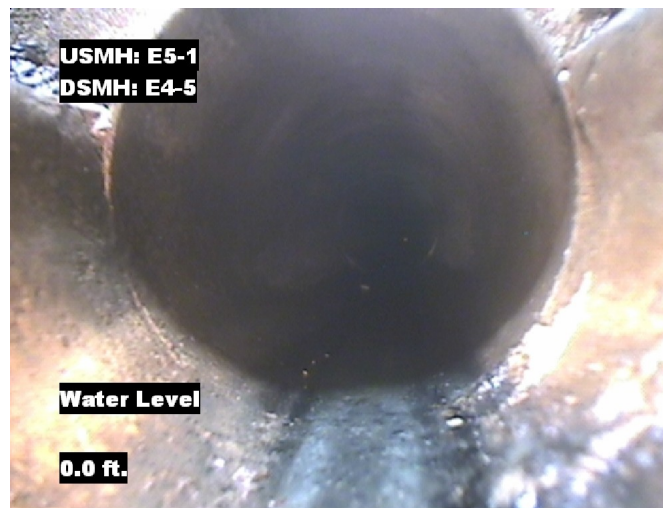
Distance: 0.0 ft. Grade: 0
Condition: Water Level
Remarks: N/A

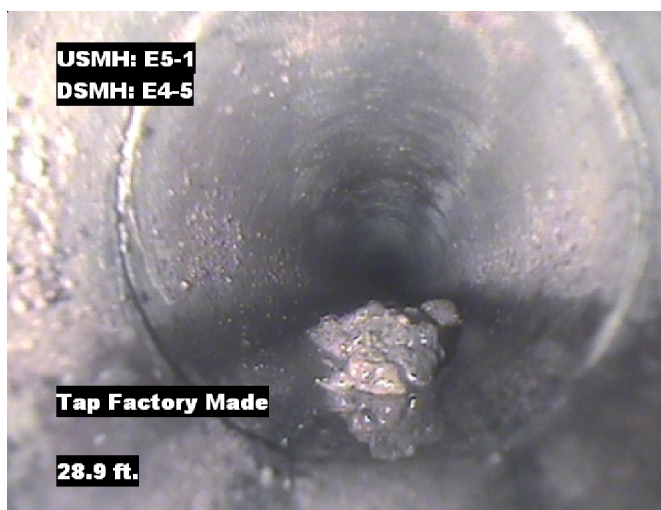
Distance: 28.9 ft. Grade: 0
Condition: Tap Factory Made
Remarks: N/A

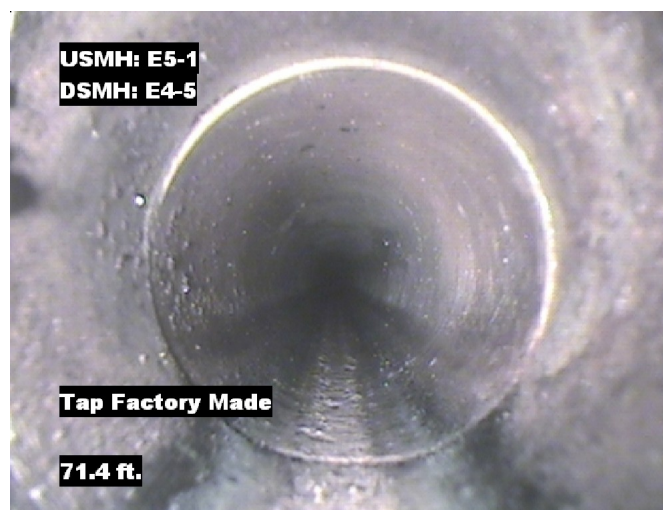
Distance: 71.4 ft. Grade: 0
Condition: Tap Factory Made
Remarks: N/A

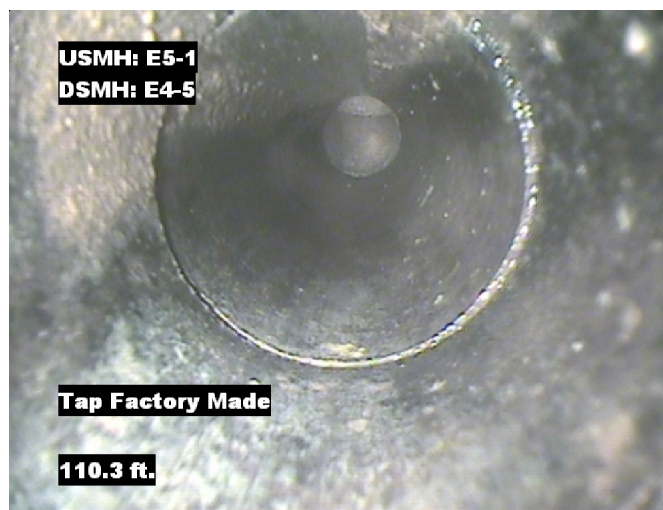
Distance: 110.3 ft. Grade: 0
Condition: Tap Factory Made
Remarks: N/A

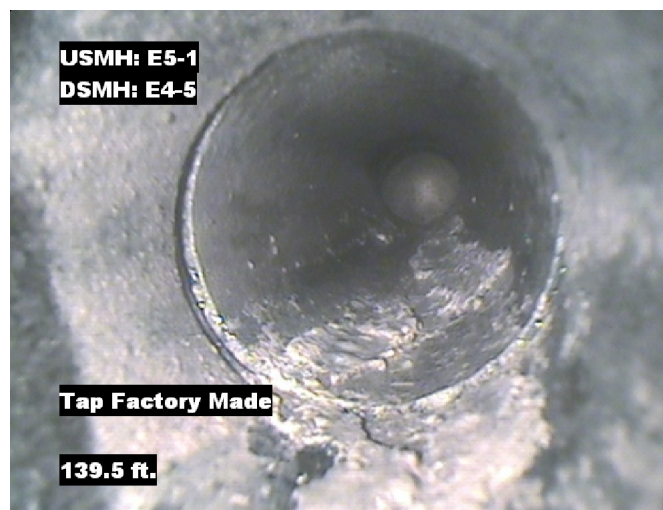
Distance: 139.5 ft. Grade: 0
Condition: Tap Factory Made
Remarks: N/A

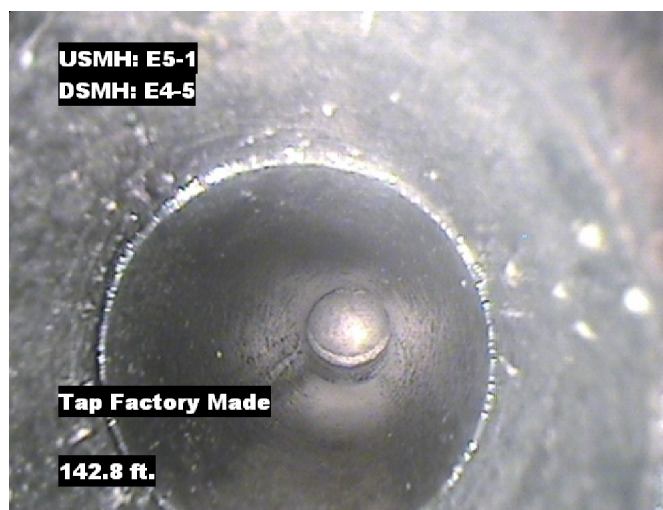
Distance: 142.8 ft. Grade: 0
Condition: Tap Factory Made
Remarks: N/A

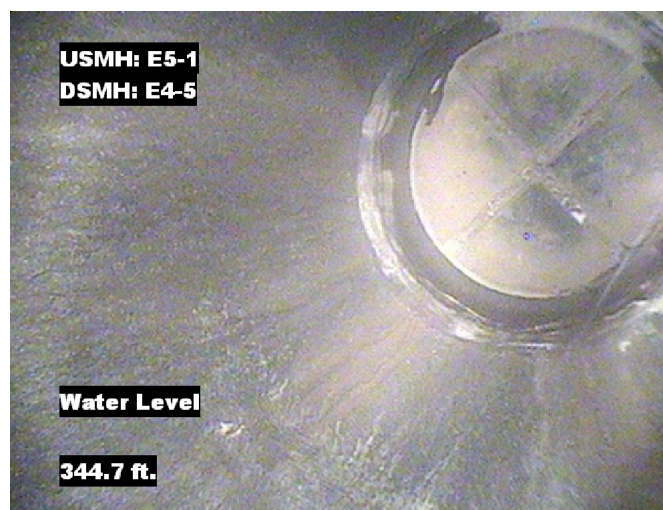
Distance: 344.7 ft. Grade: 0
Condition: Water Level
Remarks: N/A

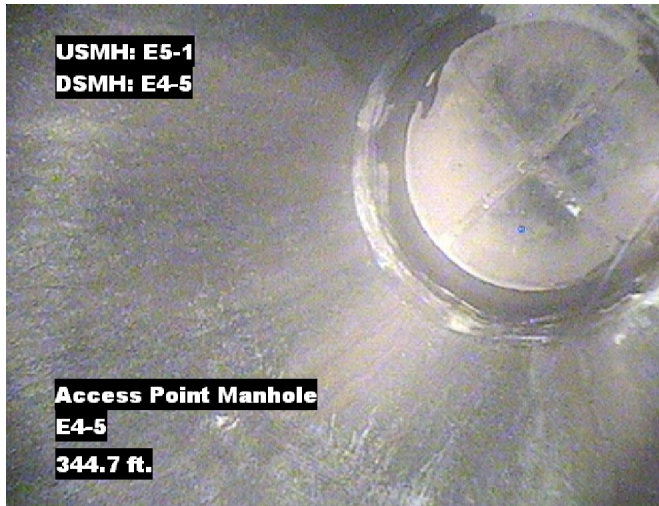
Distance: 344.7 ft. Grade: 0
Condition: Access Point Manhole
Remarks: E4-5
