## **Defect Listing**

Pipe Segment Refere		С	ity	Street	Mat	erial	Location C	Sewer Use	
E5-2	_E5-1	Oliver	Springs	Ridgeview dr	Concrete F	Concrete Pipe (non		Sanitary	
Upstre	am MH	Total I	_ength	Year Laid	Sh	Shape Location D		Details	
E5	5-2	12	0.7		Circ	ular	lar Street		
DS Ma	anhole	Length s	surveyed	Year Renewed	Height	Width	Width Pipe Joint		
E5	5-1	12	0.7		8	8	4		
SPR	N/A	MPR	4	PO Number			Customer		
				<b>4397-03</b> Work Order		GRW			
SPRI	N/A	MPRI	2			Purpose			
QSR	N/A	QMR	2200	4397-02		Pre-	Pre-Rehabilitation Survey		
Ol	PR	Surve	yed By	Direction	Da	Date Media label		label	
4	4	Barry_	Rogers	Downstream 20150612					
OF	PRI	Certificate Number		Pre-Cleaning	Time		Weather		
2		U-1012-16405		Jetting	10:23		Dry		
		Date C	leaned	E		End Time		Additional Info	
		2015	0612		10:31

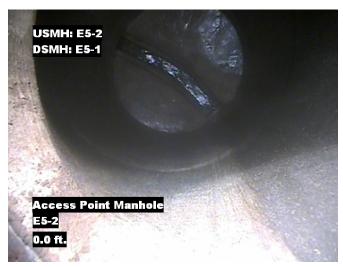
Distance: 0.0 ft. Grade: (

Condition: Access Point Manhole

Remarks: E5-2

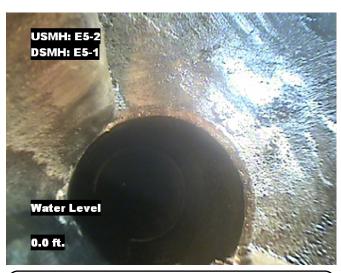
Distance: 0.0 ft. Grade: 0

Condition: Water Level

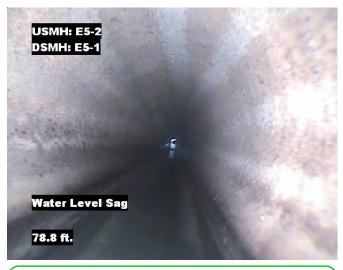
Distance: 78.8 ft. Grade: 2

Condition: Water Level Sag

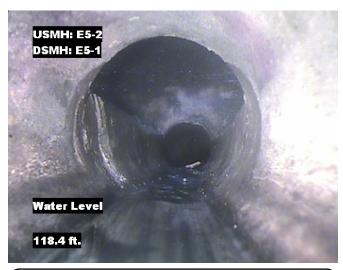
Distance: 118.4 ft. Grade: 0

Condition: Water Level

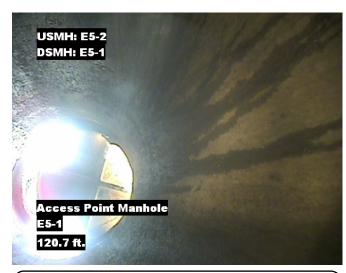
Distance: 120.7 ft. Grade:

Condition: Access Point Manhole

Remarks: E5-1
