### Defect Listing

Pipe Segment Refere... <b>E5-3_E5-2</b>	City <b>Oliver Springs</b>	Street <b>Ridge View Dr</b>	Material <b>Concrete Pipe (non-...</b>	Location C... <b>Light High...</b>	Sewer Use <b>Sanitary</b>
Upstream MH <b>E5-3</b>	Total Length <b>290.7</b>	Year Laid	Shape <b>Circular</b>	Location Details <b>Street</b>	
DS Manhole <b>E5-2</b>	Length surveyed <b>290.7</b>	Year Renewed	Height <b>8</b>	Width <b>8</b>	Pipe Joint... <b>4</b>

SPR <b>2</b>	MPR <b>21</b>	PO Number <b>4397-03</b>		Customer <b>GRW</b>	
SPRI <b>2</b>	MPRI <b>2.3</b>	Work Order <b>4397-02</b>		Purpose <b>Pre-Rehabilitation Survey</b>	
QSR <b>2100</b>	QMR <b>4226</b>	Direction <b>Downstream</b>	Date <b>20150612</b>	Media label	
OPR <b>23</b>	Surveyed By <b>Barry_Rogers</b>	Pre-Cleaning <b>Jetting</b>	Time <b>09:38</b>	Weather <b>Dry</b>	
OPRI <b>2.3</b>	Certificate Number <b>U-1012-16405</b>	Date Cleaned <b>20150612</b>	End Time <b>09:57</b>	Additional Info

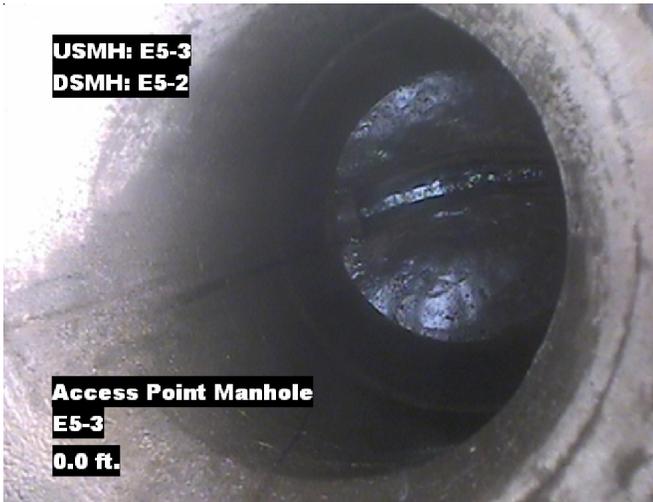
Distance: 0.0 ft.      Grade: 0  
Condition: Access Point Manhole  
Remarks: E5-3

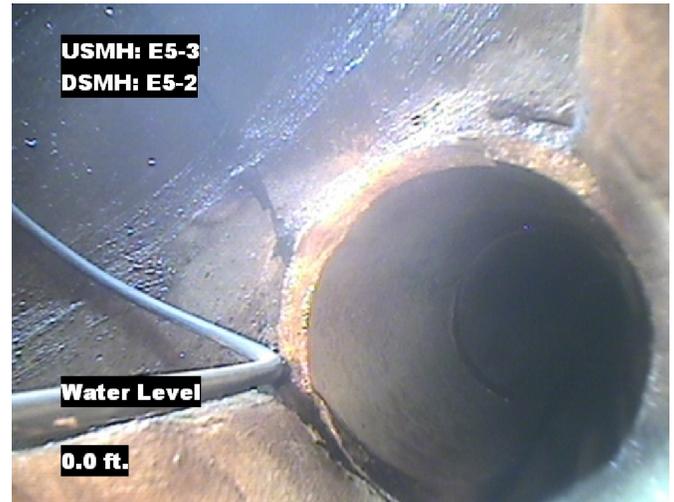
Distance: 0.0 ft.      Grade: 0  
Condition: Water Level  
Remarks: N/A

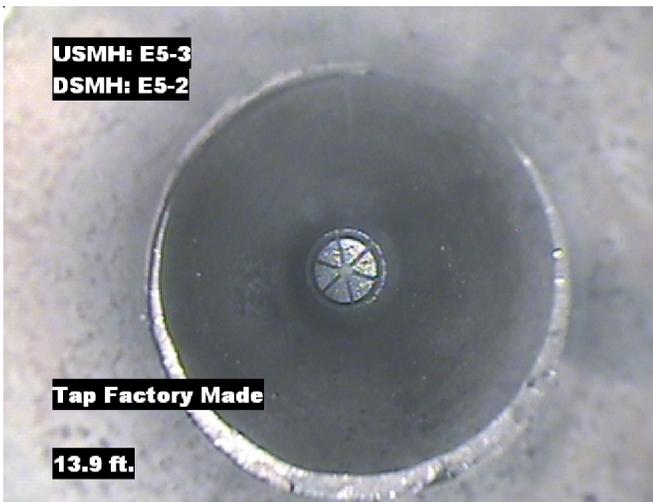
Distance: 13.9 ft.      Grade: 0  
Condition: Tap Factory Made  
Remarks: N/A

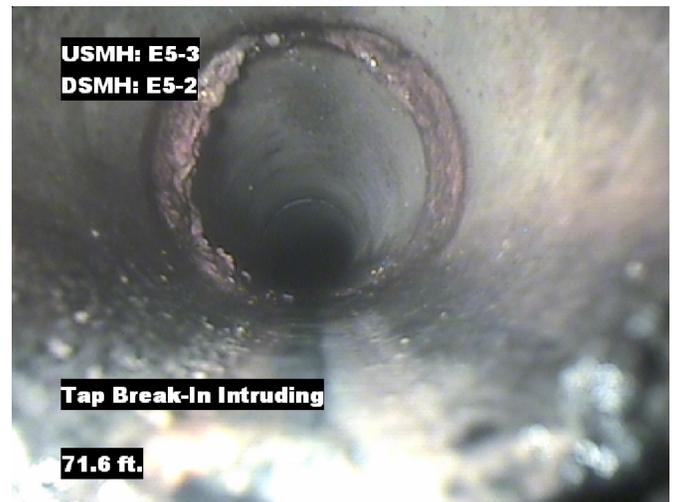
Distance: 71.6 ft.      Grade: 2  
Condition: Tap Break-In Intruding  
Remarks: N/A

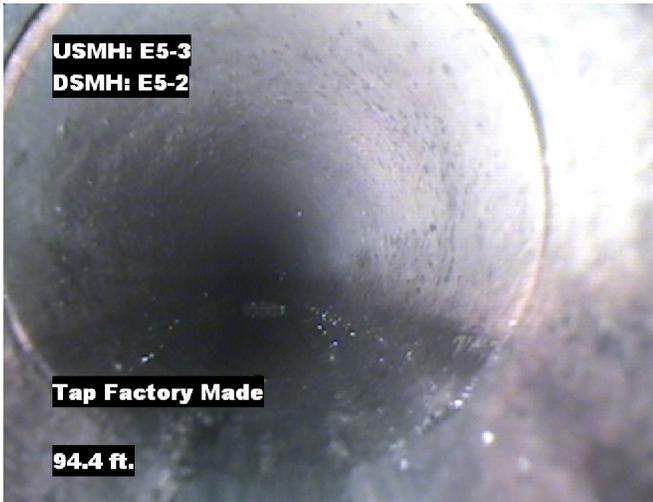
Distance: 94.4 ft.      Grade: 0  
 Condition: Tap Factory Made  
 Remarks: N/A

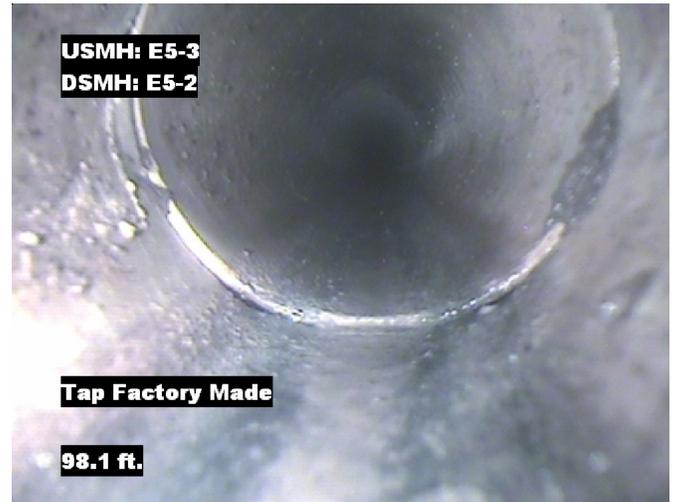
Distance: 98.1 ft.      Grade: 0  
 Condition: Tap Factory Made  
 Remarks: N/A

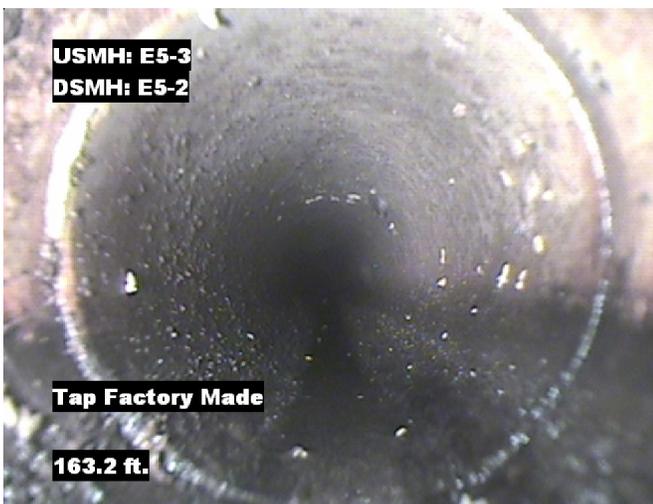
Distance: 163.2 ft.      Grade: 0  
 Condition: Tap Factory Made  
 Remarks: N/A

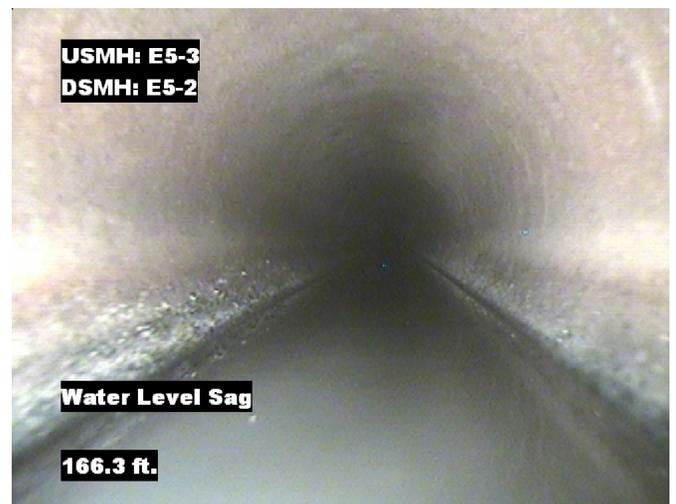
Distance: 166.3 ft.      Grade: 2  
 Condition: Water Level Sag  
 Remarks: N/A

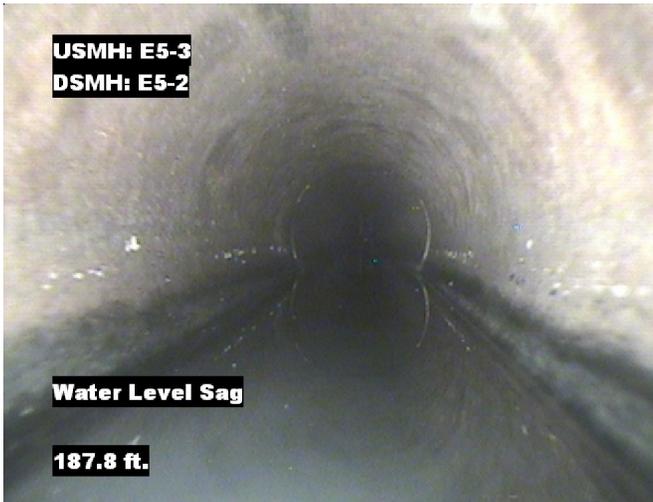
Distance: 187.8 ft.      Grade: 2  
 Condition: Water Level Sag  
 Remarks: N/A

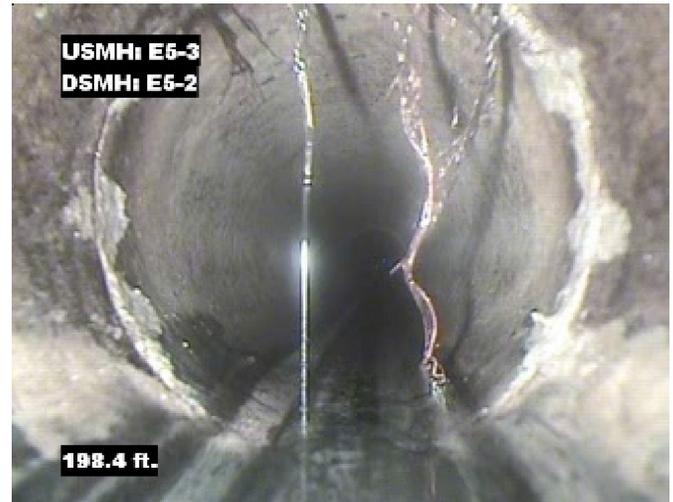
Distance: 198.4 ft.      Grade: 0  
 Condition: Infiltration Stain  
 Remarks: N/A

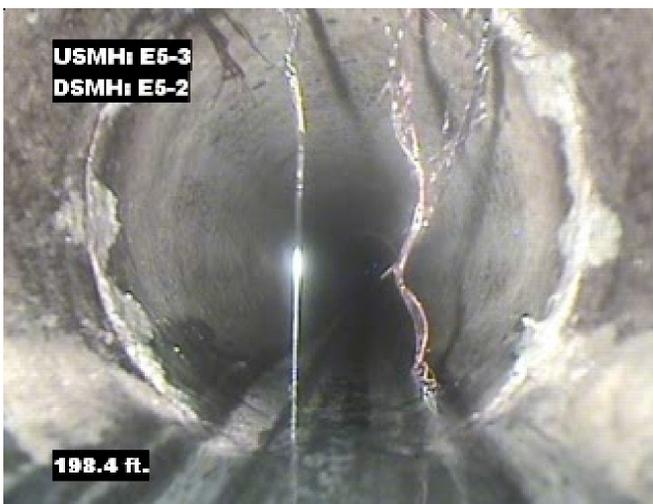
Distance: 198.4 ft.      Grade: 2  
 Condition: Surface Spalling  
 Remarks: N/A

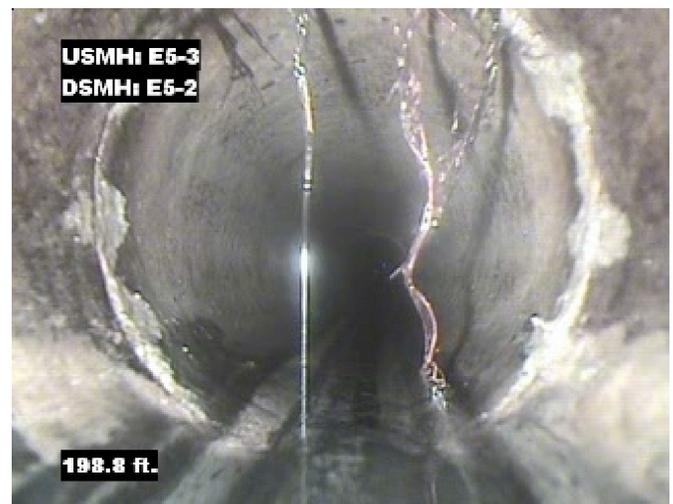
Distance: 198.8 ft.      Grade: 1  
 Condition: Roots Fine Joint  
 Remarks: N/A

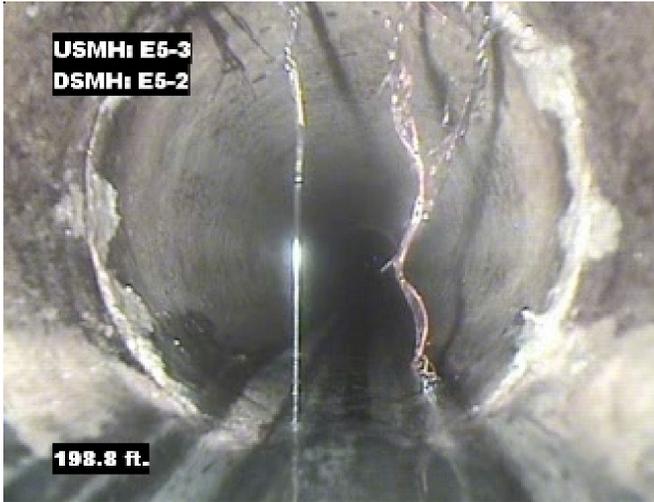
Distance: 198.8 ft.      Grade: 4  
 Condition: Infiltration Runner  
 Remarks: N/A

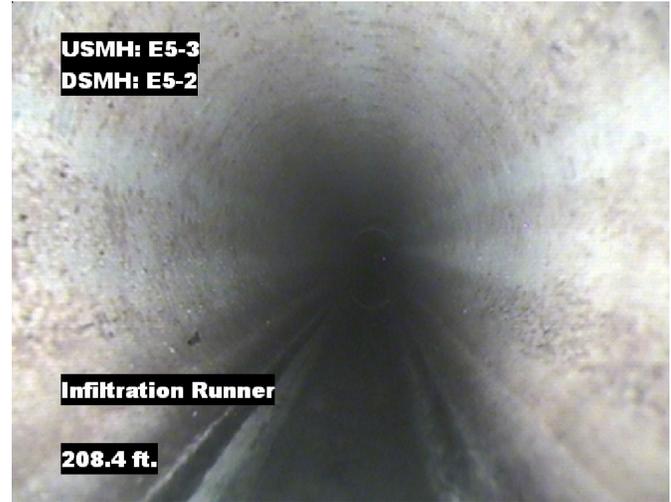
Distance: 208.4 ft.      Grade: 4  
 Condition: Infiltration Runner  
 Remarks: N/A

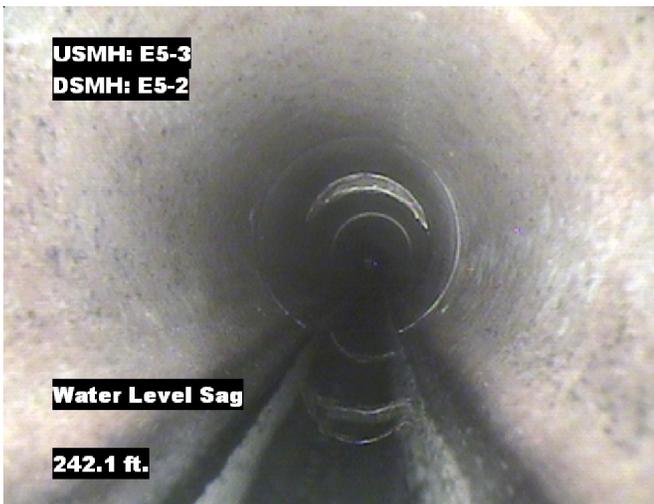
Distance: 242.1 ft.      Grade: 2  
 Condition: Water Level Sag  
 Remarks: N/A

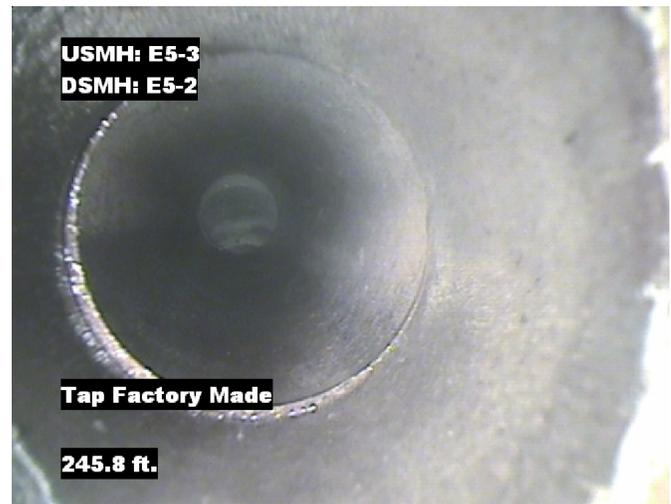
Distance: 245.8 ft.      Grade: 0  
 Condition: Tap Factory Made  
 Remarks: N/A

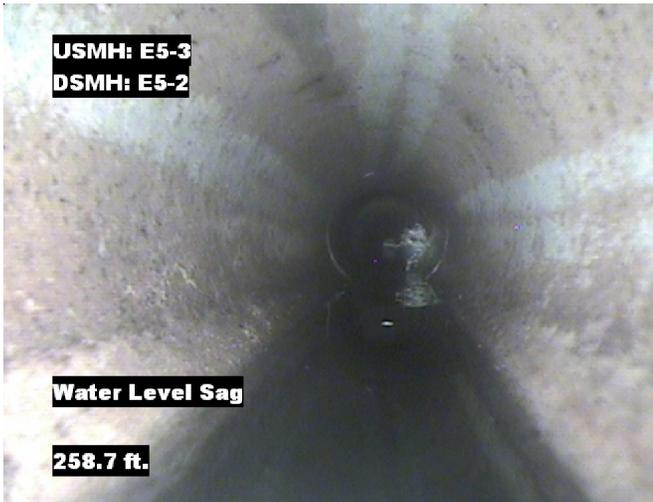
Distance: 258.7 ft.      Grade: 2  
 Condition: Water Level Sag  
 Remarks: N/A

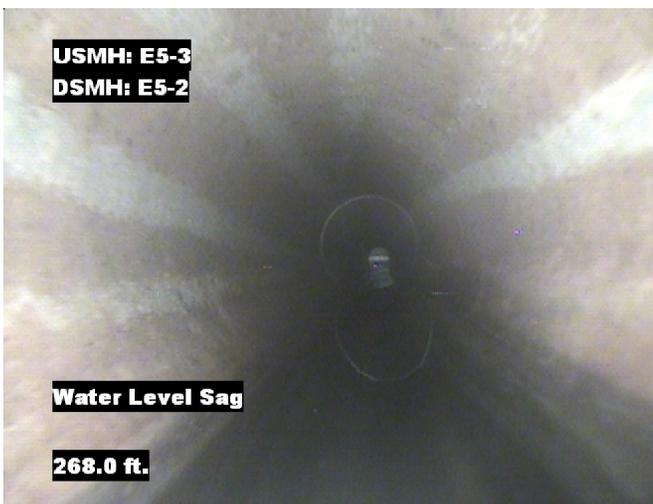
Distance: 267.9 ft.      Grade: 2  
 Condition: Water Level Sag  
 Remarks: N/A

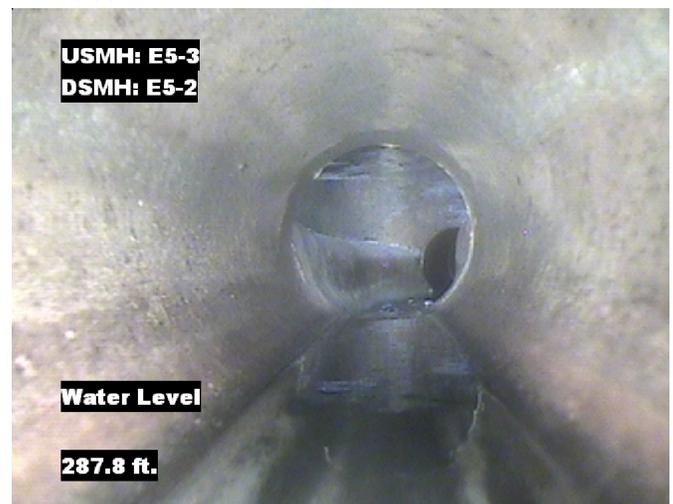
Distance: 287.8 ft.      Grade: 0  
 Condition: Water Level  
 Remarks: N/A

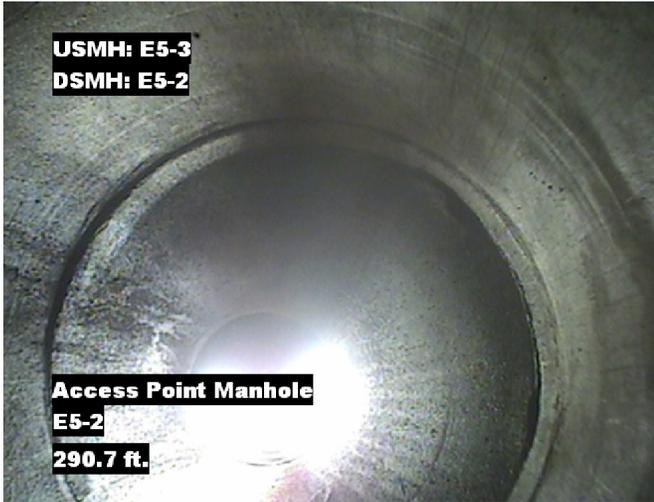
Distance:	290.7 ft.	Grade:	0
Condition:	Access Point Manhole		
Remarks:	E5-2
