Defect Listing

Pipe Segment Refere... E5-4_E5-3	City Oliver Springs	Street Ridgeview	Material Concrete Pipe (non-...	Location C... Light High...	Sewer Use Sanitary
Upstream MH E5-4	Total Length 258.3	Year Laid	Shape Circular	Location Details Street	
DS Manhole E5-3	Length surveyed 258.3	Year Renewed	Height 8	Width 8	Pipe Joint... 4

SPR N/A	MPR N/A	PO Number 4397-03	Customer GRW
SPRI N/A	MPRI N/A	Work Order 4397-02	Purpose Pre-Rehabilitation Survey
QSR N/A	QMR N/A		
OPR N/A	Surveyed By Barry Rogers	Direction Downstream	Date 20150612
OPRI N/A	Certificate Number U-1012-16405	Pre-Cleaning Jetting	Time 09:11
	Date Cleaned 20150612	End Time 09:24	Weather Dry
			Additional Info

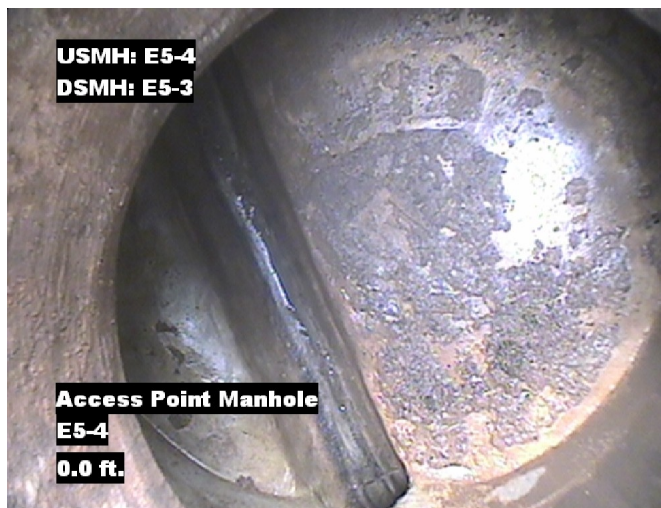
Distance: 0.0 ft. Grade: 0
Condition: Access Point Manhole
Remarks: E5-4

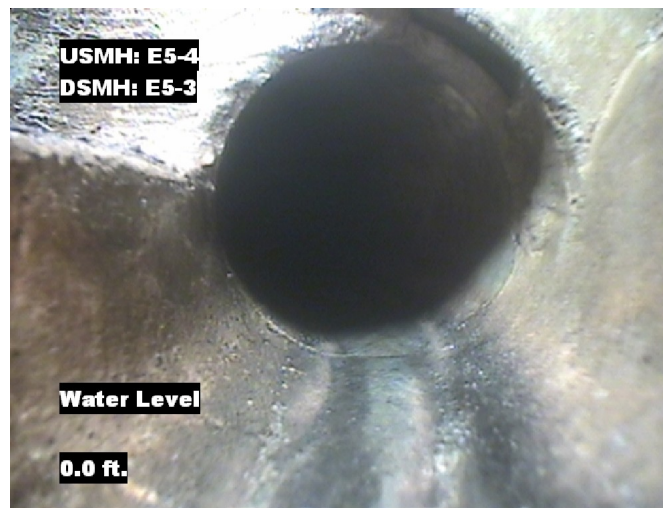
Distance: 0.0 ft. Grade: 0
Condition: Water Level
Remarks: N/A

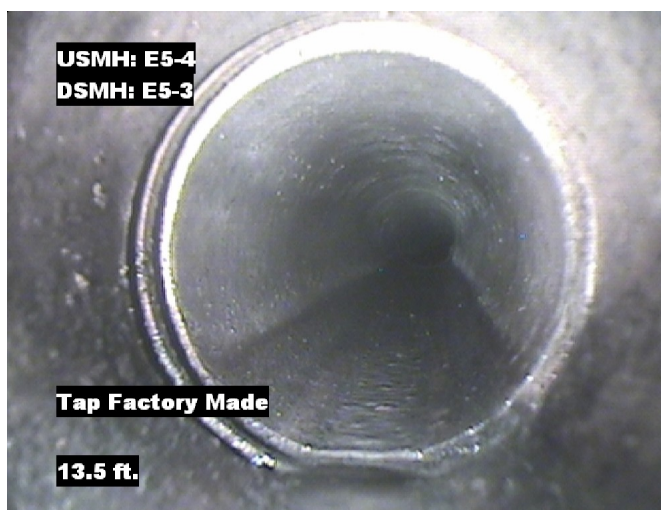
Distance: 13.5 ft. Grade: 0
Condition: Tap Factory Made
Remarks: N/A

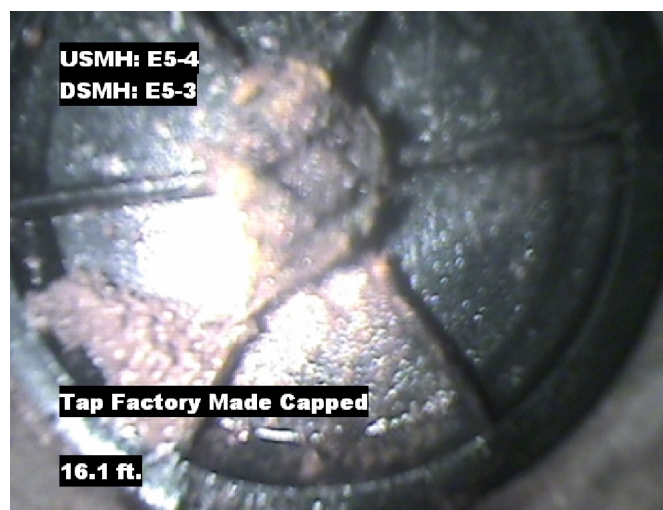
Distance: 16.1 ft. Grade: 0
Condition: Tap Factory Made Capped
Remarks: N/A

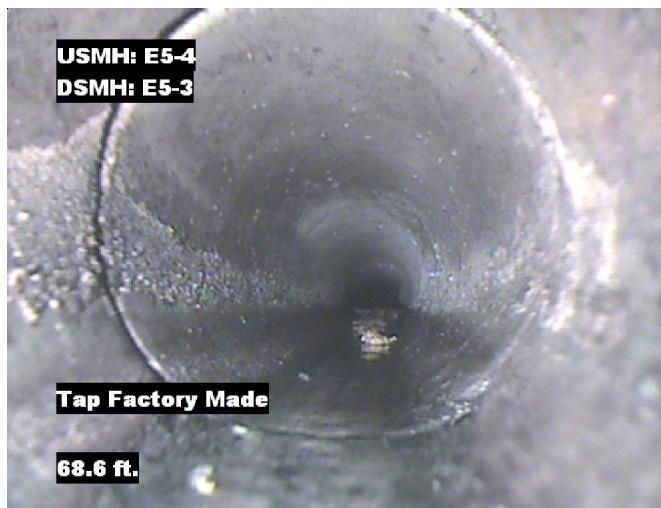
Distance: 68.6 ft. Grade: 0
Condition: Tap Factory Made
Remarks: N/A

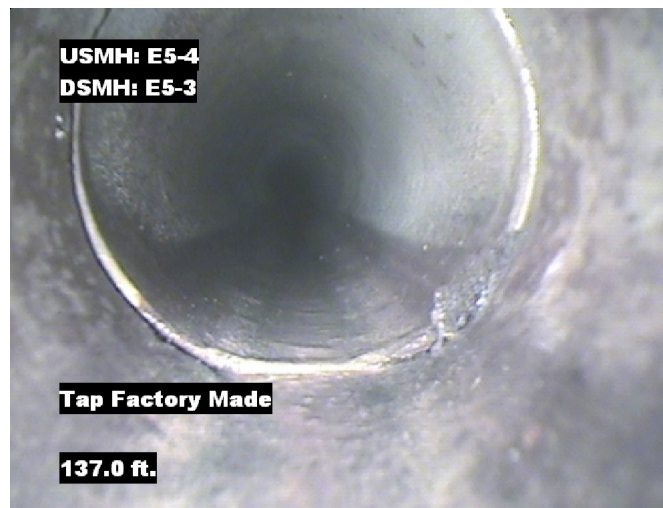
Distance: 137.0 ft. Grade: 0
Condition: Tap Factory Made
Remarks: N/A

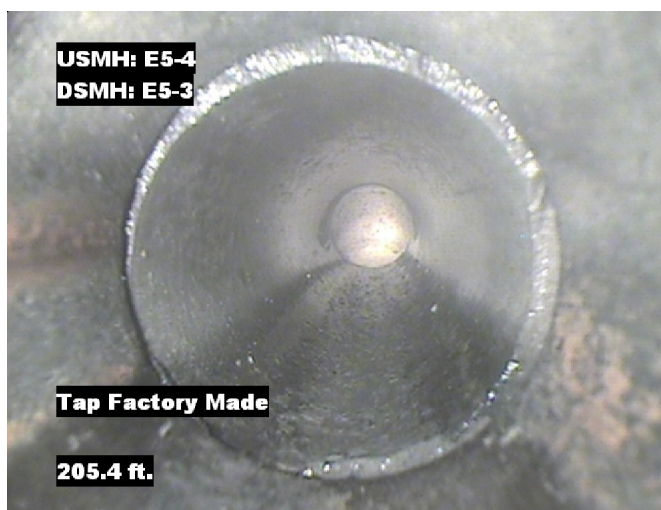
Distance: 205.4 ft. Grade: 0
Condition: Tap Factory Made
Remarks: N/A

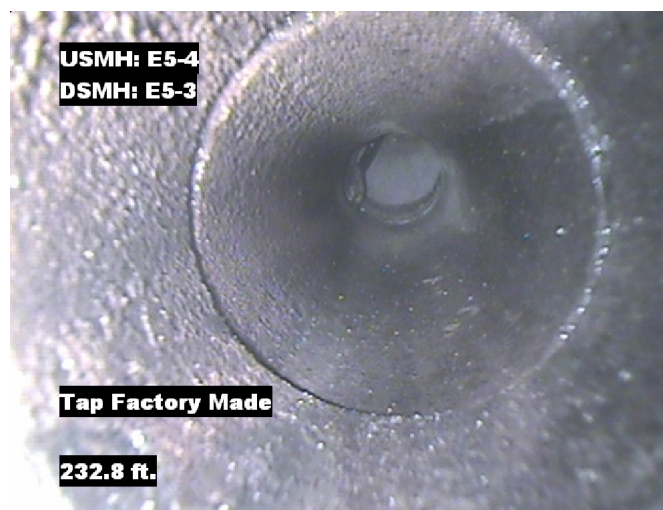
Distance: 232.8 ft. Grade: 0
Condition: Tap Factory Made
Remarks: N/A

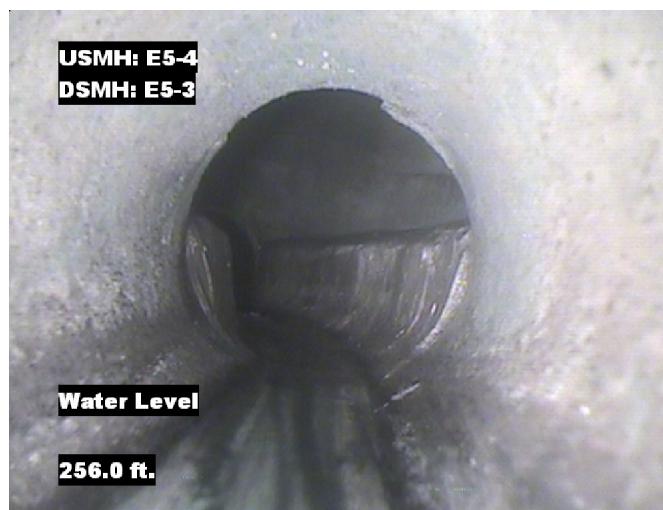
Distance: 256.0 ft. Grade: 0
Condition: Water Level
Remarks: N/A

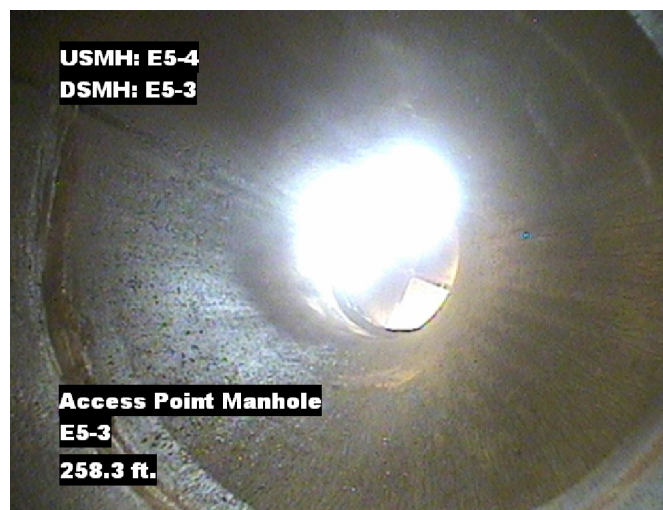
Distance: 258.3 ft. Grade: 0
Condition: Access Point Manhole
Remarks: E5-3
