Defect Listing

Pipe Segment Refere... E5-5_E5-4	City Oliver Springs	Street Ridgeview Dr	Material Concrete Pipe (non-...	Location C... Light High...	Sewer Use Sanitary
Upstream MH E5-5	Total Length 92.9	Year Laid	Shape Circular	Location Details Street	
DS Manhole E5-4	Length surveyed 92.9	Year Renewed	Height 8	Width 8	Pipe Joint... 4

SPR N/A	MPR N/A	PO Number 4397-03		Customer GRW	
SPRI N/A	MPRI N/A	Work Order 4397-02		Purpose Pre-Rehabilitation Survey	
QSR N/A	QMR N/A				
OPR N/A	Surveyed By Barry Rogers	Direction Downstream	Date 20150612	Media label	
OPRI N/A	Certificate Number U-1012-16405	Pre-Cleaning Jetting	Time 08:40	Weather Dry	
Date Cleaned 20150612			End Time 08:45	Additional Info

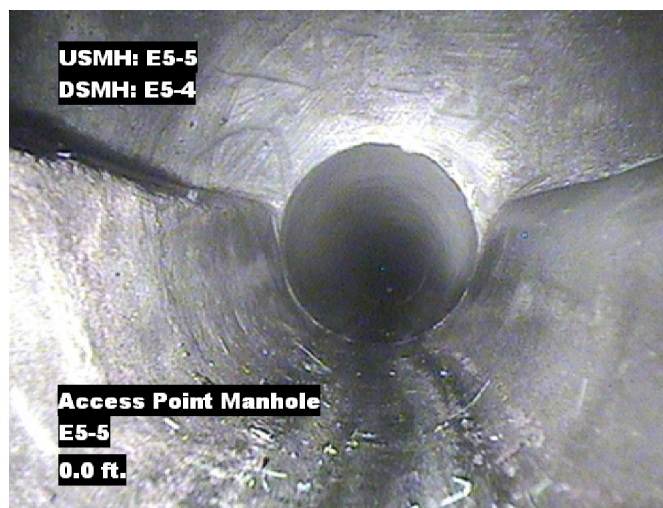
Distance: 0.0 ft. Grade: 0
Condition: Access Point Manhole
Remarks: E5-5

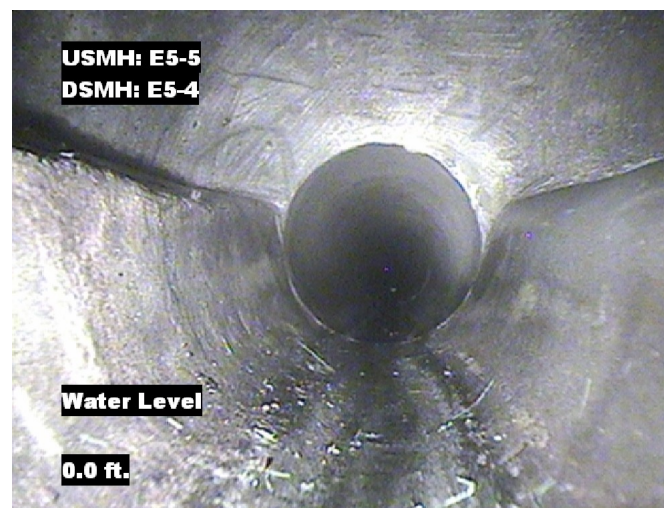
Distance: 0.0 ft. Grade: 0
Condition: Water Level
Remarks: N/A

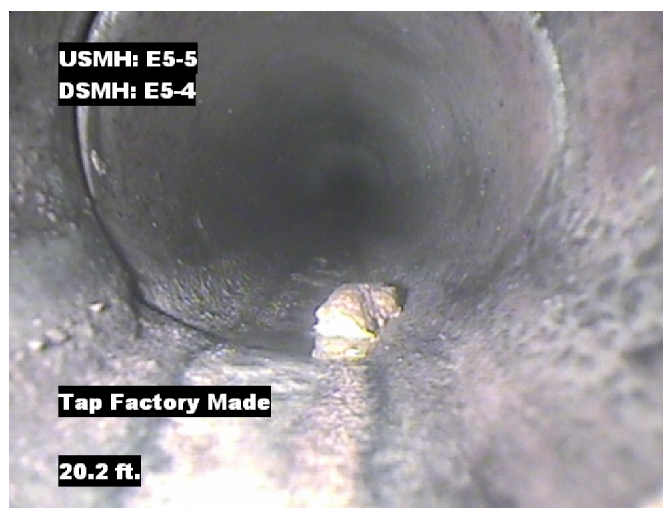
Distance: 20.2 ft. Grade: 0
Condition: Tap Factory Made
Remarks: N/A

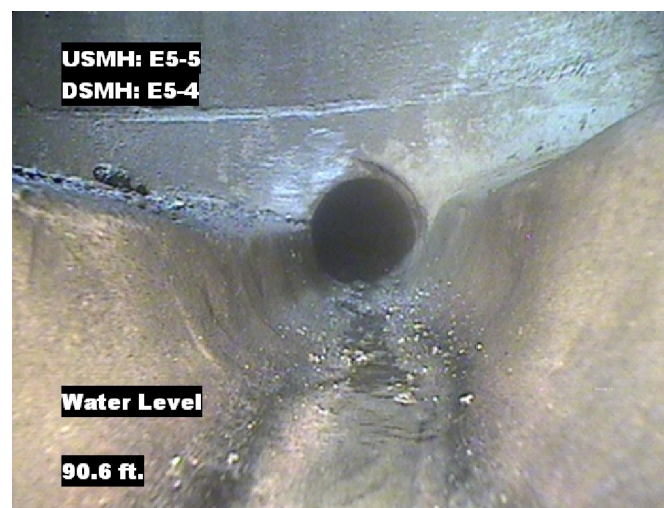
Distance: 90.5 ft. Grade: 0
Condition: Water Level
Remarks: N/A

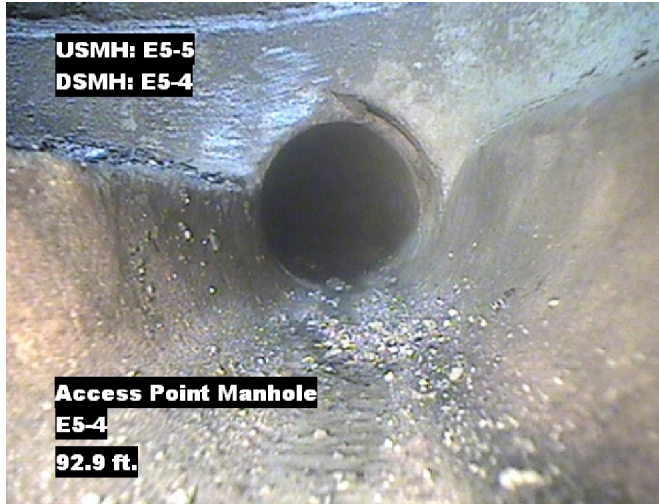
Distance: 92.9 ft. Grade: 0
Condition: Access Point Manhole
Remarks: E5-4
