Defect Listing

Pipe Segment Refere... E5-6_E5-5	City Oliver Springs	Street Ridgeview Dr	Material Concrete Pipe (non-...	Location C... Light High...	Sewer Use Sanitary
Upstream MH E5-6	Total Length 243.2	Year Laid	Shape Circular	Location Details Street	
DS Manhole E5-5	Length surveyed 243.2	Year Renewed	Height 8	Width 8	Pipe Joint... 4

SPR N/A	MPR 2	PO Number 4397-03	Customer GRW
SPRI N/A	MPRI 2	Work Order 4397-02	Purpose Pre-Rehabilitation Survey
QSR N/A	QMR 2100		
OPR 2	Surveyed By Barry Rogers	Direction Downstream	Date 20150612
OPRI 2	Certificate Number U-1012-16405	Pre-Cleaning Jetting	Time 08:20
	Date Cleaned 20150612	End Time 08:37	Weather Dry
			Additional Info

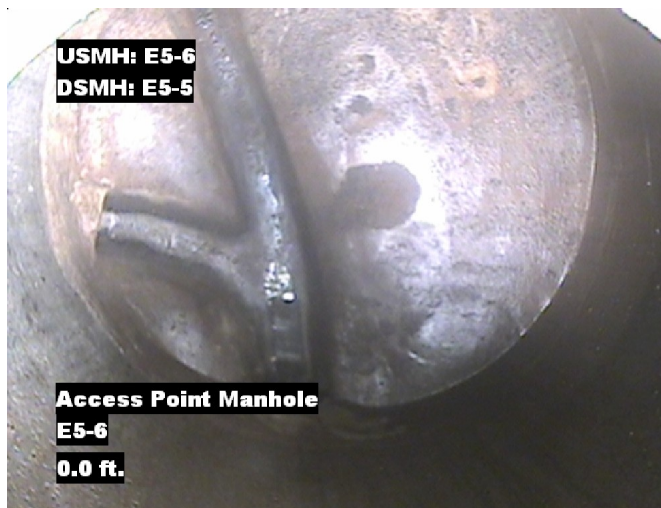
Distance: 0.0 ft. Grade: 0
Condition: Access Point Manhole
Remarks: E5-6

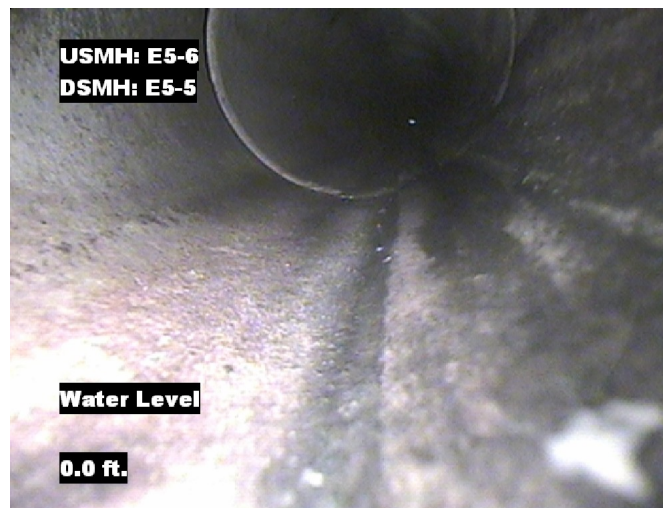
Distance: 0.0 ft. Grade: 0
Condition: Water Level
Remarks: N/A

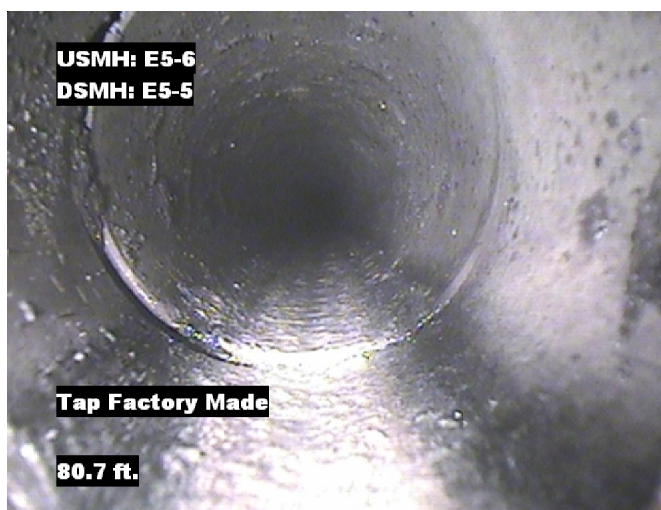
Distance: 80.7 ft. Grade: 0
Condition: Tap Factory Made
Remarks: N/A

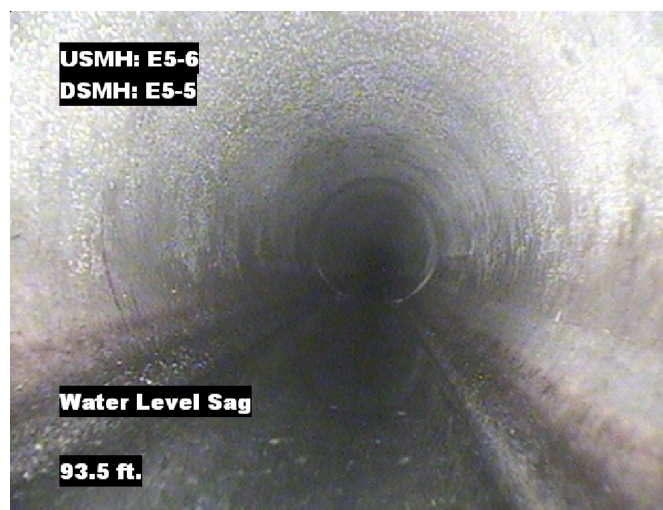
Distance: 93.5 ft. Grade: 2
Condition: Water Level Sag
Remarks: N/A

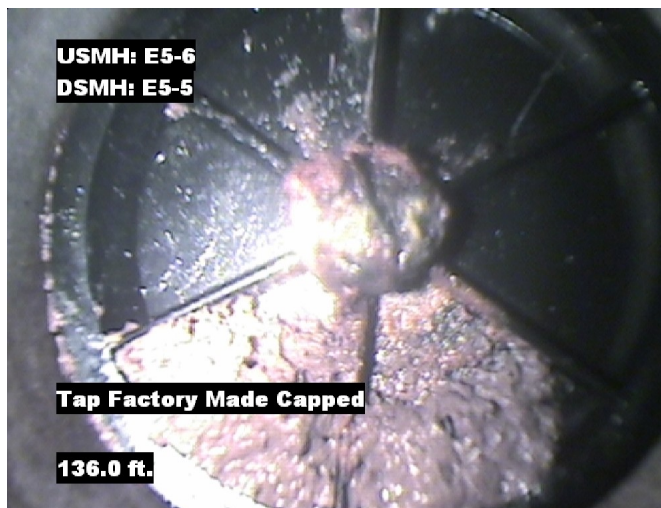
Distance: 136.0 ft. Grade: 0
Condition: Tap Factory Made Capped
Remarks: N/A

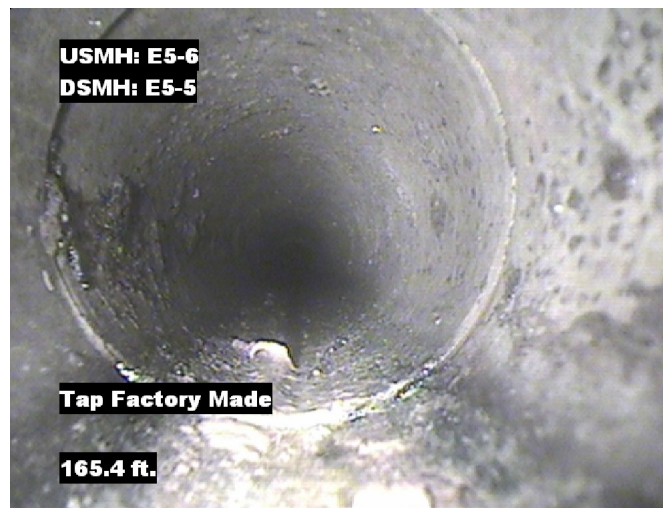
Distance: 165.4 ft. Grade: 0
Condition: Tap Factory Made
Remarks: N/A

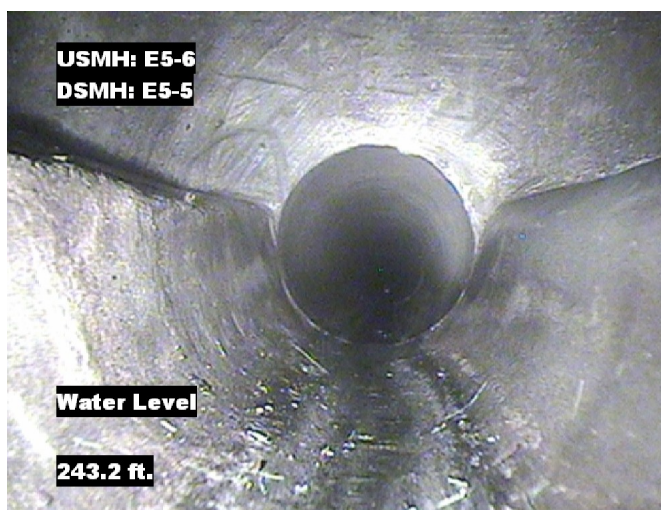
Distance: 243.2 ft. Grade: 0
Condition: Water Level
Remarks: N/A

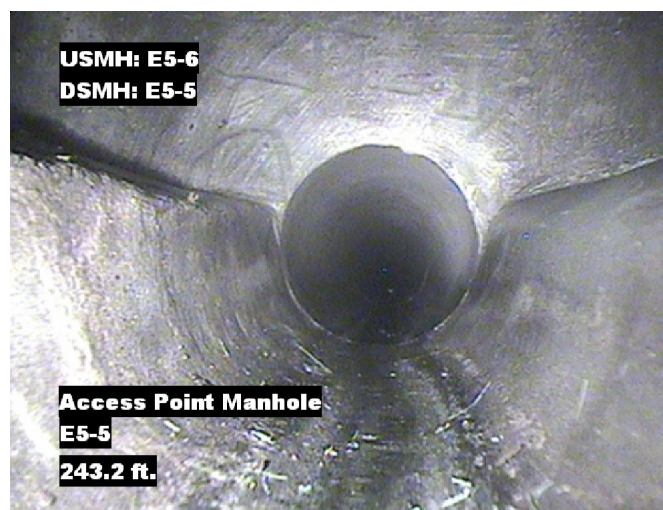
Distance: 243.2 ft. Grade: 0
Condition: Access Point Manhole
Remarks: E5-5
